**General Civil Aviation Authority**  
**Air Accident Investigation Department**  
**Abu Dhabi, UAE**  
**09/2009**

**FINAL REPORT**

**AIRCRAFT INCIDENT INVESTIGATION**

**Ayk Avia Airline**  
**IL 76 TD, EK76754**  
**Sharjah International Airport**  
**United Arab Emirates**  
**October 19<sup>th</sup>, 2009**

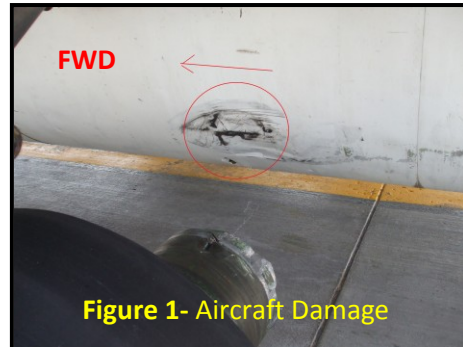
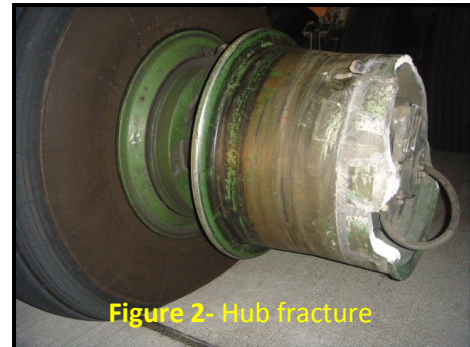
After the wheel disintegration from the axle, its debris impacted the L/H wing root fairing causing a deep dent of about 20x30 cm and a cut beneath it of about 20 cm in length and 3 cm in width (figures 1 and 2).

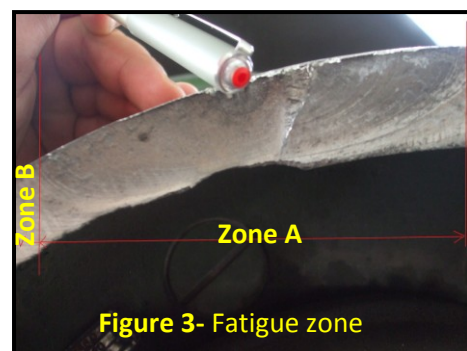
Figure 3- Fatigue zone

The visual inspection of the hub fracture surface shows two zones adjacent to each other (figure 3):

- Zone A of the fracture surface exhibited beach marks with dark and soft texture.
- The rest of the fracture surface (Zone B) was shiny and coarse.

The beach mark is generally a shape formed by fatigue failure, while the shiny shape is a result of sudden overload failure.

Examining the surface of fracture revealed that the inboard part of the hub was in place whereas the outboard part was fractured circumferentially except an intact portion of approximately 15%. The rim was totally defragmented into five pieces. The surface of fracture exhibited marks of fatigue failure.

The hub of the incident Aircraft fractured without prior detection. The length of the fatigue fracture surface indicates that the fatigue was old and the hub should have been detected before the final phase of fatigue is reached.

The Investigation Department determined that the probable cause of the Ayk Avia Airline "aborted takeoff incident" was the fracture and disintegration of left hand inboard aft wheel due to progressive undetected fatigue stress. The cause of why the fatigue was undetected is not determined.

Establish adequate wheel hubs' inspection program containing all the necessary program's elements.

To provide the IL76TD operators with a maintenance planning data/document for wheels' hubs' NDT Inspection.
