Air Accident Investigation Sector

- Summary Report -

AAIS Case N° AIFN/0011/2020

Ground Contact during Attempted Go-Around

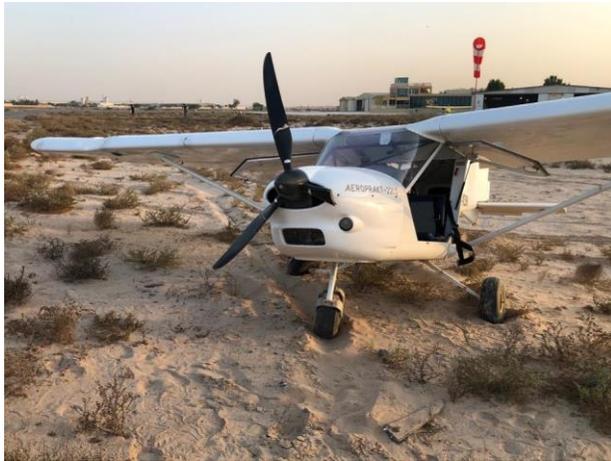
Figure 1. Aircraft resting point

The aerodrome observation camera footage showed the Aircraft turning to the right and tracking across the ground for approximately 25 meters until it came to a stop facing north-east, 14 meters to the left of the runway edge. (Figure 1.)

Because of the ground impact, the Aircraft sustained damage to the left wing, right wing, right flaperon, right main landing gear, nose wheel strut and shock absorber, tail wheel, and all three propeller blades.

The engine did not show any signs of leakage and the flaps were found extended to position 1.
