# Air Accident Investigation Sector

AAIS Case N° AIFN/0012/2020

# Fatal Ground Impact after Loss of Control

Operator:	Jetman Dubai
Make:	Jetwing
Place of Occurrence:	Margham, Dubai
State of Occurrence:	The United Arab Emirates
Date of Occurrence:	17 November 2020

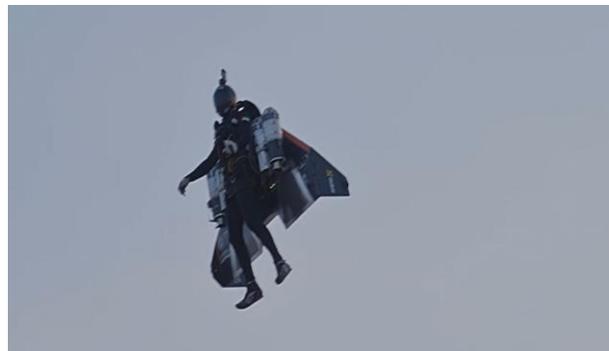
Figure 1. Jetwing pilot hovering

to the helicopter location and arrived hovering slightly above the altitude of the helicopter as shown in figure 1. He was then observed to reduce the altitude during the hover, but at a rate that appeared higher than usual.

Once the Pilot reached the approximate altitude of the helicopter, he was observed to enter a back-leaning attitude, followed by an abrupt back-flip. He entered a steep descent until he disappeared underneath the helicopter and out of sight of the helicopter occupants.

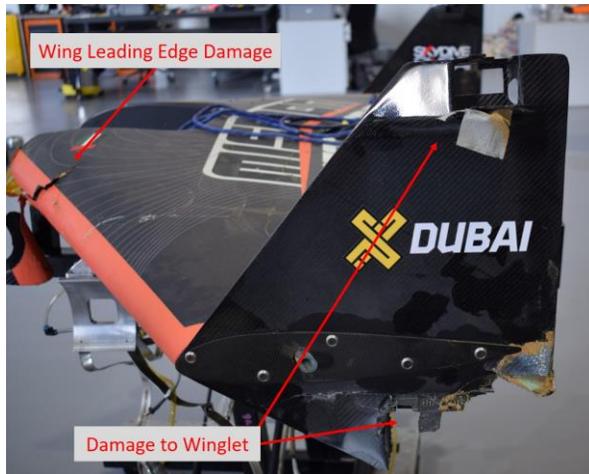
As a result of the impact with the ground, the Jetwing sustained damage to the pilot harness seat, the left wing leading edge and the left winglet, as shown in figure 2.

Figure 2. Jetwing damage

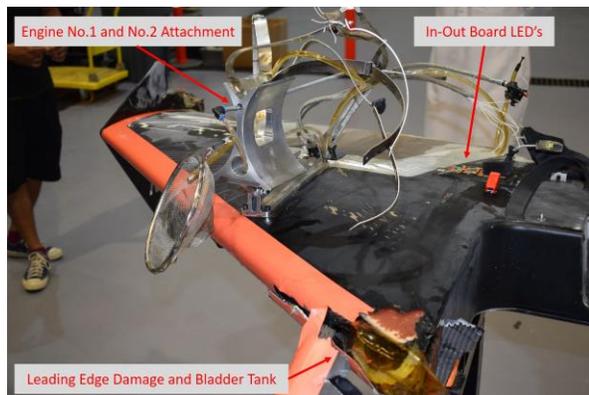
The fuel bladder tank was damaged and leaking fuel as seen in figure 3. However, approximately two liters of fuel was drained from the bladder tank during the post-accident examination.

Figure 3. Left wing damage

Both left engines, No.1 and No.2, were separated from the wing and damaged.

The No.1 engine thrust vector unit and the No.2 engine exhaust protection shield were damaged.

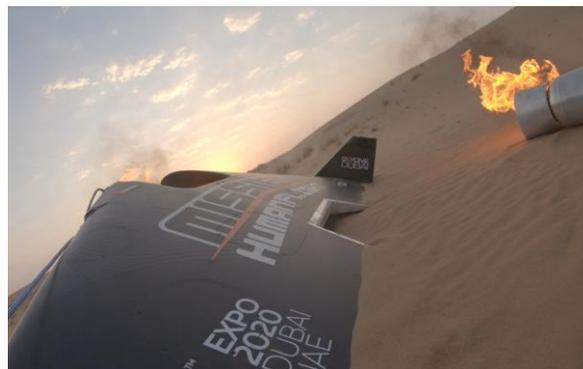
Footage retrieved from the two winglet cameras and the two helmet cameras captured post-impact fire at the separated No.2 engine and the wing, after impact with the ground as seen in figure 6. The fires extinguished after a minute.

After ground impact, the left winglet camera recorded an initial fire at the underside of the right wing and in the separated No.3 engine, as seen in figure 6. Both fires extinguished within a minute.

**Figure 6.** Jetwing fire after impact
