- Summary Report -

AAIS Case N° AIFN/0013/2019

Paramotor Ground Impact After Lift-off

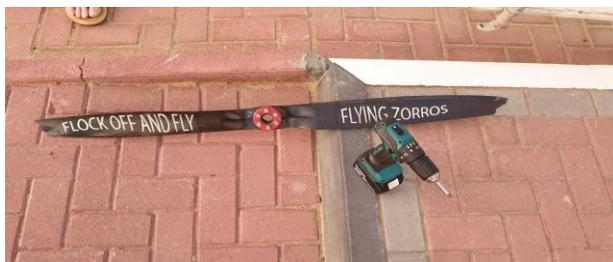
As a result of the impact with the ground, a Paramotor propeller blade was damaged on contact with the ground.

Figure 2. damage to the propeller blade resulting from the impact

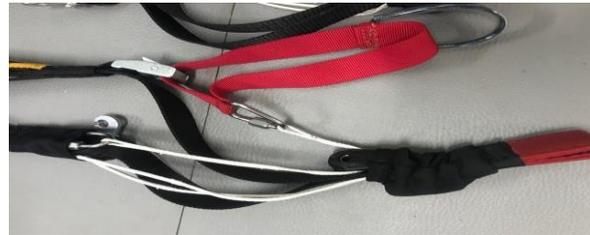
Figure 6. Both trims were equally trimmed for the accident flight

After an initial failed wing launch, the Pilot attempted a second launch and he set engine power to full. Putting the engine to full power on this engine generates a negligible veer to the right as a result of residual torque. To counter such an effect, an adjustment in a form of riser's installation can be applied, or the trim on the side can be slightly opened to reduce the residual torque. The Investigation verified that no risers were installed to counter residual torque, nor the trims on the side were slightly opened to reduce it.

The General Manager demonstrated two takeoffs: one with right trim opened; and one with both trim fully closed. It was found that the residual torque was not significant and did not affect the Paramotor controllability if left unadjusted. Although the application of this technique may be beneficial in counteracting the slight residual torque, this benefit may be outweighed by the effort that paramotor pilots need to pay for controlling the paramotor.

The Investigation found that residual torque was not a factor in the Pilot losing control of the Paramotor.
