AAI Case Reference: 02/2011

AIR ACCIDENT INVESTIGATION REPORT

AIRCRAFT CRASH AFTER TAKEOFF

McKinnon G-21G
N221AG
Triple S Aviation
Al Ain International Airport
United Arab Emirates
27th February 2011

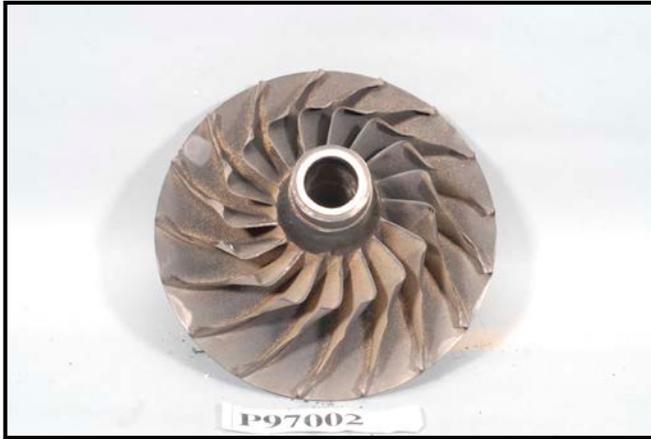
- The first stage compressor impeller shroud showed heavy rubs at exducer and knee with heavier indications at the bottom.
- The first stage compressor impeller showed that all blades at the inducer and exducer were bent in direction of rotation. There was also rotational scoring at the rear curvic outer diameter and back face at hub. (Appendix 1, Figure 1). The first stage compressor diffuser showed rubs corresponding to impeller back face.
- The second stage compressor housing showed 360 degrees uniform heavy rub from inducer to exducer.
- The second stage compressor impeller showed rub on the entire length of the blade. . (Appendix 1, Figure 2).

Figure 1- Rub on the entire length of the engine No. 1 first stage compressor impeller

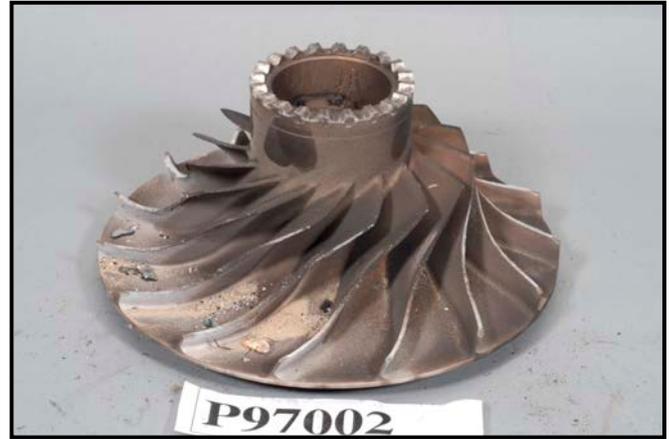
The rub marks and the bending of the impeller blades to the direction of rotation gave clues that both engines were rotating pre-impact but with unknown engines' power settings.

Figure 2- Bent blades and scores on engine No. 1 second stage compressor impeller

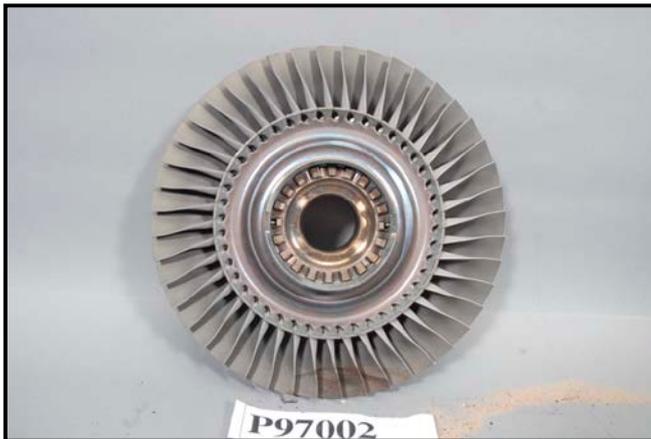
- The first stage turbine stator and rotor were intact and showed metal spray and material deposit on shroud over 90 degrees. There was also rubs at the aft inner diameter of the rotor platform.
- The second stage turbine stator and rotor showed metal spay on suction sides. The stator showed rubs on forward inner platform and heavy rubs in honeycomb seal offset to aft side. The rotor showed rub on aft side of rotor platform and blade tips.
- The third stage turbine stator showed heavy rubs on the inner diameter honeycomb seal.
- The third stage turbine rotor showed metal spay on the suction side and rub on the aft side of rotor at platform and at aft edge of blade tips. (Appendix 1, Figure 3).

Figure 3- Rub marks at engine No. 1 third stage turbine rotor platform

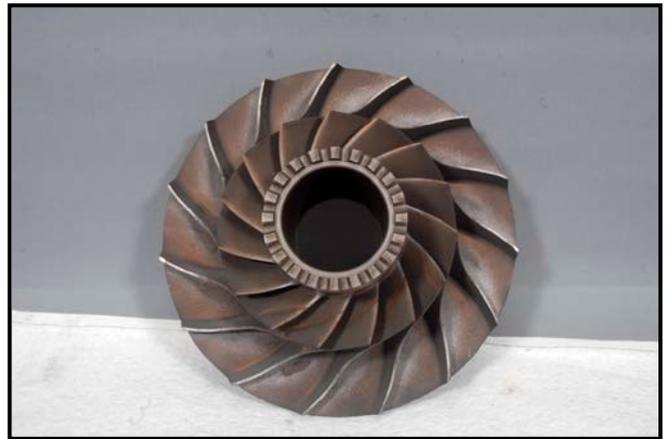
- The first stage compressor impeller intact, undamaged with marks of rub from knee to exducer.
 - The second stage compressor housing was intact with shroud rubs of 360 degrees at the exducer and local rub at 3 o'clock at inducer.
 - The second stage compressor impeller was intact with marks of blade rubs in knee to exducer. (Appendix 1, Figure 4).
- (b) The turbine section:
- The first stage turbine stator, shroud and rotor were intact and showed metal spray leading edges and suction sides.
 - The second stage turbine stator, rotor showed metal sprays on the leading edge and suction sides.
 - The third stage turbine stator and rotor were intact metal sprays on the suction side trailing edges.

Figure 4- Marks of blade rubs in engine No. 2 first stage compressor impeller

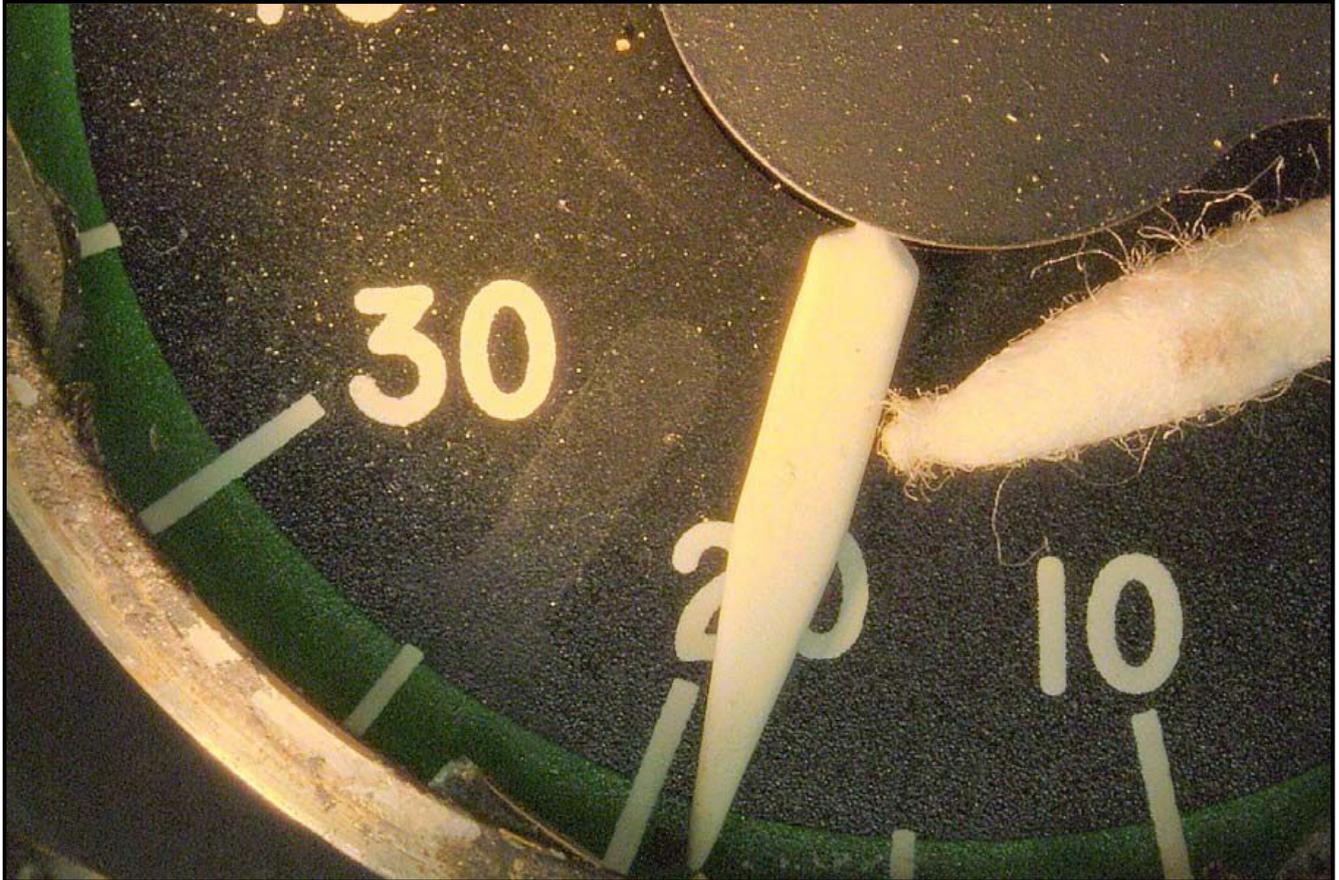
Except the engine No. 1 Torque Indicator, all indicators were either hidden by heavy soot or could not depict any witness mark.

The engine No. 1 Torque Indicator depicted a witness mark near the 25 psi marker.(Appendix 2, Figure 5).

Figure 5- The torque indicator of engine No. 1 depicted a witness mark near the 25 psi marker.
