AAI Case Reference: 03/2010

AIR ACCIDENT INVESTIGATION REPORT

AIRCRAFT CRASH DUE TO ABRUPT MANOEUVRE

Light Sport Aircraft
Aeroprakt A-22
A6-XAP
Al Jazirah Aviation Club
Ras Al Khaimah
The United Arab Emirates
19th March 2010

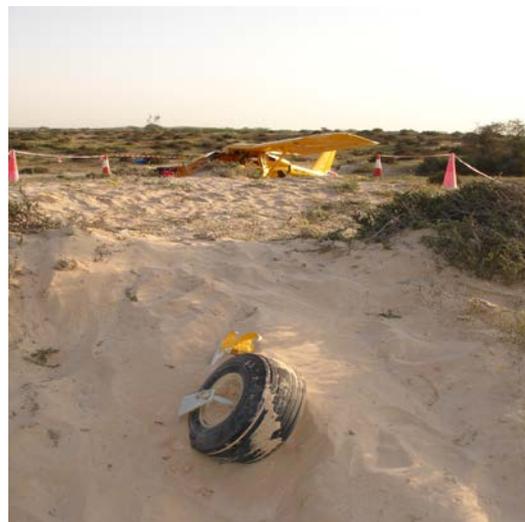
Figure 1- Wreckage distribution diagram

The location of the impact was at approximately 500 ft meters southwest of RWY 28. The Aircraft was in one unit except the nose landing gear which detached and found (65 ft) before the Aircraft final stop.

The nose of the Aircraft was heading to approximately (37°). The airspeed indicator was pointing to approximately 35 km/hr (18.9 kts), the vertical speed and altitude indicators were pointing to zero,

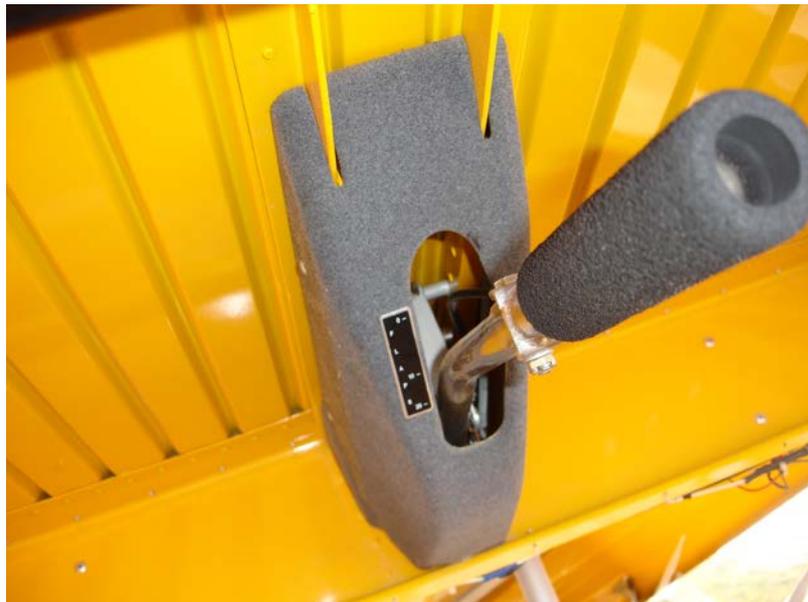
Figure 2- Flaps’ handle

A ‘Warning’ in the A-22 Manual prohibited pilots to raise the flaps suddenly at low level, either on the approach or climb-out, because the aircraft will sink noticeably as the flaps retract. The position of the cockpits flaps’ handle showed that the flaps were set at position 1 (out of three positions- 0, 1 and 2, see figure 2), that position was not covered in any of the ‘missed approach and go-around’ two methods mentioned above.

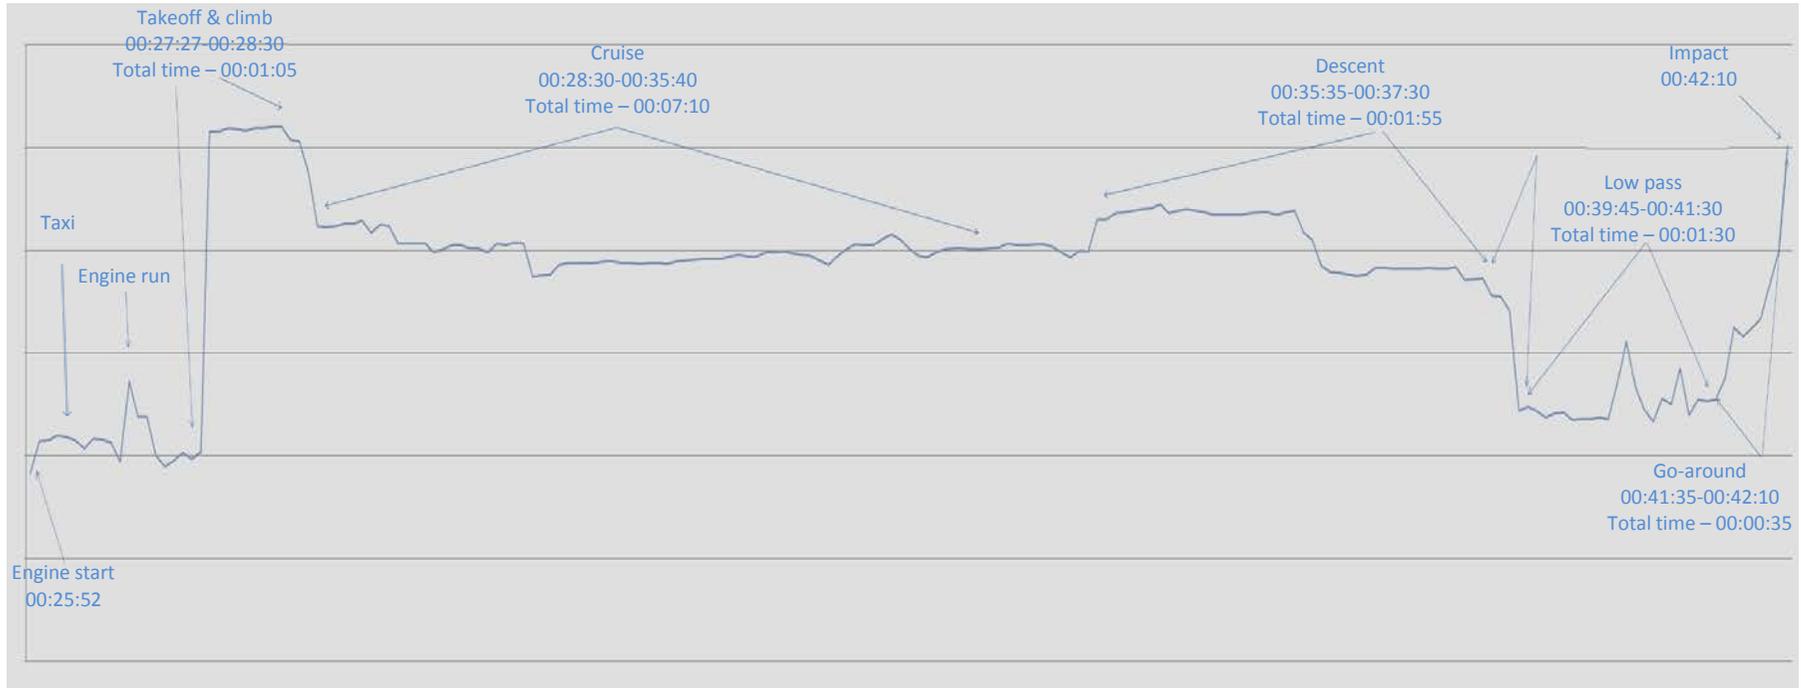
APPENDIX A- ENGINE POWER SETTING CHART

After takeoff, the engine power was continuously varied by the pilot to manage the in-flight manoeuvrability. The recorded engine parameters showed that the engine power was advanced to maximum takeoff power and kept for 45 seconds; thereafter the power was reduced to 4000 RPM to stay for around 7 minutes and 20 seconds.

The engine power then increased to 4400 RPM and continued for around 2 minutes before reduced to 3820 RPM and stay constant for 1 minute and 50 seconds. During the next 2 minutes, the power was fluctuating between 2350 and 3110 RPM before being increased gradually to 4000 RPM.

The field examination of the engine revealed that the engine was functioning normally: the induction, fuel, ignition, cooling and lubrication systems were intact with no indication of in-flight deficiency or signs of malfunction. The engine reader's downloaded data confirmed that there was a consistent response of the engine within the different phases of the flight.

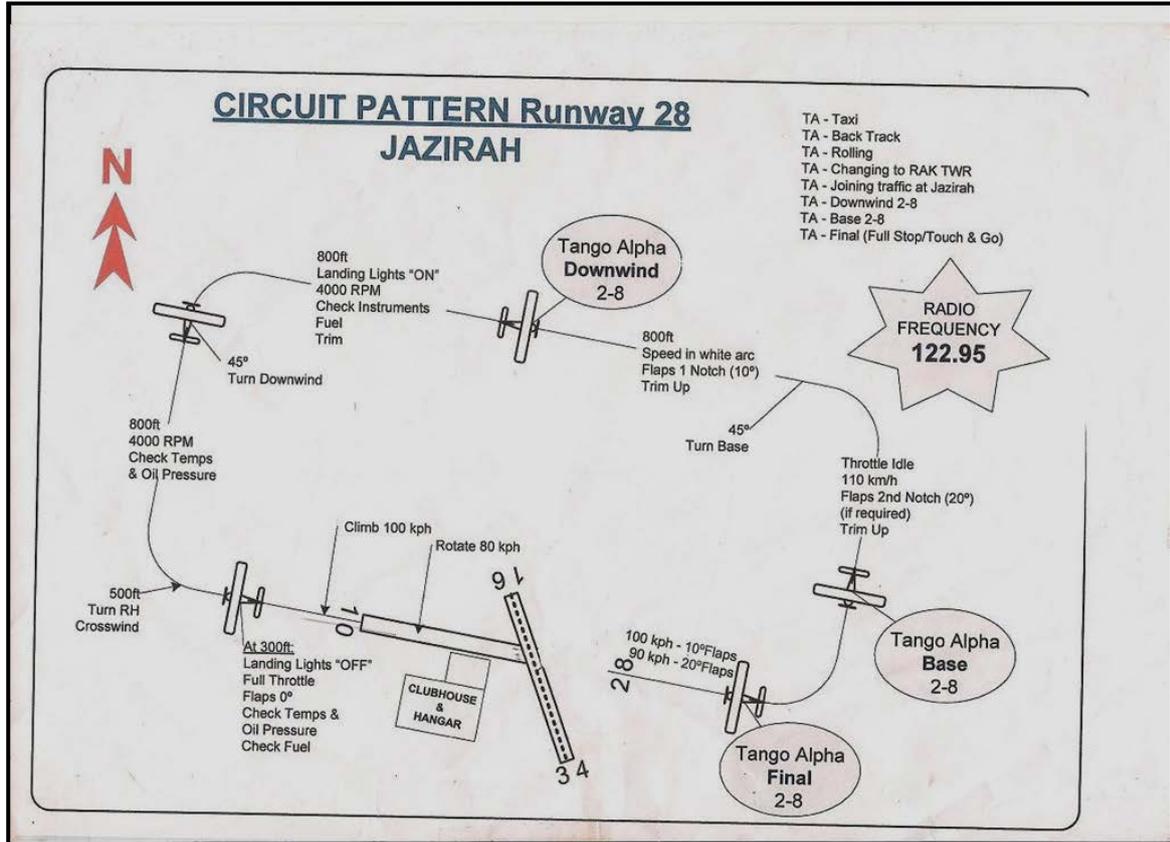
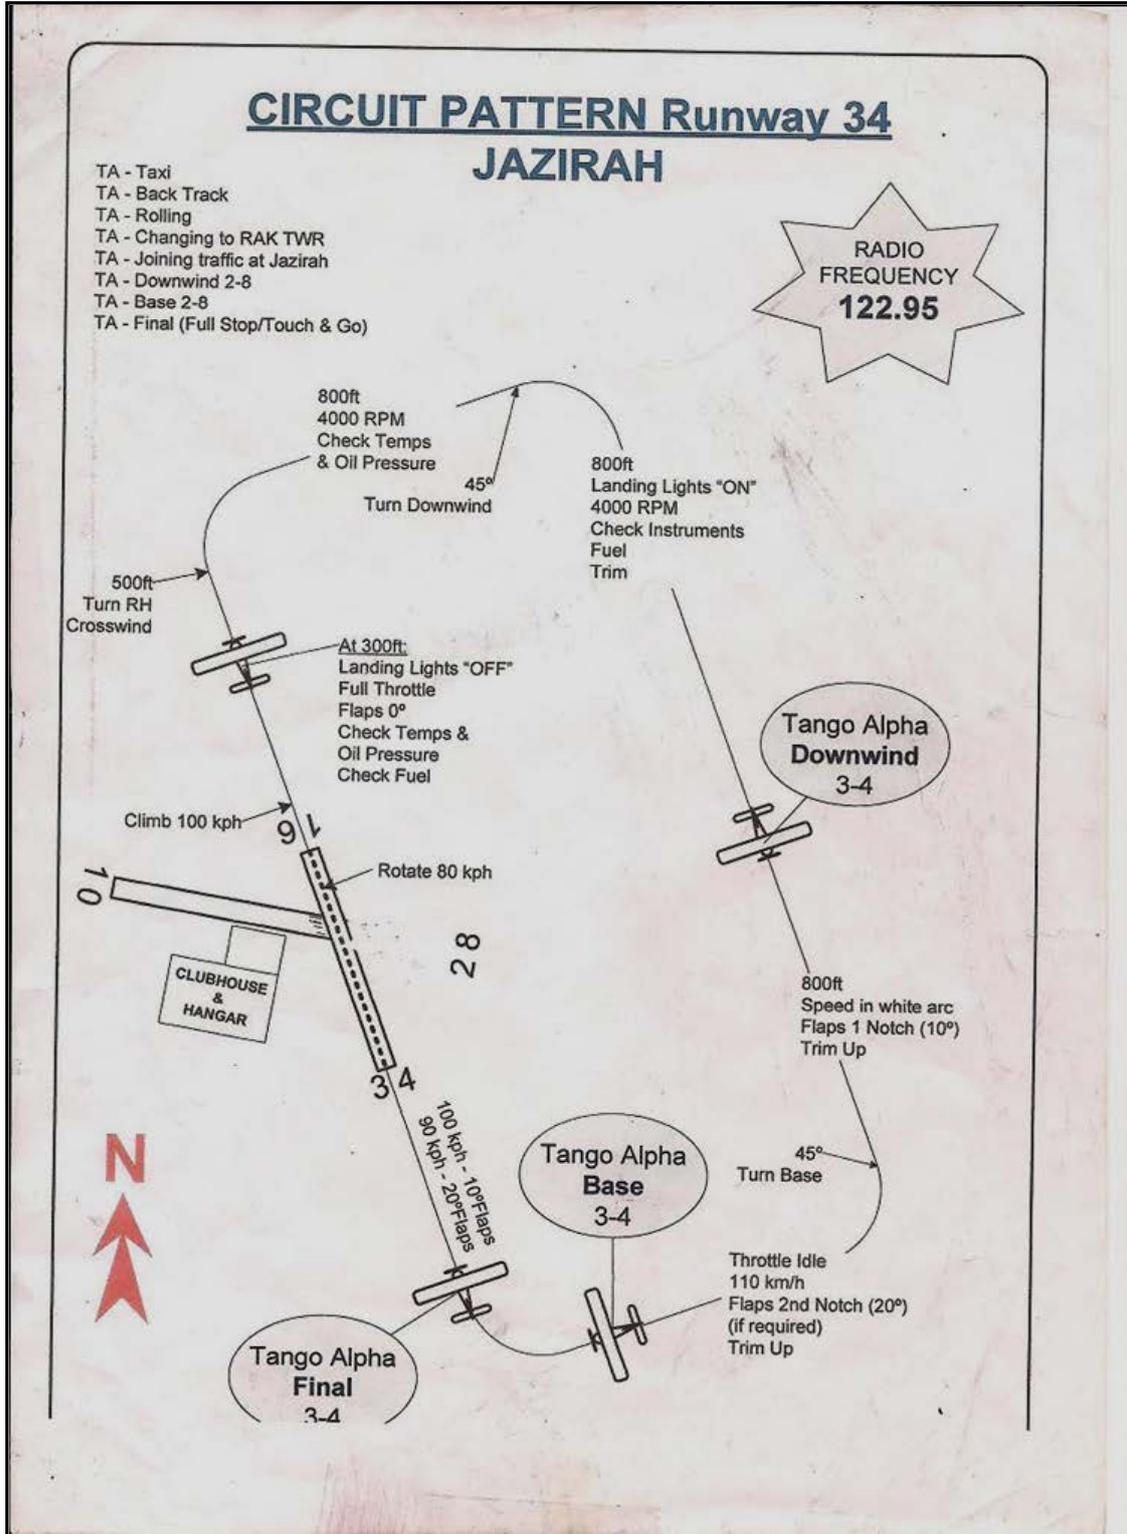
APPENDIX B- CIRCUIT PATTERNS AS CONTAINED IN THE CLUB'S MANUAL

According to the Club's Operations Manual, circuit pattern flight for RWY 34 should be initiated to the right while it should be to the left for RWY 16. Traffic pattern altitude should be 800 ft AGL. Aircraft joining the circuit should join on the downwind side of the circuit only after passing overhead centre field at not less than 1000 ft and not more than 1400 ft AGL. Vertical limitations were to be strictly followed, which was not more than 1400 ft AGL and not less than 500 ft AGL. (Appendix B).

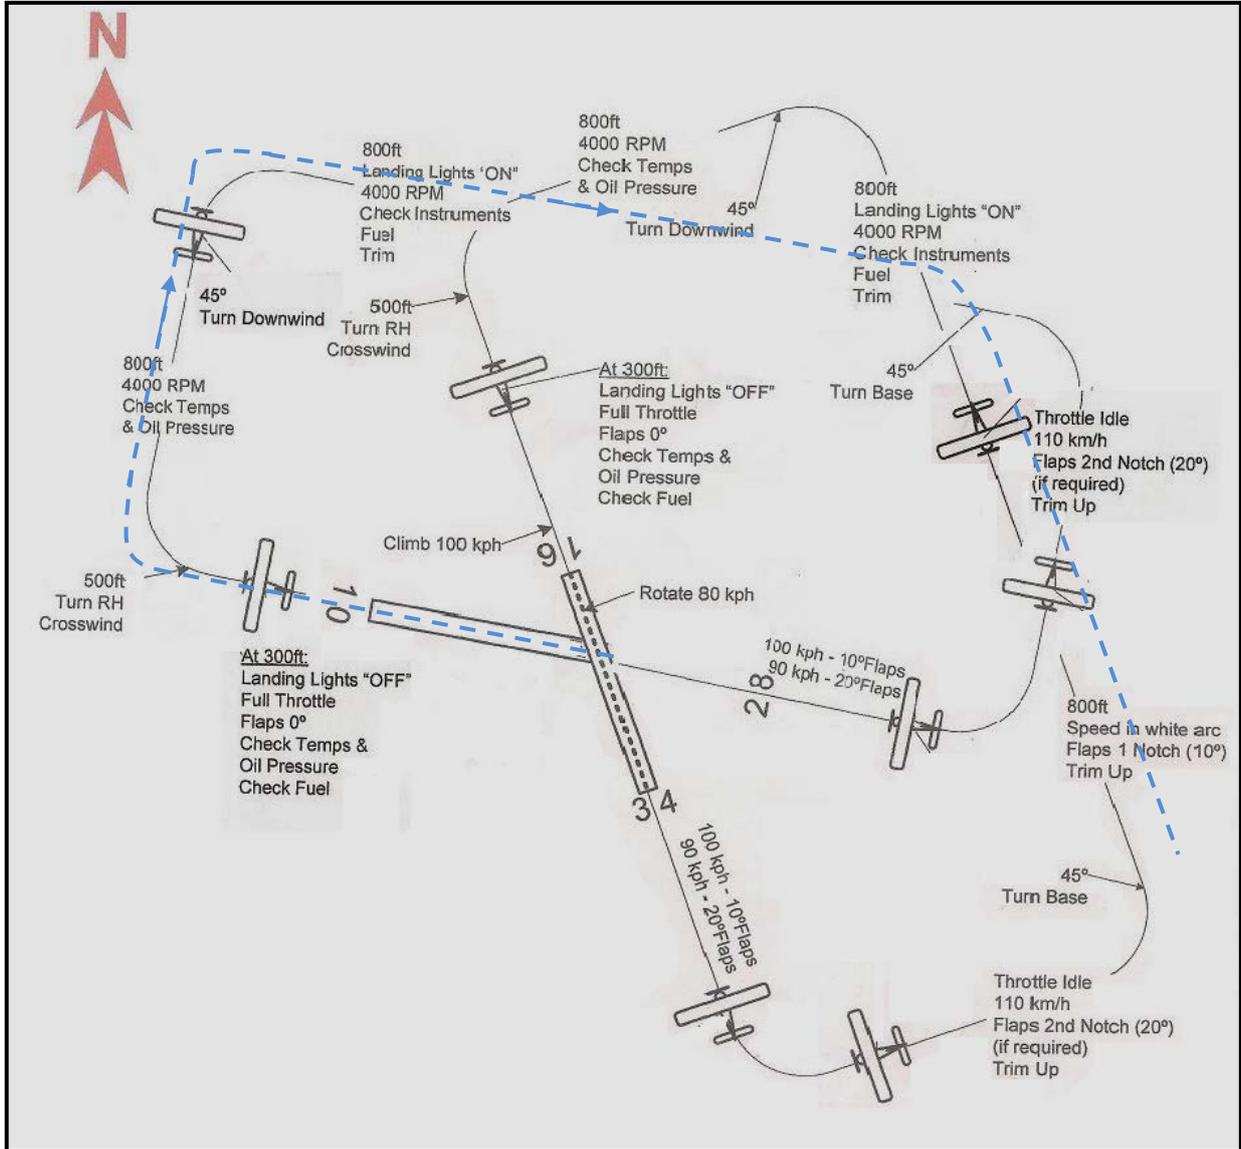
APPENDIX C- CIRCUITS PATTERNS OF BOTH RUNWAYS

According to the Club's Operations Manual, and according to the published AIP, approaching RWY 34 should be from the right side, i.e after the go-around from RWY 28, the Aircraft should continue climbing, follow the RWY 34 circuit pattern before the final approach to RWY 34 (blue line in Appendix C).
