Serious Incident
- Final Report -
AAIS Case N° AIFN/0010/2014

Aircraft Attempted Takeoff from Taxiway

Operator: Bahria Town Aviation
Type: Hawker Beechcraft 400XP
Registration: AP-RBA
Location: Al Maktoum International Airport, Dubai
State of Occurrence: The United Arab Emirates
Date of Occurrence: 23 May 2014

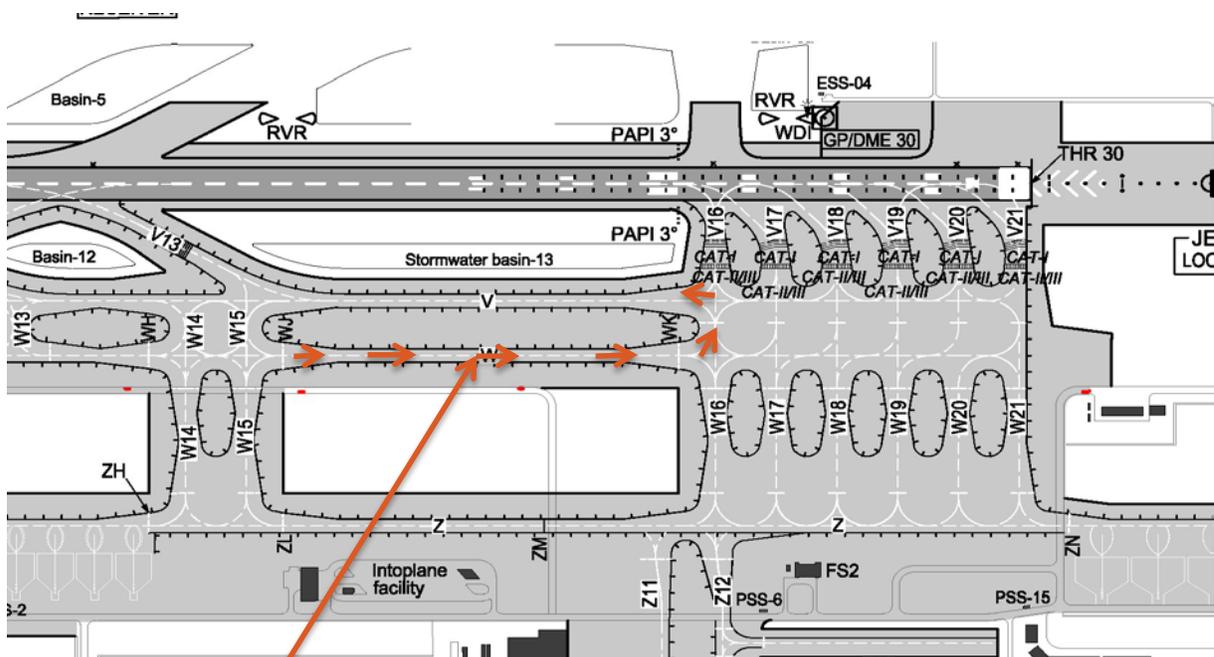
Figure 01. Airport layout

As the Aircraft approached the end of taxiway Whisky, it turned left at junction Whisky 16, and then, mistakenly, made a premature left turn and lined up on taxiway Victor instead of continuing straight ahead on taxiway Whisky 16 to Runway 30 (See Figure 01, airport layout).

As the Aircraft approached the end of taxiway Whisky it turned left via junction Whisky16, and then mistakenly made another left turn and lined up on taxiway Victor instead of continuing straight on Whisky16 to Victor 16, crossing taxiway Victor, and then turning left to enter runway 30.

The Red Arrows showing the taxiing phase on taxiway Whiskey and premature turn left on taxiway Victor to commence the take-off roll mistakenly from taxiway Victor.

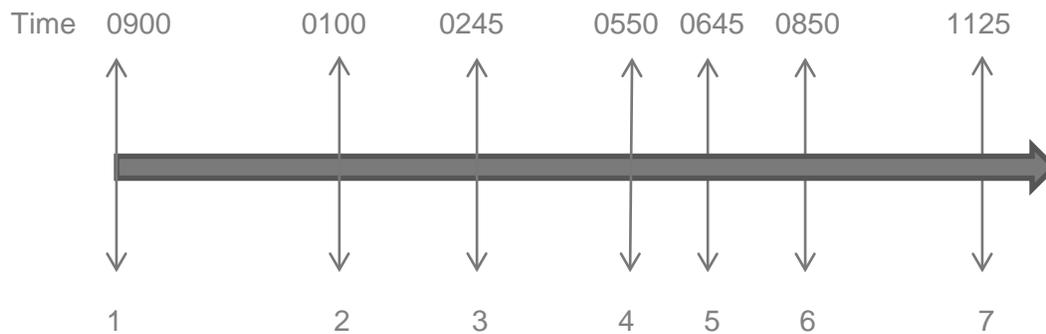
The flight crew started their duty time at approximately 0100 UTC. They flew two sectors before the Incident flight. Their duty time duration was 10 hours 25 minutes, including the additional waiting time for refueling at Al Maktoum Airport, as is shown below:

1. End of duty time on the day before the incident day, (16 hours rest).
2. Start duty time in the day of incident
3. Takeoff from Islamabad
4. Landed Karachi
5. Takeoff from Karachi
6. Landed Al Maktoum
7. Incident takeoff

The cumulative effect of awakening in the early morning, operating two sectors before the Incident flight during a time when the crew's Circadian rhythm was low, and then managing the problems during the delay, while exposed to elevated temperatures and high humidity, caused the crew to become tired and degraded their situational awareness.
