الهيئة العامة للطيران المدني
GENERAL CIVIL AVIATION AUTHORITY

- Final Report -

AAIS Case N°: AIFN/0005/2015

Fatal Parachute Accident

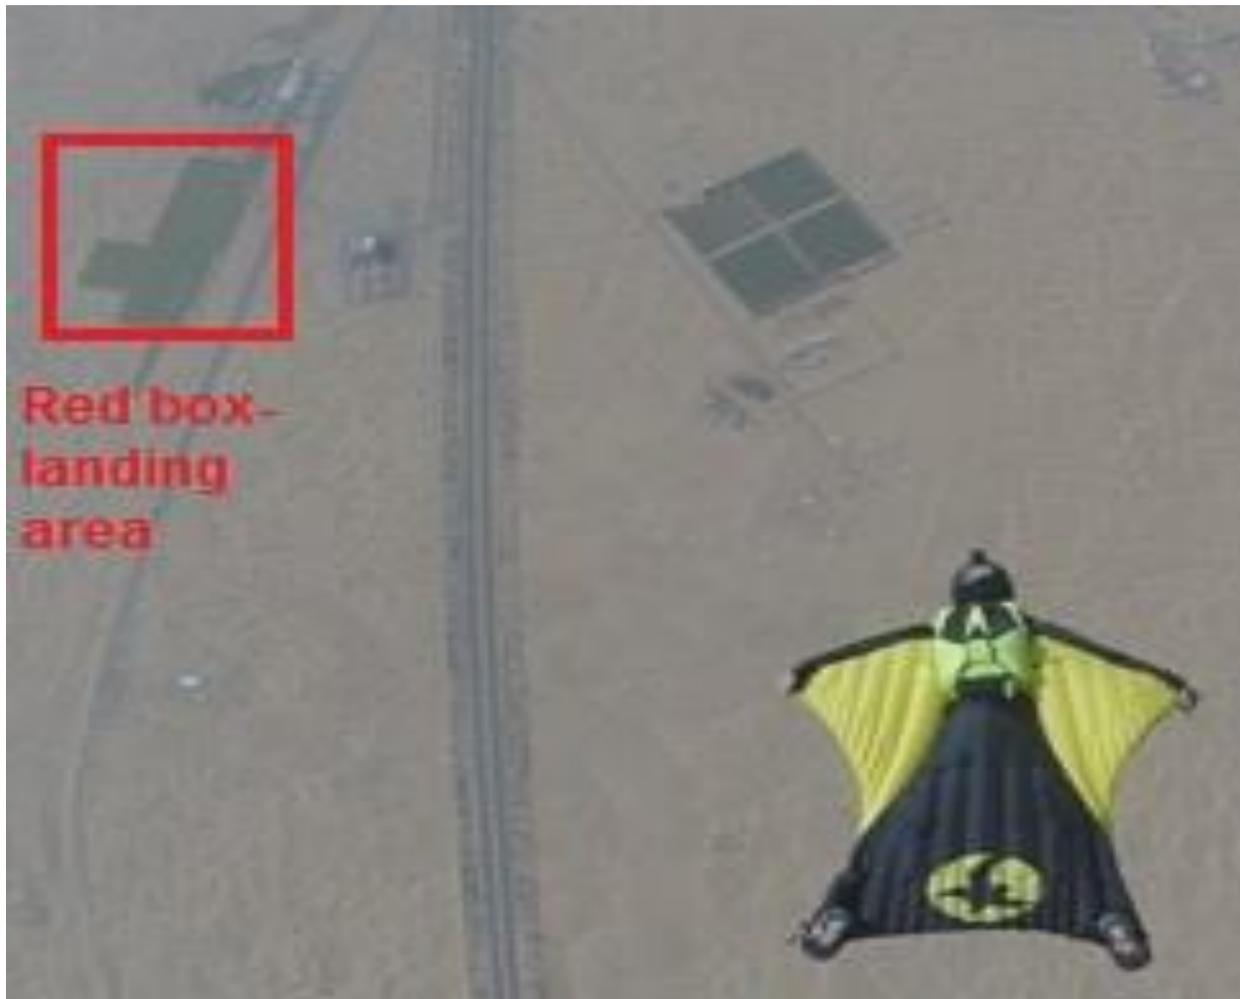
On 30 April 2015, at approximately 0830 local time of the United Arab Emirates (LT), a Skydiver, after an uneventful exit from the aircraft at 13,000 feet, had a normal free flight through the air. However, shortly after the parachute main canopy deployment, the Skydiver's descent to the ground became uncontrolled leading to impact with the ground and the Skydiver's death.

Figure 2. The Skydiver and landing site

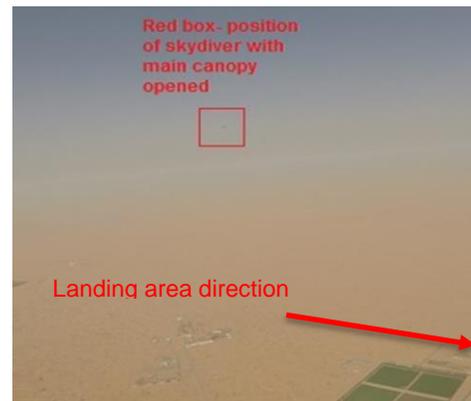
Figure 3. Skydiver main canopy open

- 110 to 121 seconds- Figure 3- The accompanying skydiver's main canopy is seen to open normally.
- 135 seconds- The accompanying skydiver's camera showed the Skydiver to the left of the designated landing area. The recording shows that the main canopy was deployed,

The Investigation could not determine the exact time of the Skydiver deploying his canopy but the recording showed that his canopy had opened. When the Skydiver was next seen in the video recording, it was noted that he was in an anticlockwise spiral descent. It was estimated that he made a 360-degree spiral descent in about 13 seconds. The probable cause for this action was that he might have lost his situational and altitude awareness as it appeared that he was far from the designated landing area.

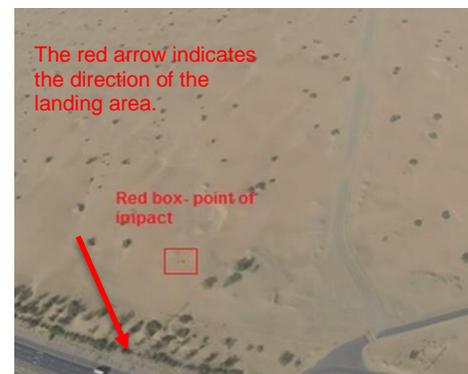
Figure 4. Impact position

- 201 seconds- The Skydiver made a sharp right turn,
- 202 seconds- The Skydiver entered into a violent anti-clockwise spin directing towards the sand,
- 220 seconds- Figure 4 - The Skydiver impacted the sand,

Thereafter, the Skydiver entered into an anticlockwise spin at an approximate rate of one spin every three seconds. The spin lasted for about 18 seconds until the Skydiver impacted the ground. The high rate of spin would have made it difficult for the Skydiver to cut away the main canopy and deploy his reserve canopy.

The Air Accident Investigation Sector determines that the cause of the Skydiver fatal Accident was, most probably, a loss of situational awareness and the inappropriate use of the parachute breaks.
