# Air Accident Investigation Sector

### - Preliminary Report -

AAIS Case N°: AIFN/0013/2015

## Gyrocopter Loss of Control

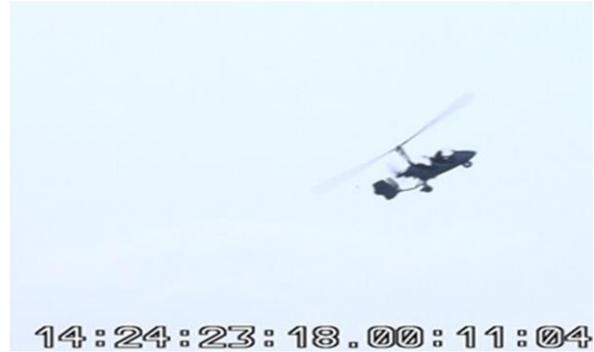
Figure 4. The Aircraft climbs to 250ft

9. Time 101 secs (Figure 4) – The Aircraft is nose high. The pilots left hand momentarily returns to the throttle. The control stick is full forward and it appears that the Gyrocopter goes into zero or negative G, with the Rotor RPM at approximately 400.

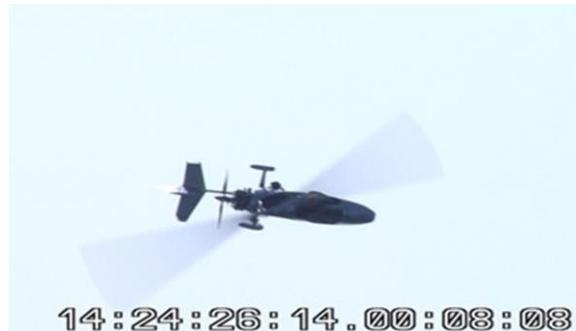
Figure 5. Aircraft starts to invert

10. Time 103 secs (Figure 5) - The Aircraft rolls to the right at almost 90 degrees after reaching 250 feet altitude. The Pilot pulls the control stick back and to the left. Airspeed is indicating near zero and the

rotor RPM was dropping rapidly.

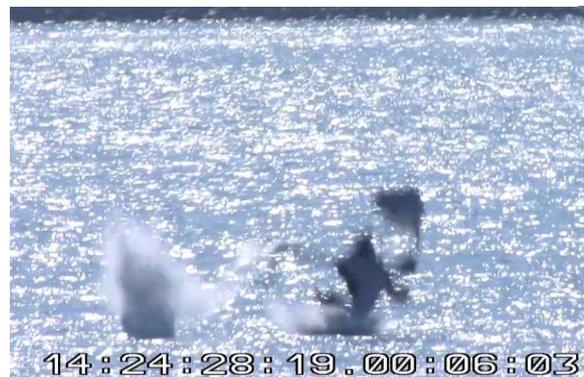
Figure 6. Aircraft impacts the water

11. Time 105 secs (GoPro 06:01) (Figure 6) – The Aircraft impacts the water at approximately 90km/h in a nose down attitude.
12. Time 109 secs (Figure 7) - The Aircraft rolls onto its back and submerges six secs after the impact. The Pilot is not seen until he is recovered by the Dubai Police Search and Rescue team.

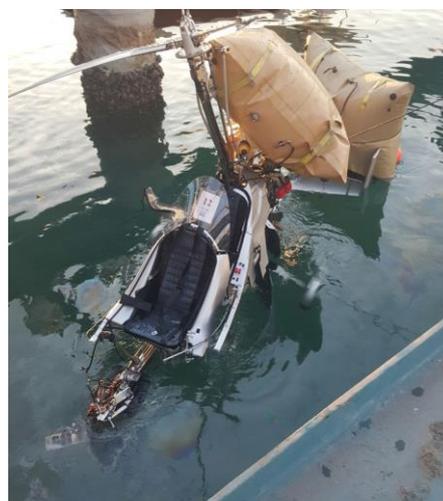
Figure 8. Gyrocopter lifted from the sea.

There was extensive damage to the Aircraft. The majority of the glass fibre monocoque at the front of the Aircraft was damaged and a large area was absent.

The instrument panel was still loosely attached to the Aircraft by numerous cables and tubes.

The nose wheel had departed and the push rods attached to the pedals had broken.

The rudder cables were in good condition, whilst the controls rods were bent and distorted due to the impact.

The main cyclic control and all its associated control rods were bent and distorted in certain places due to the impact, but the cyclic control was still intact.

The main fuel tanks were ruptured and contaminated with sea water. A fuel sample was therefore not obtainable.

The exterior of the Rotax engine and the propeller showed no signs of damage. One rotor blade had sheared off and the other was bent and distorted.

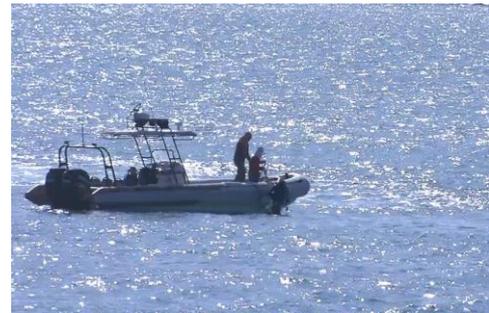
Figure 10. Diver in the water

The Search and Rescue Team arrived at the Accident location within 40 seconds and the first diver (Figure 10) was in the water 72 secs after the impact. The Pilot was recovered after 10 minutes (Figure 11) and cardiopulmonary resuscitation (CPR) was applied approximately two minutes after he was placed in the rescue boat.
