الهيئة العامة للطيران المدني
GENERAL CIVIL AVIATION AUTHORITY

Accident - Final Report -

AAIS Case N° AIFN/00018/2012

Passenger Door Separation In-flight

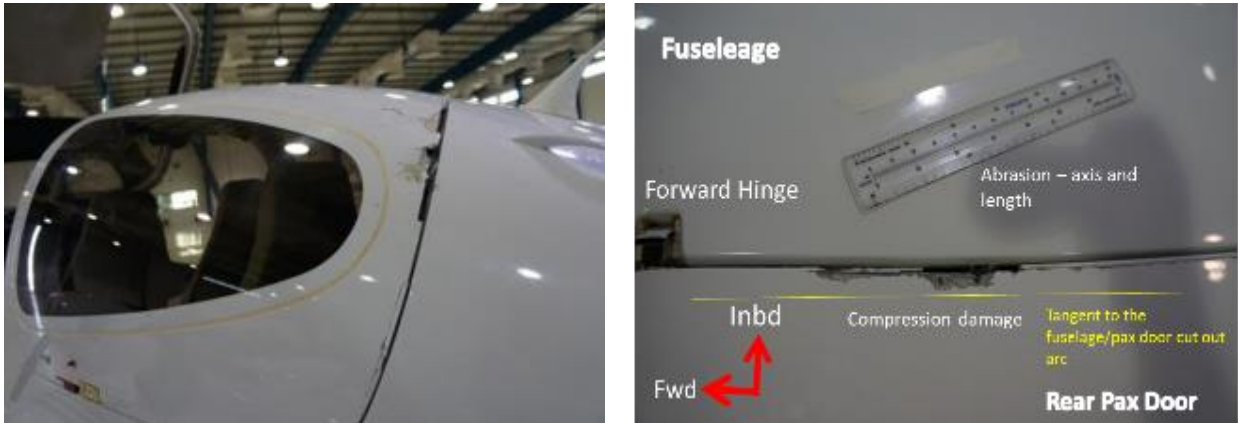
Figure 1. Passenger door damage

The passenger door separated from the fuselage as a complete assembly. The door detached from the latched lower edge and was blown upwards due to aerodynamic loads, before separating from the upper hinge line, which failed beyond the hinge design limit load.

The rear passenger door was recovered from the sand area adjacent to the active runway. The door was intact but had sustained edge damage due to impact with the ground.

The upper hinges for the aft passenger door suffered damage consistent with failure beyond limit load. The door support/gas operated strut retainer had failed under load.

There was impact damage consisting of an abrasion/scuff mark on the upper surface of the fuselage consistent with the angle of elevation of the door as it was lifted due to aerodynamic loads and the door hinge geometry.

The abrasion line indicated that the door elevation restraint mechanism (the gas spring strut) had failed.

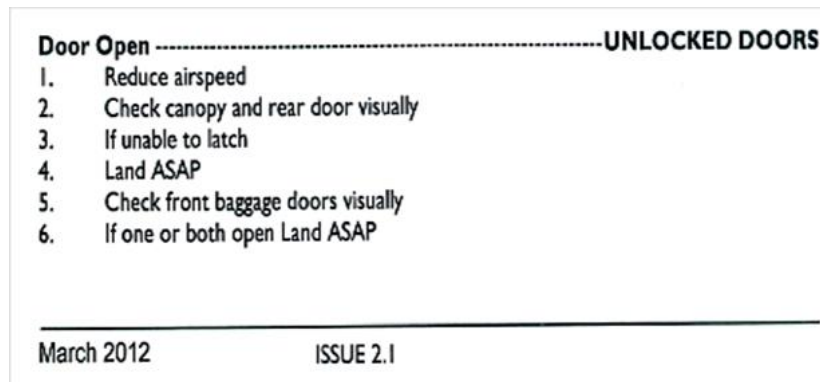
Figure 4. The Academy's *Door Open* warning checklist

The Academy's *Door Open* checklist was not in line with the manufacturer's '*Rear Passenger Door Unlocked*' checklist.

The Academy's *door open warning* checklist warning required the crew to check canopy and rear door visually and if unable to latch land "ASAP [as soon as possible]." (Figure 4).

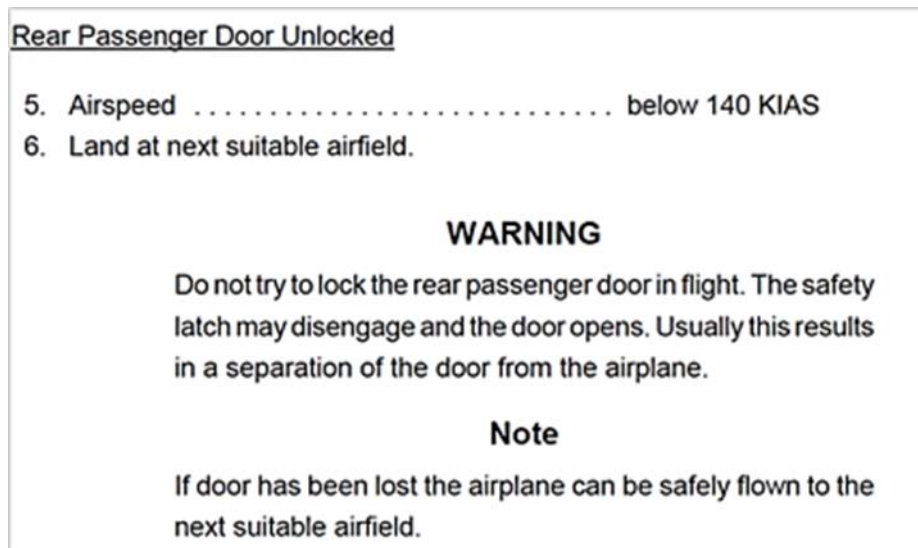
Figure 5. The manufacturer's *Rear Passenger Door Unlocked* checklist

The manufacturer's *Rear Passenger Door Unlocked* checklist implicitly states that no attempt should be made to 'lock the rear door in flight'. The reason for this is that the safety latch may disengage and the door may open in flight. (Figure 5).

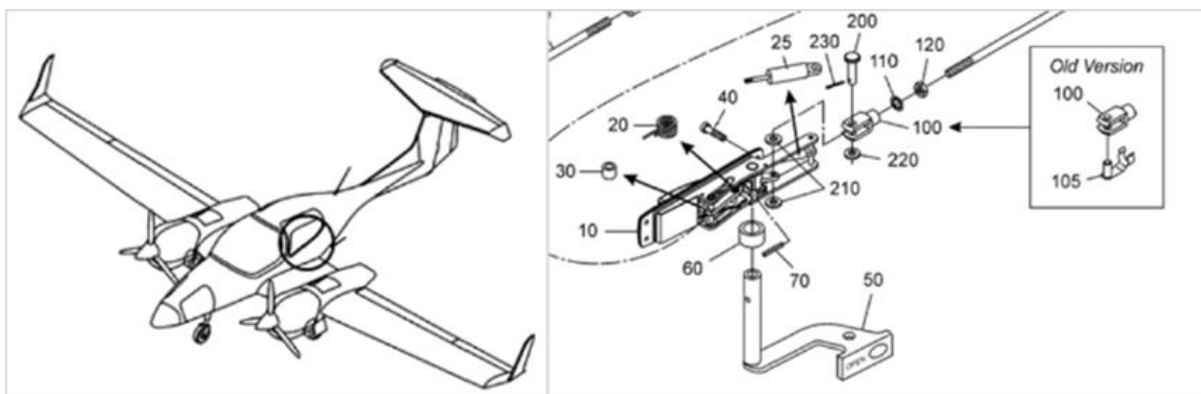
Figure 6. Passenger door locking mechanism and secondary safety latch

With the door fully closed, pushing the door handle towards the doorframe engages the locking bolts in the fuselage holes. The forward locking bolt operates the door unlocked micro switch. When the handle is flush with the doorframe, the door is locked. Pushing outwards on the bottom of the door frame verifies that the door is locked.

During the pre-flight inspection, it must be physically verified that the door is locked and latched.

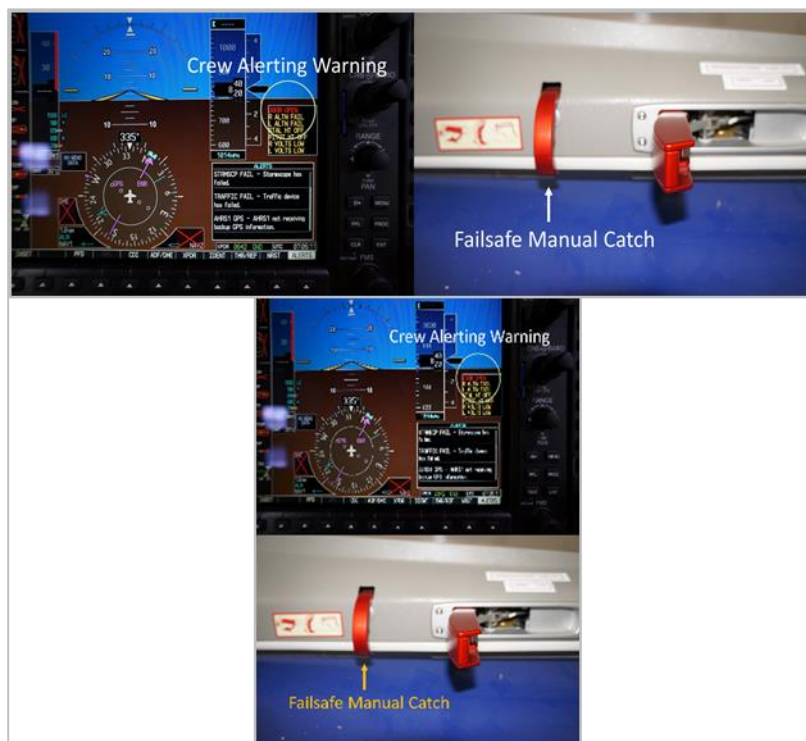
Figure 7. Crew alert warning and failsafe catch

The Garmin G1000 PFD provides a clear warning in red to notify the crew of a door open indication. There is also an audible warning tone to alert the crew to a potential problem.

The red failsafe/latch is installed to prevent the door from opening completely, if the door locking mechanism is not secured.
