Accident

AAIS Case N° AIFN/0012/2024

Wingsuit Flyer Loss of Control - In Flight

Operator:	Skydive Dubai
Make and Model:	AirGlider, Falcon 2
Place of Occurrence:	Margham, Dubai
State of Occurrence:	The United Arab Emirates
Date of Occurrence:	20 October 2024

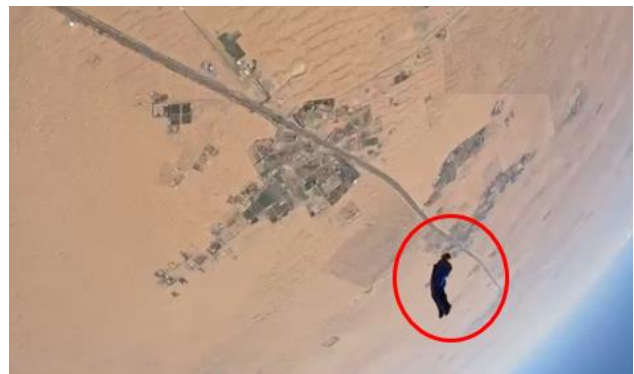
Figure 1. Wingsuit Flyer after recovering

Video footage from the Instructor's overhead camera shows the Wingsuit Flyer exiting the aircraft in an unstable position and successfully regaining control on his first attempt (figure 1).

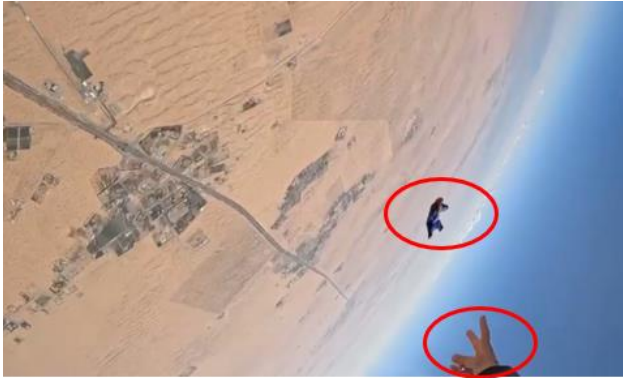
Figure 2. Instructor directed him to re-enter instability

After stabilizing, the Instructor directed Wing Flyer to re-enter instability, as he stated and indicated from his hand signal (figure 2).

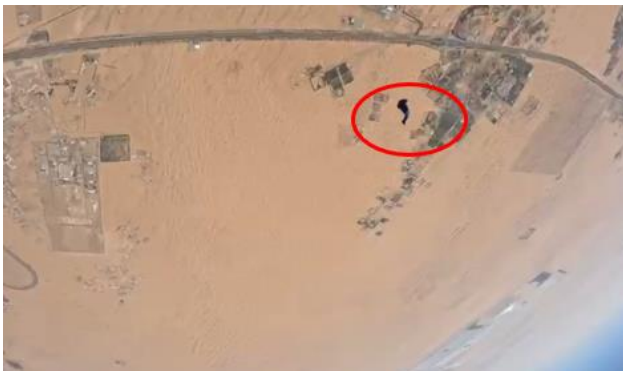
Figure 3. Flyer spinning

In response to the Instructor's signals, the Flyer initiated the manoeuvre for a barrel roll⁴ but became unstable during the attempt, resulting in an inadvertent flat spin. However, his recovery movements did not align with standard operating procedures (SOP) which resulted in a rapid, uncontrolled descent toward the ground (figure 3).

The Wingsuit Flyer initially recovered successfully from the first instability caused by the barrel roll. However, upon encountering a second attempt of instability, he was unable to recover, leading to an unintentional flat spin. This flat spin resulted in a rapid and uncontrolled descent toward the ground.

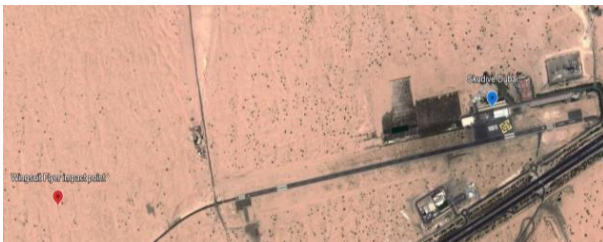
Figure 4. The Flyer's impact point

The Wingsuit Flyer descended outside the designated skydive drop zone area (figure 4). This area was not equipped with cameras to capture the impact.

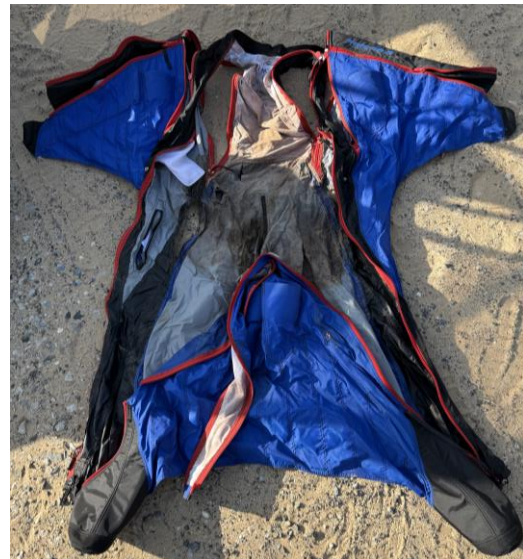
Figure 5. Wingsuit

No damage was observed in the Wingsuit, main parachute, or reserve parachute (figure 5)

Following the impact, an inspection of the Wingsuit revealed that the zipper on the leg section had opened, likely as a result of the force of the impact. However, the Wingsuit did not exhibit marks of cuts, tears, or other structural damage along the sides or the wings.

A comprehensive post-Accident inspection of the Wingsuit revealed no signs of physical damage, such as cuts, tears, or structural compromise.

A post-Accident inspection confirmed that the Wingsuit sustained no cuts or damage, indicating that the accident was not related to equipment failure but rather to procedural or recovery-related challenges.

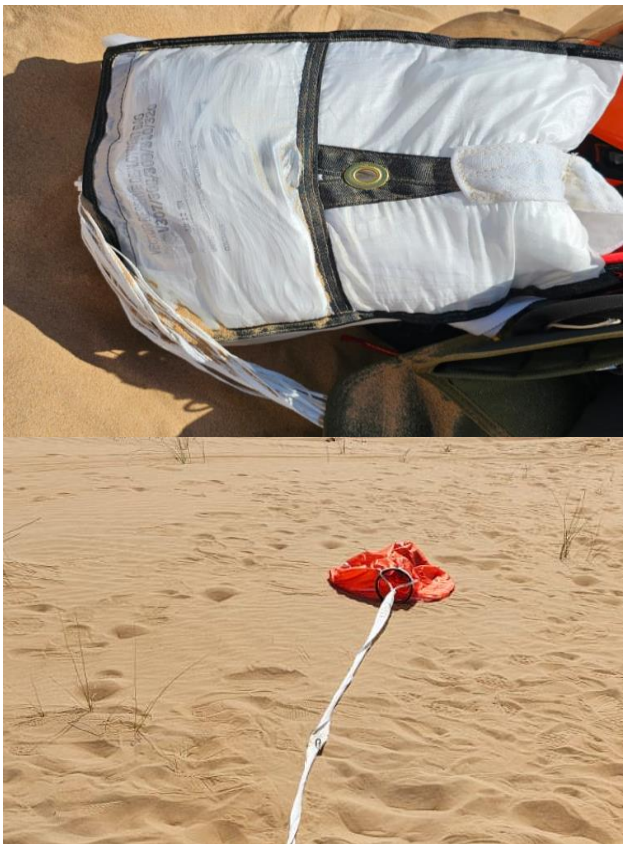
Figure 7. Pilot chute, main and reserve canopies

The Flyer did not deploy the main parachute during the jump (figure 7) as per the SOP. Although the AAD successfully activated the pilot chute, it was unable to fully deploy the reserve due to the Flyer's rapid spin, which caused the reserve pilot chute bridle entangled to wrap and prevented the Parachute from inflating properly.

In the Accident, the AAD activated and deployed the pilot chute; however, it was unable to fully deploy the reserve due to the Flyer's rapid spin, which caused the reserve pilot chute bridle entangled to wrap and prevented the reserve Parachute's extraction.

The AAD successfully initiated the deployment of the pilot chute. However, it was unable to fully deploy the reserve parachute due to the rapid spin of the Wingsuit Flyer. This high rotational velocity caused the reserve pilot chute bridle entangled to wrap tightly, preventing the reserve Parachute's from properly inflating and arresting the descent.

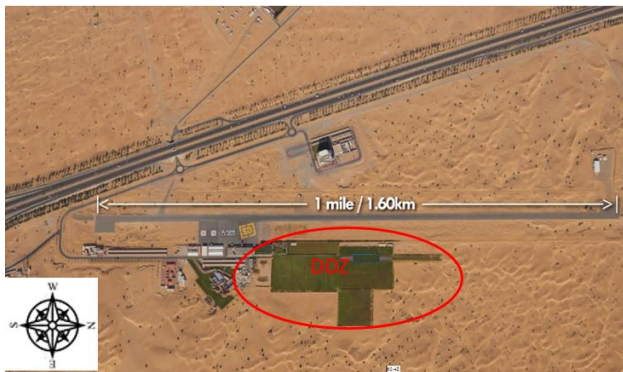
Figure 11. Skydive DDZ drop zone and runway for skydiver flight operations

DDZ is situated at a latitude of 24°53'14.65"N and a longitude of 55°32'53.03"E, with an elevation of 515 feet above sea level (ASL). It includes a 1,600-meter (1 mile) runway dedicated to skydiving flight operations and a designated boarding area for skydivers (figure 11).

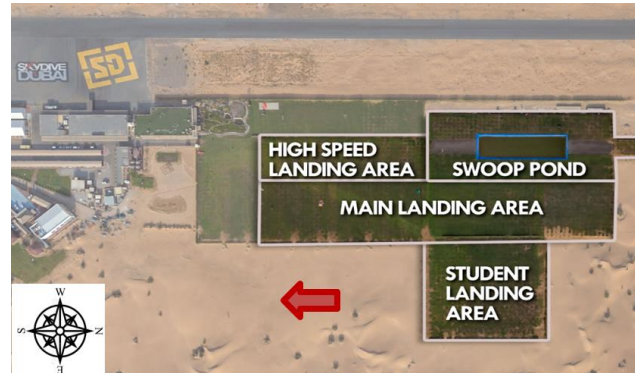
Figure 12. Skydive Desert Drop Zone landing area

The PLA of DDZ was divided into four distinct zones: student landing area; main landing area; high-speed landing area; and swoop pond.

The red arrow in figure 12 indicates the designated landing direction for parachutists, always pointing into the wind (opposite to the wind direction), as specified in the SOP.

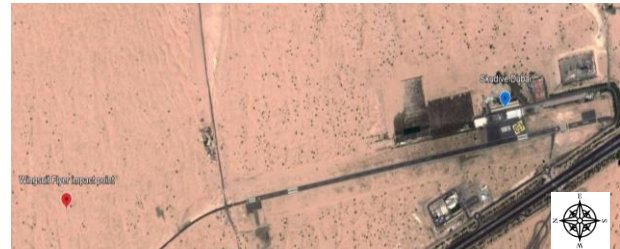
Figure 13. Wingsuit Flyer impact point

The Wingsuit Flyer impacted the ground outside the Club facility, approximately 2 km to the north (figure 13).
