الهيئة العامة للطيران المدني
GENERAL CIVIL AVIATION AUTHORITY

Air Accident Investigation Sector

AAIS Case N° AIFN/0011/2024

AutoGyro Loss of Control

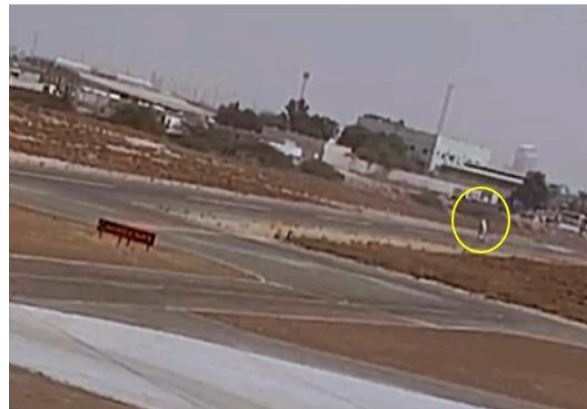
The CCTV² footage from the airfield recorded the sequence of events: at 1138, the Gyrocopter aligned on the runway; at 1139, another aircraft landed on the same runway; at 1140, the gyrocopter commenced forward motion to generate power; forty-six seconds later, it entered a steep vertical climb (figure 1)

Figure 1. Gyrocopter moving into a steep, vertical angle

The Gyrocopter sustained substantial damage due to ground impact involving its main rotor, propeller blades, nose gear, which was completely detached, and the right-side structure (figure 1).

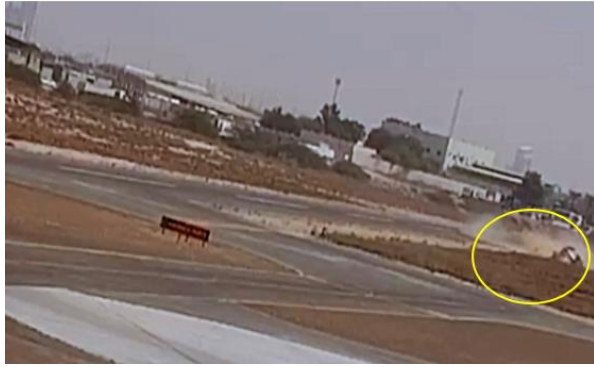
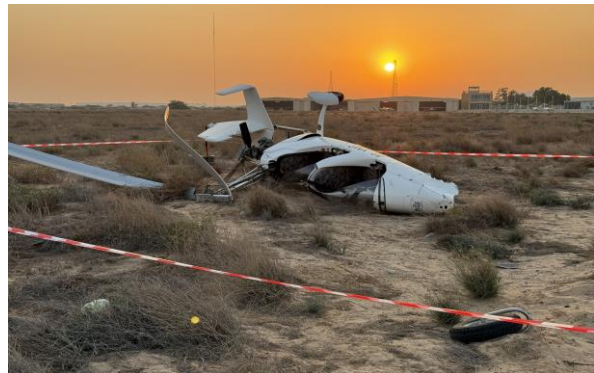
Two seconds later, the Gyrocopter struck the runway, veered to the left, and came to rest on the sand (figure 2).

Figure 2. Gyrocopter resting on the sand

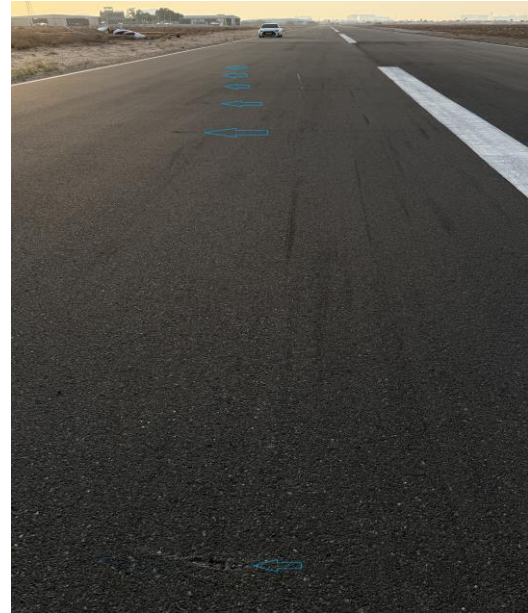
The rotors struck Runway 28, creating six slashes (figure 3).

Figure 3. Runway 28 slashes

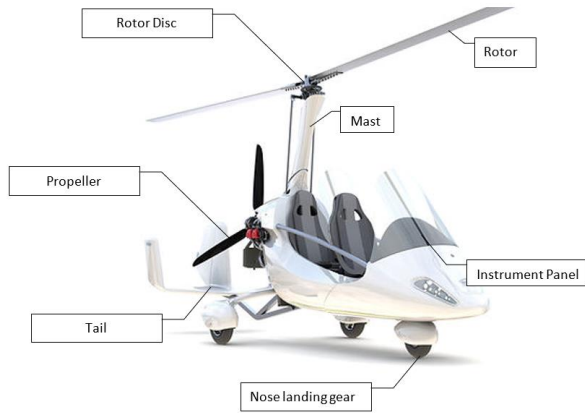
In general, gyrocopters consist of several key parts, including the fuselage, which houses the pilot and controls, and the rotor system with blades that spin freely within the rotor disc to generate lift.

The engine powers a propeller (in a pusher configuration) that provides forward thrust. The mast supports the rotor system, while the landing gear includes main wheels and a nose wheel for ground stability.

Control is performed by a cyclic stick, which tilts the rotor disc for pitch and roll, and rudder pedals for yaw. A tail assembly with a rudder and horizontal stabilizers aids stability, while the fuel tank and instrumentation panel support operation and monitoring. (Figure 4)

Figure 4. Gyrocopter construction

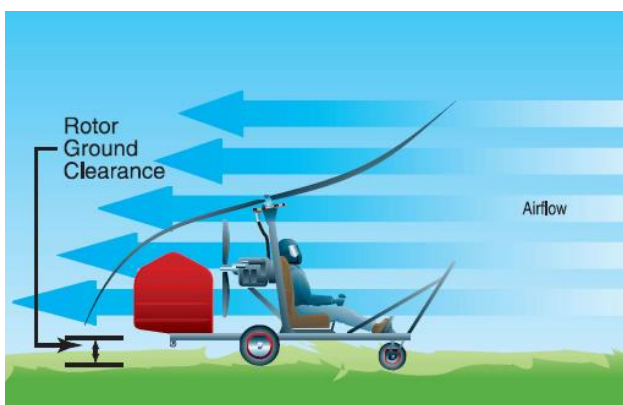
In a gyrocopter, rotor flap describes the vertical movement of rotor blades as they rotate, balancing lift across the rotor disc. This phenomenon is particularly significant in gyrocopters, given their unpowered rotors, which rely on autorotation—where airflow, rather than an engine, drives the blades. Blade flap is especially prominent during takeoff or rapid acceleration.

Blade flap generally occurs when the gyrocopter accelerates forward before the rotor has reached the optimal rotational speed. Under these conditions, the advancing rotor (moving in the direction of the aircraft's forward motion) generates significantly more lift than the retreating rotor, causing an upward flapping motion. This lift imbalance can lead the rotors to reach the maximum allowable teeter range, impacting the teeter stops and creating vibrations felt in the cyclic control. Without proper management, these vibrations may intensify, as low rotor RPM reduces centrifugal force, making the rotors less rigid and more prone to flexing. (Figure 5).

Figure 5. Blade flap

In the Accident, the rotor flap condition was identified as “high-speed blade flap”, a phenomenon that occurs when the gyrocopter is at high ground speed but with relatively low rotor RPM. This condition can cause the gyrocopter to flip onto its side if corrective action is not taken.

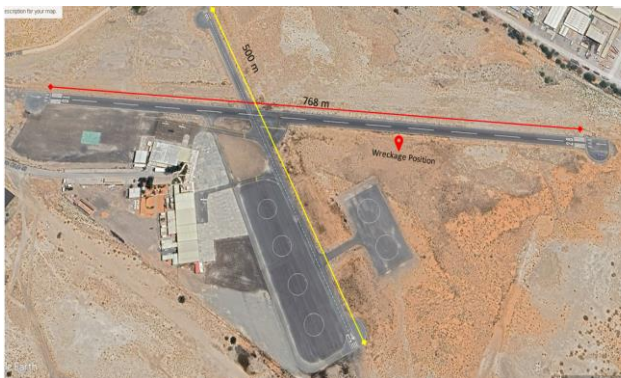
The airport includes two runways: Runway 16/34, measuring 500 meters in length and 8 meters in width, and Runway 10/28, which is 768 meters long and 14 meters wide (figure 6). The facility operates only during daylight hours.

Figure 6. Runways and wreckage position

The accident occurred on Runway 10/28 as the pilot was attempting to take off.

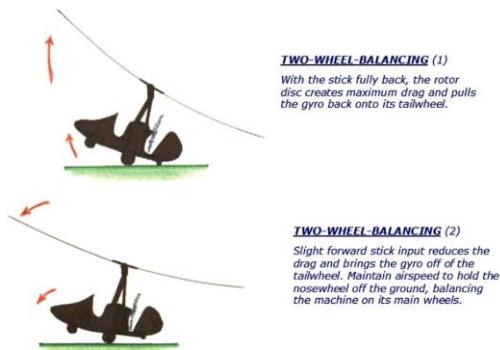
To mitigate the risk of dynamic rollover during takeoff, the pilot must maintain precise control of the rotor and avoid aggressive or premature movements of the control cyclic. Gradual power application while keeping the control cyclic centered supports stability. In crosswind conditions, cautious steering inputs are essential, as even minor adjustments at high rotor speeds can exert significant lateral forces on the wheels.

As the gyroplane gains speed, the rotor lift force increases. Moving the control cyclic forward too early can cause the nose to dip, heightening susceptibility to side-loading forces from slight steering inputs or wind gusts, potentially leading to a rollover. Proper take-off procedure involves allowing the gyroplane to gradually reach take-off speed, maintaining a steady control cyclic position, and following a straight runway path until lift-off. (Figure 7)

Figure 7. Movement of cyclic and its effect in the takeoff

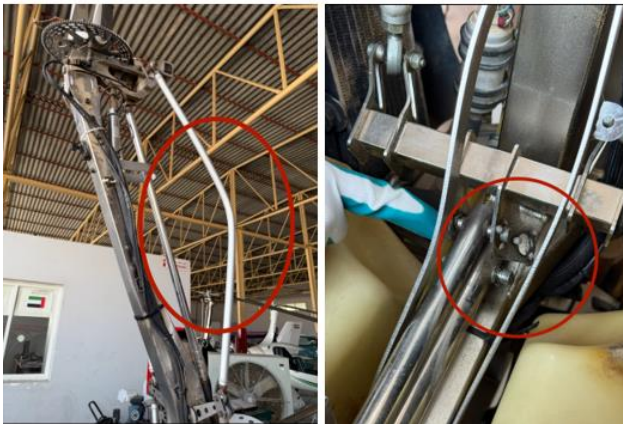
For the control cyclic mechanism, it was noted that the push rods operating the rotor were bent as a result of the Accident. While the main rotor operation mechanism remained intact and functional, some push/pull rods exhibited bending marks (Figure 8). This deformation in the control cyclic mechanism affected the system's efficiency.

Figure 8. deformation in the cyclic

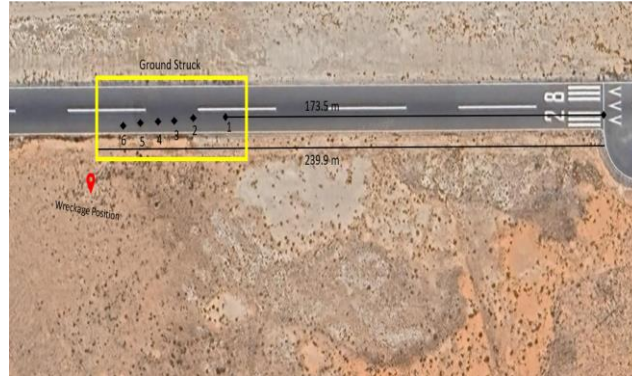
The rotors struck Runway 28, creating six slashes (figure 9).

Figure 9. deformation in the cyclic

The Gyrocopter's initial velocity at the first impact was approximately 26.56 m/s (approx. 95.62 Km/h), with a deceleration rate of -5.31 m/s^2 over the 239.9 meters from the first impact to the wreckage position. This high deceleration rate suggests a significant loss of control and rapid reduction in speed, likely due to the "high-speed rotor flap" condition.
