Accident

AAIS Case N° AIFN/0015/2024

Parachutist Ground Impact in High-Performance Landing

Operator:	Skydive Dubai
Make and Model:	Performance Designs (PD), Valkyrie VK -79
Place of Occurrence:	Margham, Dubai
State of Occurrence:	The United Arab Emirates
Date of Occurrence:	1 December 2024

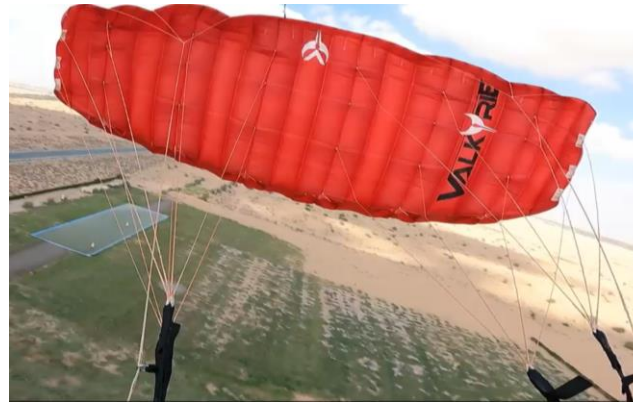
Figure 1. the Parachute

Footage from the Parachutist's overhead camera recorded his descent. During the landing sequence, the Parachutist performed several high-speed spiral turns in preparation for landing in the designated area east of the (DDZ)¹ (figure 1).

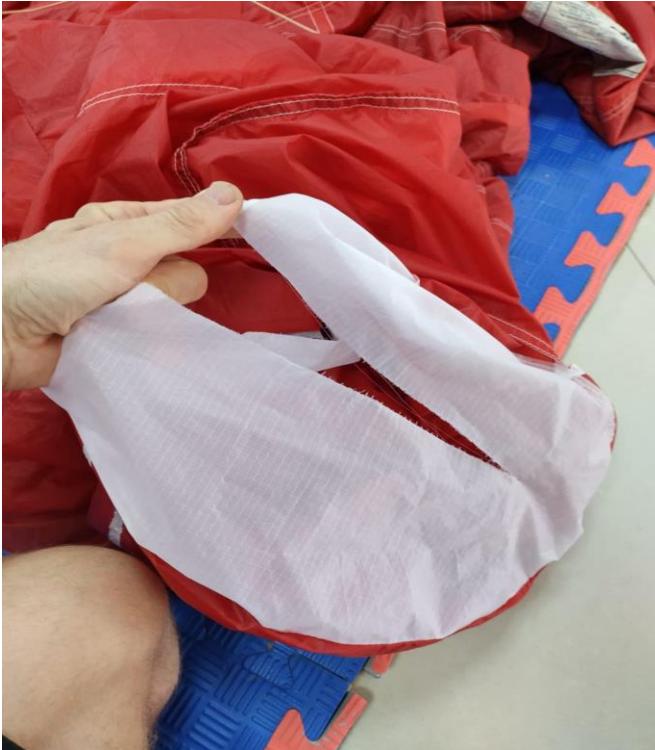
Figure 2. Rib damage

The expert rigger's inspection report² identified two types of damage that most likely resulted from the impact.

The first was located at the initial unloaded rib on the right side near the A1 line through the C1 area (figure 2). The second was a minor hole damage on the removable slider.

Upon inspection, the observed damage to the Parachute appeared to have most likely resulted from the impact. Footage from the top-mounted helmet camera confirmed that no abnormalities in the Parachute were visible prior to or during the descent. The Parachute appeared to deploy correctly and function as designed during the jump, with no indication of malfunction. The Investigation concludes that the observed damage was a consequence of the high-energy collision with the ground rather than a defect or failure in the Parachute during the jump.

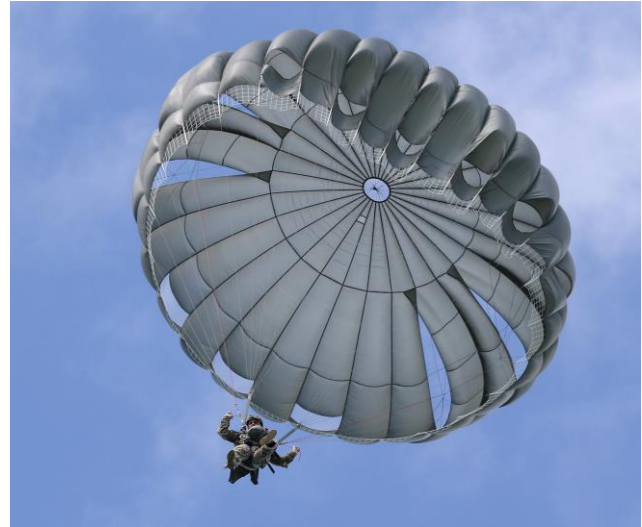
Figure 3. Round parachute

Historically, round parachutes were standard for military operations and emergency applications. These canopies resemble domes and are engineered to descend almost vertically, prioritizing simplicity and reliability. While they are no longer the primary choice for recreational skydiving due to their limited manoeuvrability and forward drive, round parachutes remain used for military cargo drops and certain emergencies (figure 3).

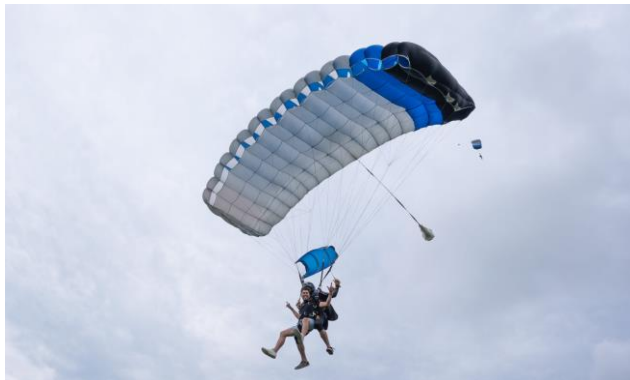
Figure 4. Ram-air (rectangular) parachute

The modern rectangular or “square” parachute is the predominant choice in sport skydiving. Despite the name, these canopies often have slightly tapered corners. Rectangular canopies typically feature larger surface areas, which results in lower wing loading (the ratio of skydiver weight to canopy size). This design leads to stable openings and gentler landings, making rectangular canopies particularly suitable for novice and intermediate jumpers seeking predictable flight characteristics (figure 4).

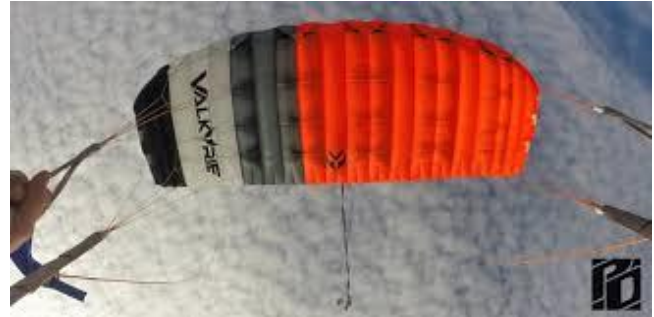
Figure 5. Elliptical parachute

As skydivers gain experience, they may transition to elliptical or semi-elliptical parachutes for increased manoeuvrability and speed. These canopies are shaped with tapered wingtips that reduce drag and allow for faster turns and forward drive. Semi-elliptical canopies offer a middle ground between stable rectangular designs and more aggressive, fully elliptical shapes, making them an appropriate next step for intermediate skydivers. Fully elliptical canopies present faster, more responsive flight dynamics, often favoured by experienced jumpers who aim to refine high-performance landings, also known as swooping (figure 5).

During the Accident, the Parachutist was piloting an elliptical, high-performance Parachute.

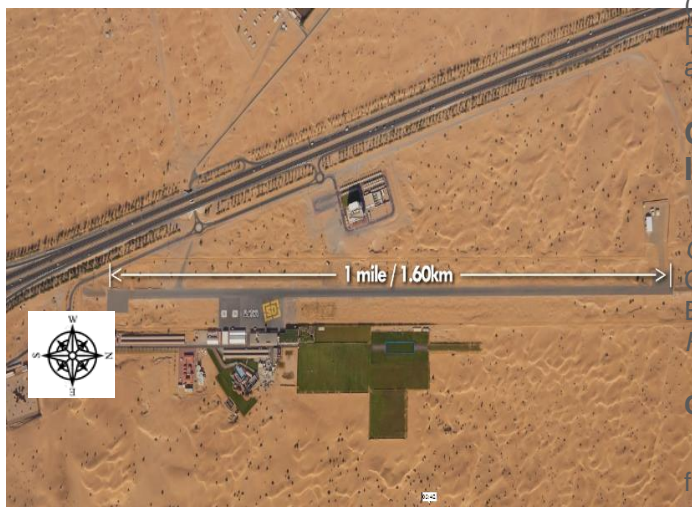
Figure 6. Skydive runway for skydiver flight operations

DDZ is situated at a latitude of 24°53'14.65"N and a longitude of 55°32'53.03"E, with an elevation of 515 feet above sea level (ASL). It includes a 1,600-meter (1 mile) runway dedicated to skydiving flight operations and a designated boarding area for skydivers (figure 6).

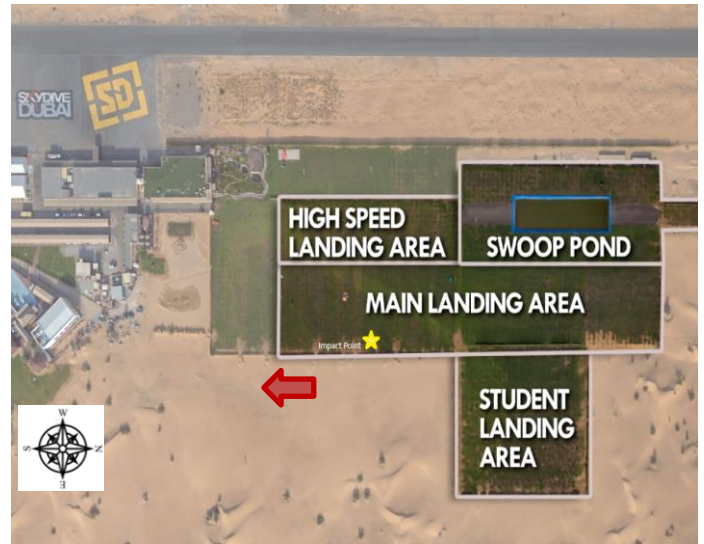
Figure 7. DDZ landing area

The red arrow in figure 7 indicates the designated landing direction for parachutists, always pointing into the wind (opposite to the wind direction), as specified in the SOP.

The Club designated the high-speed landing area, (figure 7). However, during the loss of control, the Parachutist impacted the ground in the main landing area (indicated by the yellow icon).

The PLA of DDZ was divided into four distinct zones: Student landing area; main landing area; high-speed landing area; and swoop pond.
