الهيئة العامة للطيران المدني
GENERAL CIVIL AVIATION AUTHORITY

Air Accident Investigation Sector

AAIS Case N° AIFN/0006/2021

Parachutes Mid-Air Collision

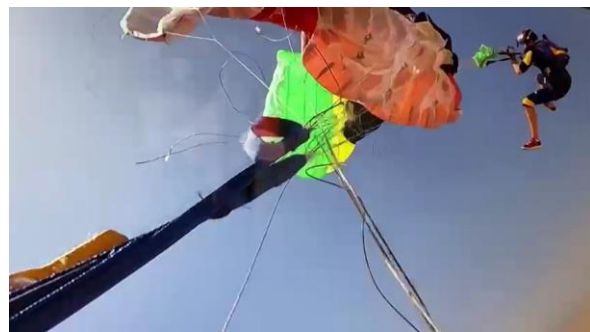
At the same time, another skydiver performing third jump for day and he was above the fatally injured Skydiver, while he was heading south initiated a right swooping spiral turn, at about 900 AGL, to targeting a high-speed landing. The other skydiver, before he completes a 360 turn, impacted the fatally injured Skydiver Parachute from the top at about 600 feet AGL. The lines of the fatally injured Skydiver and the other skydiver parachutes were entangled.

The fatally injured Skydiver was cleared from entanglement with the other parachute, but his Parachute lines were twisted. He cut away his main Parachute at about 450 feet AGL (figure 1). He attempted to recover stability and pulled the Reserve Parachute handle, but there was no enough height to inflate the Reserve Parachute. The fatally injured Skydiver dived in a free fall until he impacted the ground causing fatal injuries.

Figure 1. The fatally injured Skydiver Parachute entangled with another skydiver parachute

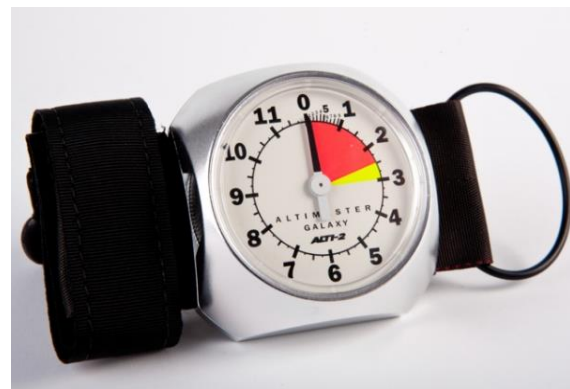
The skydiving altimeter is an essential device worn on the hand or wrist. It shows the altitude on an analogue altimeter by clock illustration.

The digital altimeter shows a digital number display as opposed to the round clock face. The yellow colour on the dial indicates to the skydiver the decision height of preparation for landing. The red colour indicates decision height for landing. The numbers on the dial show a 1:1,000 scale, so any number indicated by the pointer shall be multiplied by 1,000 to indicate the altitude (figure 2). Parachuting is limited to 13,000 feet altitude.

Figure 2: Skydiver Altimeter

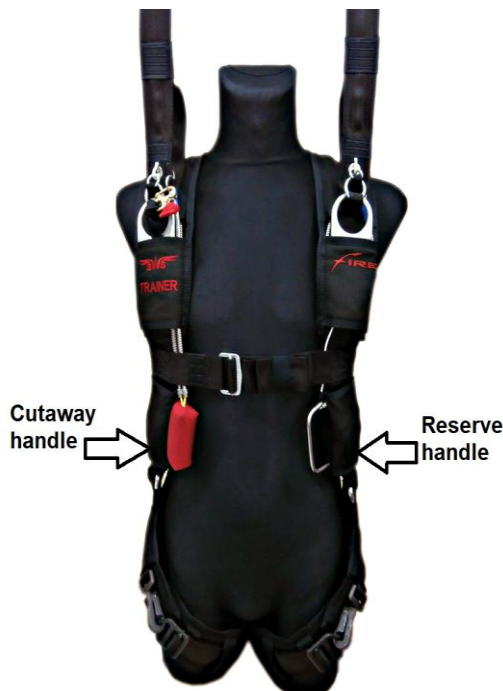
Skydiving gear has two handles for emergencies. One handle to cut away the main parachute and a second handle to deploy the reserve parachute. In sequence, the main cutaway handle is pulled first then the reserve parachute handle (figure 3). The manual described the sequence as follows:

Figure 3. Cutaway and reserve handle

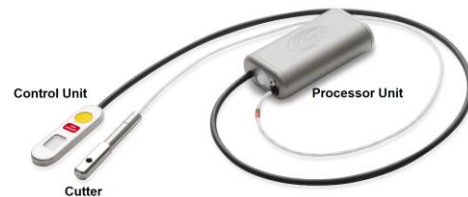
The AAD consists of three functional parts

- Processor unit
- Control unit
- Cutter (release) unit

Figure 4. Automatic Activation Device (AAD)

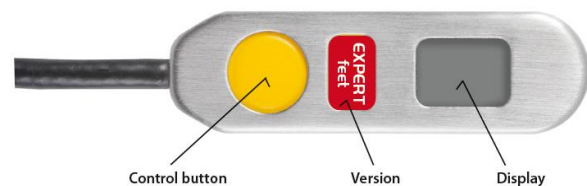
The body of the control unit is made of stainless steel and is connected to the processor unit by a flexible cable. The control unit has a display for various icons, the control button and the label specifying the device version that is STUDENT, EXPERT, TANDEM and SPEED.

The fatally injured Skydiver was equipped with m2 EXPERT version which indicates that the reserve parachute activation triggers if the altitude above the landing area is below 270 m (885 feet) and above 100 meters (330 feet) and also the falling speed is over 35 meters per second (78 mph).

Figure 5. AAD Control unit

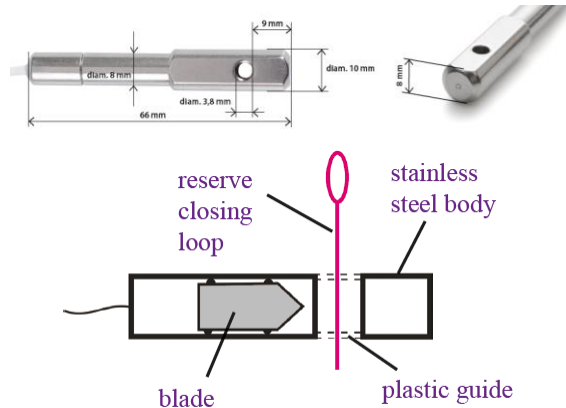
The cutter unit (release) for the reserve parachute container is completely independent of the rig’s primary system because it does not pull the ripcord pin out of the closing loop but rather cuts

the loop inside the reserve container to initiate the opening sequence. The reserve closing loop has to pass through the cutters passing hole. (Figure 6)

Figure 6. Cutter (release) unit functional diagram

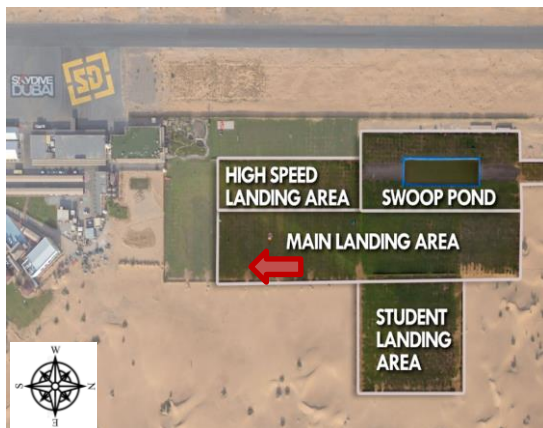
There will be a red arrow mark indicating the parachutist which way to land (figure 8). As per the SOP, the red arrow always indicates landing into the winds opposite to the wind direction.

Figure 8. Skydive Desert Drop Zone landing area

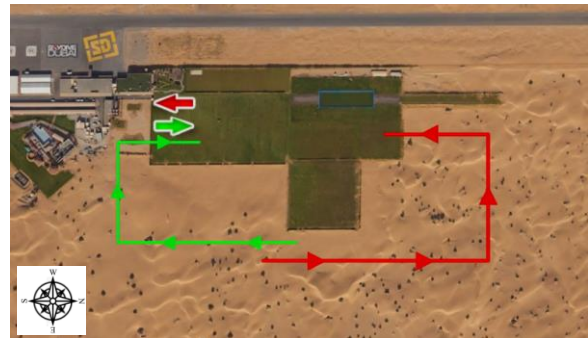
The landing pattern can be performed from either the right side of the desert or the left side depending on the wind direction. (Figure 9)

Figure 9. Skydive parachute landing pattern

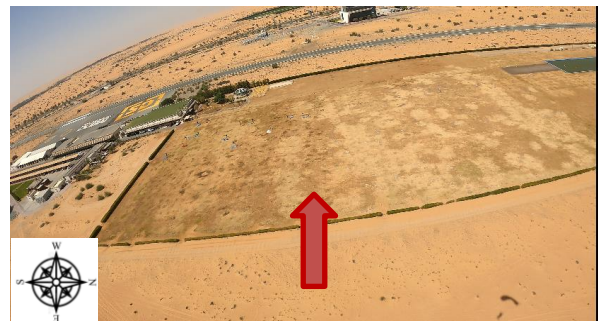
On the day of the Accident, the landing direction at the Main Parachute Landing Area was towards the west as the wind direction was towards the east. (Figure 10).

Figure 10. Skydive Desert Drop Zone landing area direction

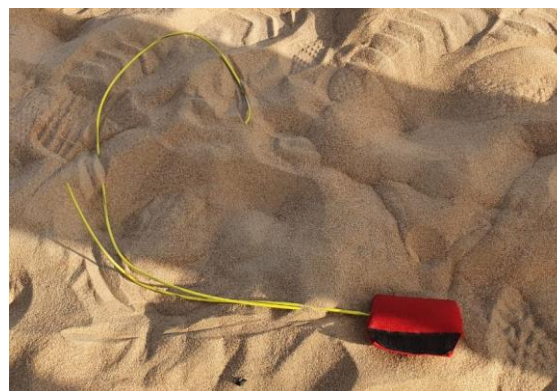
Investigation observed the video recording and collected evidence of cutaway handle from the Accident site which revealed that the main Parachute detached upon pulling the cutaway handle by the Skydiver. (Figure 11)

Figure 11. Fatally injured Skydiver cutaway handle

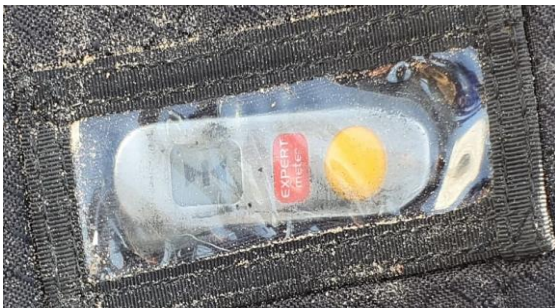
The Investigation observed at the Accident site that the status of the AAD display was on 'Standard Mode'. (Figure 12)

Figure 12. AAD status display- 'Standard Mode'

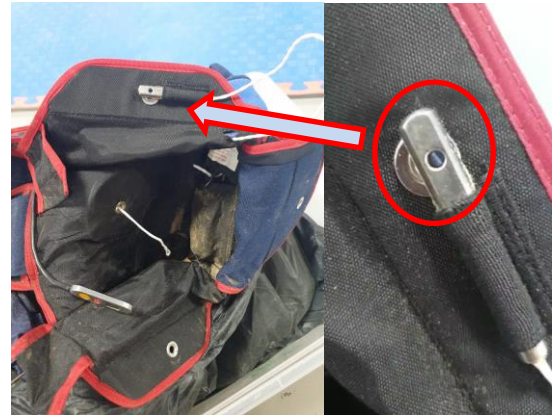
The Investigation also observed at the Accident site that the cutter (release) was intact and the reserve closing loop was not released to activate the Reserve Parachute.

Figure 13. AAD cutter in the fatally injured Skydiver Parachute Container

As per the Investigation analysis, the AAD did not activate as the reserve ripcord closing loop passing through the cutter's hole was found intact which indicate that it did not cut to release the reserve parachute and that the Reserve Parachute opening sequence did not initiate. (Figure 13)

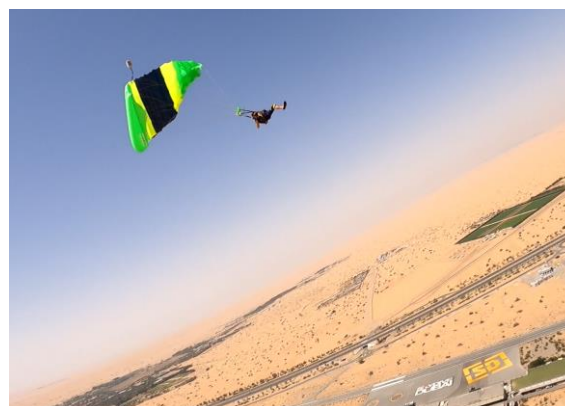
Figure 14. Skydiver Parachute after clear from entanglement

The fatally injured Skydiver's main Parachute was liberalised from entangled lines with the other skydiver's main parachute. The Skydiver's main Parachute lines were still connected to the Container. (Figure 14)

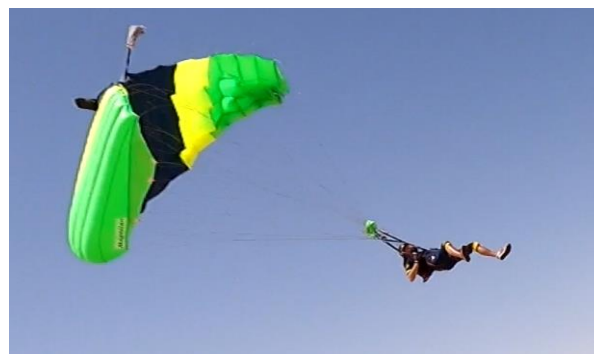
Figure 15. Skydiver pulling cutaway handle to release main Parachute

The video recording revealed that the fatally injured Skydiver pulled the cutaway handle to release the main Parachute (figure 15) and within the next two seconds (at 10:45:08 LT), the Skydiver was freefall with left hand on the reserve ripcord handle, however, the Skydiver impacted the ground with not deployed Reserve Parachute. (Figure 16)

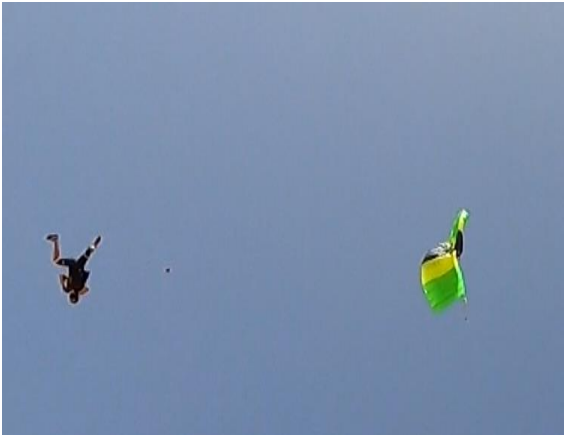
Figure 16. Skydiver main Parachute and trying to pull Reserve Ripcord Handle

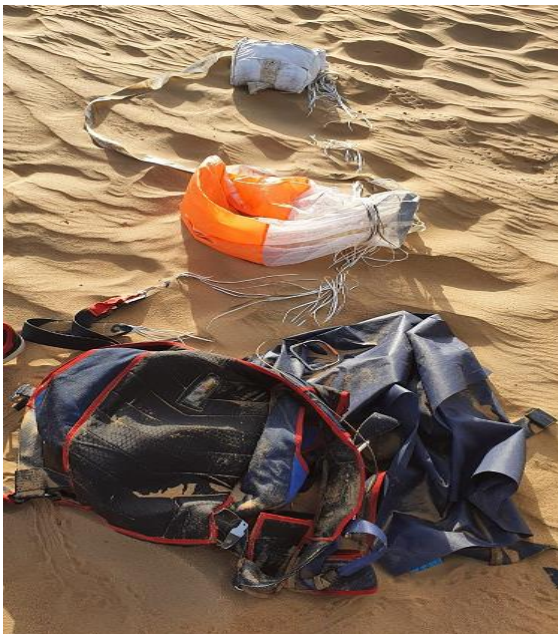
The Investigation observed at the Accident site that the ripcord was pulled out triggering the Reserve Parachute out of the Container without inflating. (Figure 17)

Figure 17. The fatally injured Skydiver's Reserve Parachute
