Air Accident Investigation Sector

Accident — Final Report —

AAIS Case N°: AIFN/0004/2017

Helicopter Controlled Ditching due to Failure of Main Gearbox Oil Cooler Fan Shaft and Associated Abnormal Noise

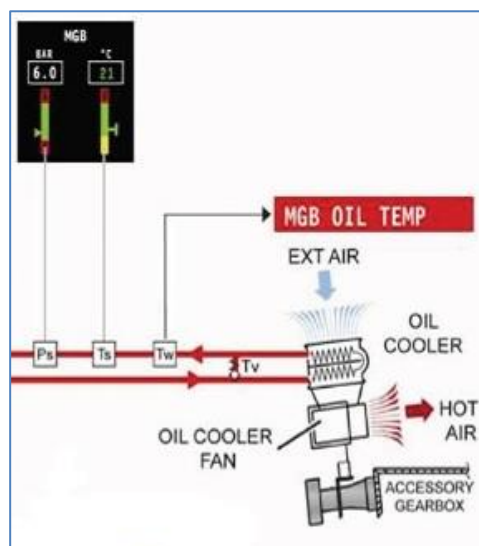
Figure 3. MGB cooling fan
[Source: Leonardo Helicopters]

The AW139 MGB oil is cooled by ambient air from the top of the open gearbox fairing, which is forced through an oil cooler by the attached oil cooling fan (figure 3).

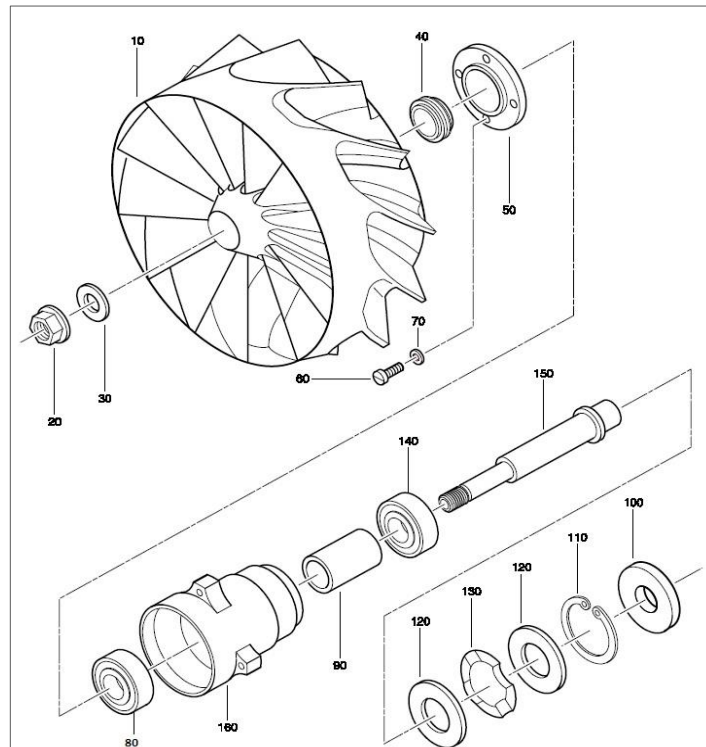
Figure 4. Cooling fan assembly overhaul parts [Source: Technofan]

The fan assembly is disassembled, checked, re-assembled with new parts and tested during an overhaul. An overhaul kit, part number 4611416981, provides the parts required to complete the assembly of the cooling fan. This kit includes new screws (60), washers (30, 70, 120), a spring washer (130), the top bearing (80), the lower bearing (140), the fan nut (20), a retaining ring (110), the lower lipseal (100), a new fan shaft (150) and other parts to fit the fan into the cooling fan housing (figure 4).

The upper sealing spacer (40) is not part of this kit.

During the overhaul in 2013, the fan assembly was fitted with new bearings and a new lower lip seal as part of the overhaul kit. The top sealing spacer was not replaced. A balance test was completed satisfactorily and the fan assembly was returned to service by an *EASA Form 1 – Authorized Release Certificate*, issued on 23 October 2013.

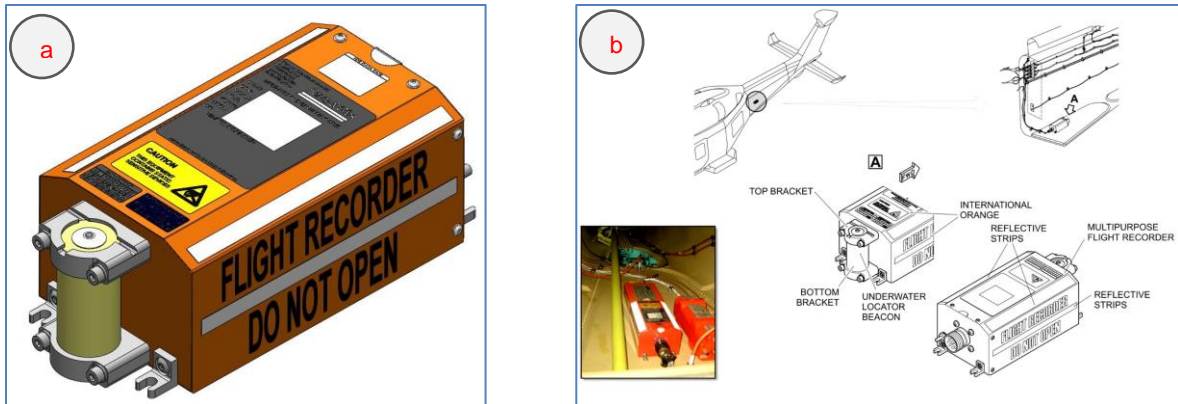
Figure 10. Multi-purpose flight recorder and location [Source: Leonardo Helicopters]

The Aircraft was fitted with a multi-purpose flight recorder (MPFR), part number D51615-102, which was an integrated solid state digital cockpit voice recorder combined with a flight data recorder, manufactured by Penny & Giles Aerospace Ltd (figure 10a).

The MPFR consisted of an orange coloured steel chassis with white reflective stripes and was fitted on the left side of the rear fuselage (figure 10b). An underwater locator beacon was attached to the side of the recorder. The crash survivable memory unit (CSMU) (figure 11b) module consisted of a tungsten steel cylindrical casing with a non-volatile memory.

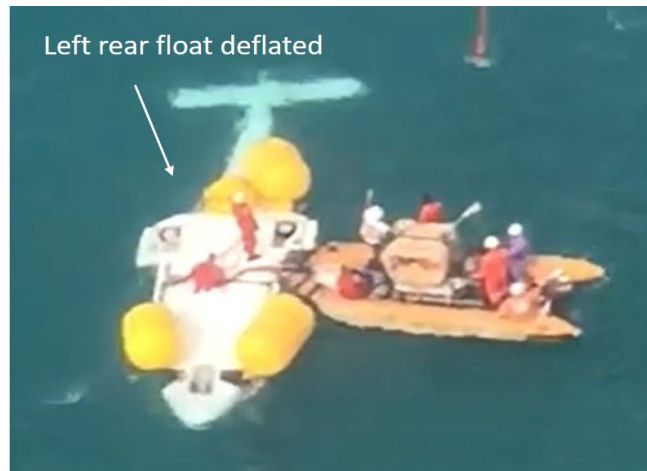
Figure 12. Aircraft recovery

After the evacuation of the occupants, the Aircraft capsized and remained afloat at the surface (figure 12). The recovery team penetrated the floats to be able to turn the Aircraft for the recovery and the transport.

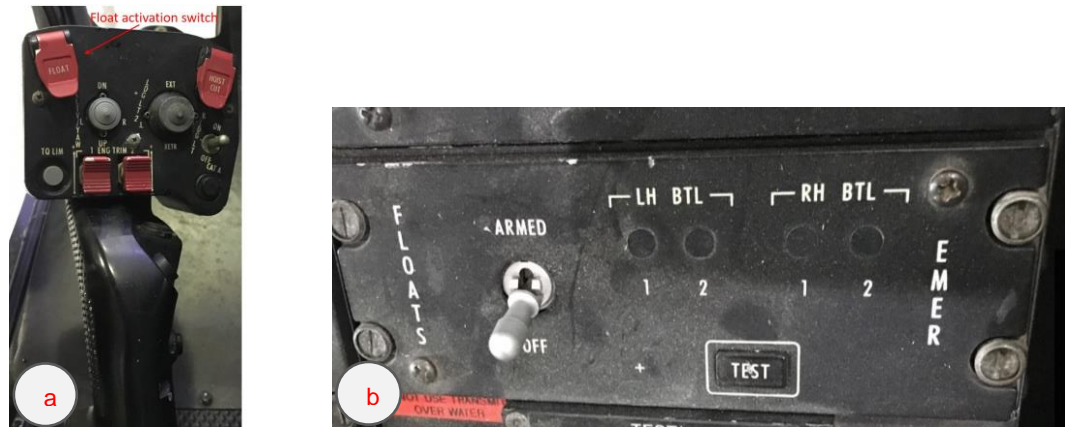
Figure 13. Flotation system activation switch and arming/test panel

The floats were fitted on each side of the forward fuselage, below the flight deck entrance doors, and also below the cargo doors at the rear fuselage. A control panel on the flight deck center console (figure 13b) allows for arming of the system. Once armed, the system will automatically deploy during ditching. The system can also be manually deployed by the flight crew by selecting the deployment switch on each pilot's collective grip (figure 13a). When the floats are deployed and inflated, shear bolts release the float covers from the fuselage.

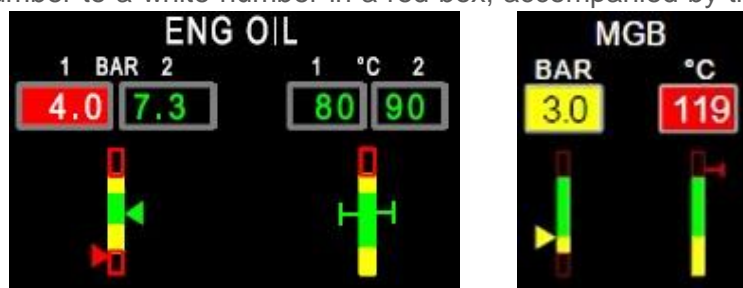
Figure 22. Engine and MGB indications [Source: Leonardo Helicopters]

The engine oil indications and the MGB oil indications are displayed on a similarly designed graphic (figure 22). While the MGB oil temperature and oil pressure indications have a yellow range for the minimum values, they are not designed to display a yellow range for values before the maximum levels are reached. The MGB oil temperature indication changes from a standard green number to a white number in a red box, accompanied by the MGB temperature
