# Air Accident Investigation Sector

### - Final Report -

AAIS Case N°: AIFN/0008/2016

# Runway Impact during Attempted Go-Around

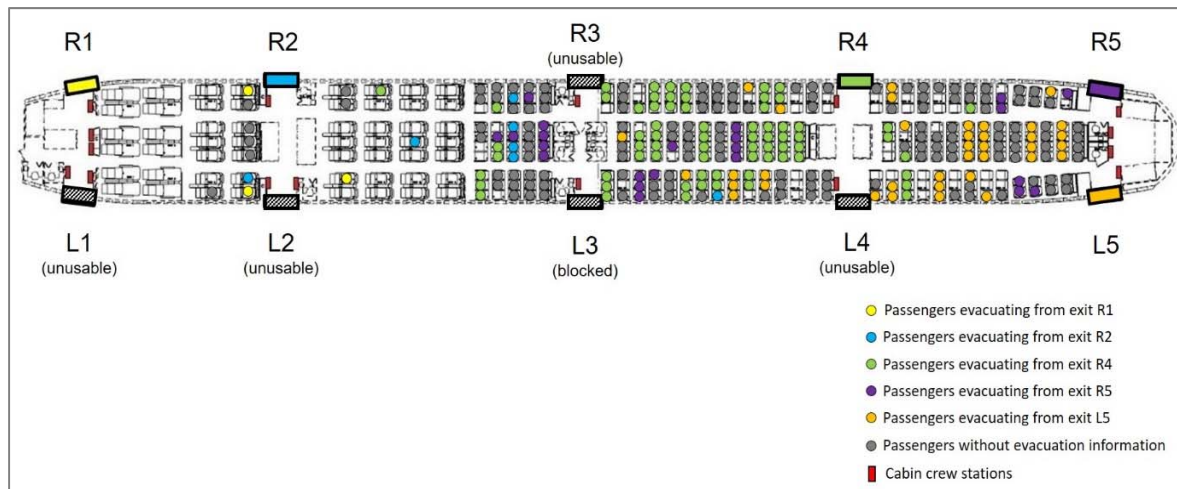
**Figure 20.** Passenger seating allocation and emergency exit status

- At the end of the evacuation, except for the senior cabin crewmember, all of the cabin crewmembers evacuated from the right side doors.
- 86 percent of all occupants evacuated through the three exits R4, R5 and L5.

Figure 20 shows the seat locations and exits used. Passengers who did not respond to the questionnaire are represented by grey dots.

One passenger, seated next to the right side over-wing exit (R3), stated that he was directed to the front of the cabin to evacuate from one of the forward exits, but he was then directed back because the forward exits were blocked. This passenger passed through dense smoke in the center cabin on his way to exit from the R4 door.
