Air Accident Investigation Sector

Serious Incident

AAIS Case N° AIFN/0004/2019

Engine Failure after Takeoff

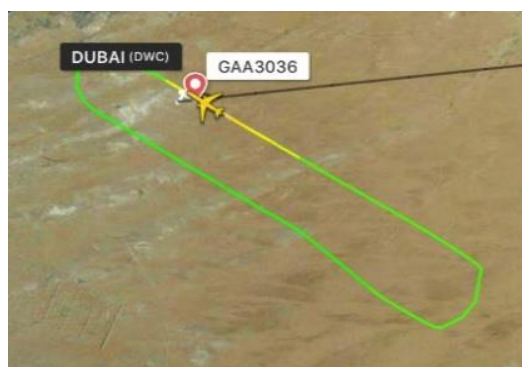
The Commander declared a PAN PAN and advised air traffic control (ATC) that GA3036 was returning to OMDW, and requested vectors to runway 30 with a 15 nautical mile final approach. (Figure 1)

Figure 1. Incident flight path [Source: Flihtadar 24]

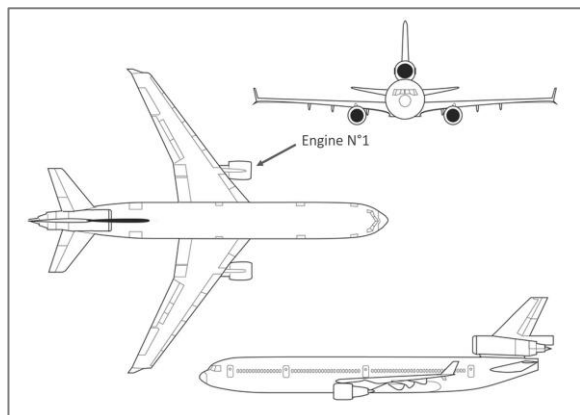
Figure 4. MD-11 engine locations
[Source: Boeing]

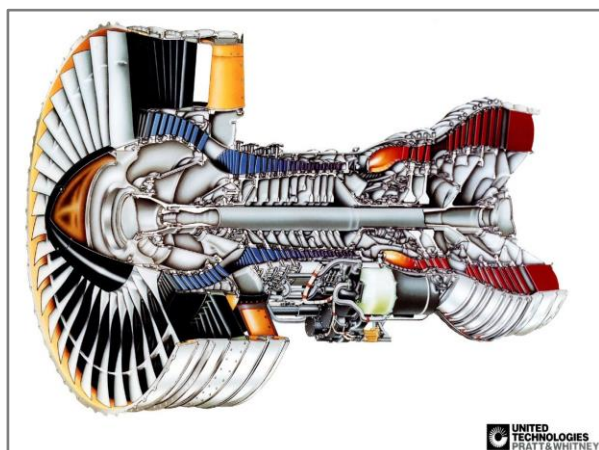
Figure 5. PW400-94 Engine [Source: Pratt & Whitney]

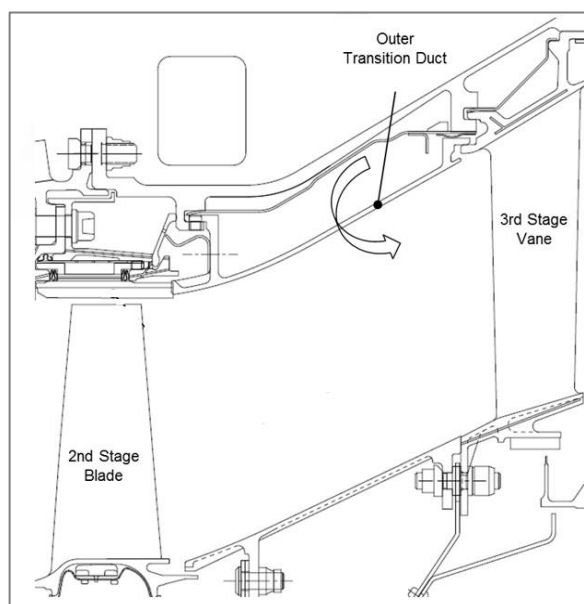
The duct between the 2nd stage high pressure turbine and the 3rd stage low pressure turbine, the transition duct, contains replaceable outer duct segments to deflect the hot gas exiting the high pressure turbine. (Figure 6)

Figure 6. PW4000 Outer transition duct (3rd stage low pressure turbine duct segments) [Source: Pratt & Whitney]

The engine manufacturer, Pratt & Whitney, identified that the riveted seal plates on the outer transition duct segments, also known as the 3rd stage low pressure turbine duct segments, may become loose and could be liberated into the low pressure turbine duct due to normal engine vibrations.

As a result, Service Bulletin PW4ENG 72-488, initially issued on 29 October 1993, required the identification and replacement of outer transition duct segments part numbers during the next low pressure turbine disassembly.
