Air Accident Investigation Sector Accident – Final Report –

AAIS Case N°: AIFN/0002/2018

Impact with Building After Takeoff

Operator:	UAL Incorporated
Make and Model:	SkyRunner MK 3.2
Nationality:	The United States of America
Registration:	N143SR
Place of Occurrence:	Sky Hub Margham, Dubai
State of Occurrence:	The United Arab Emirates
Date of Occurrence:	9 February 2018

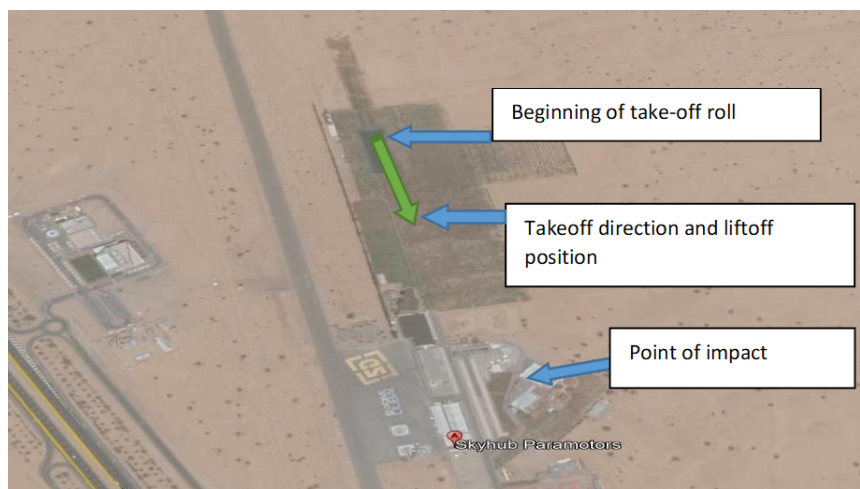
Figure 1. Sky Hub location of the Accident

At 0953 LT, the Pilot positioned the Aircraft on an open grass area for the pre-flight check. He completed the engine start and the warm-up pre-takeoff checklist at 0958 LT. He then taxied the Aircraft to the north side of the runway to prepare for takeoff (figure 1).

The take-off roll was commenced at 1015 LT approximately on a southerly heading of 160 degrees. The Aircraft lifted off after 150 meters and was airborne for 15 seconds before it impacted a building located to the southeast of the runway heading (figure 1).

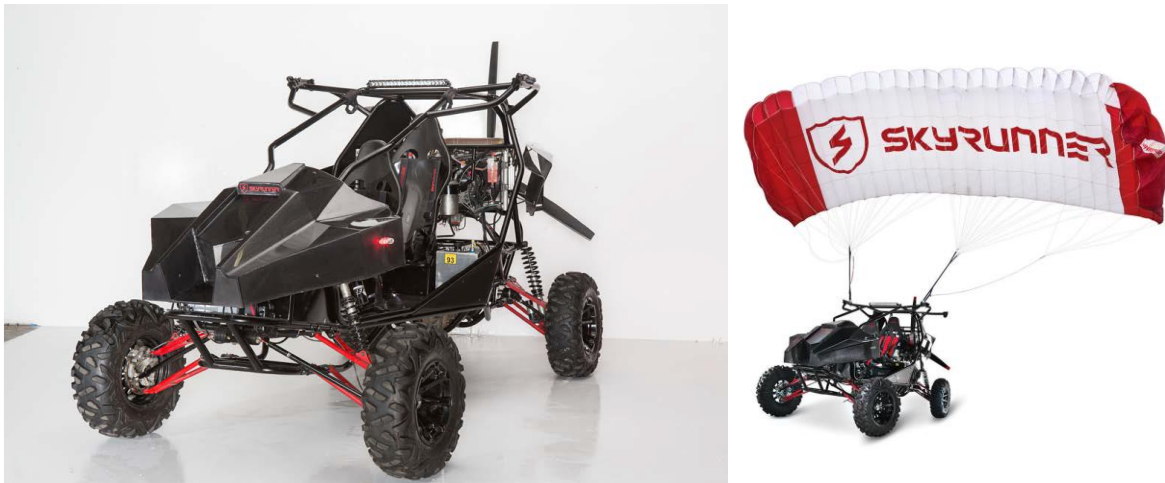
Figure 4. SkyRunner Aircraft: carriage and parachute assembly

The SkyRunner aircraft (figure 4) is a powered parachute with a carriage constructed of welded steel tubing. It was fitted with two engines: one for ground movement and a second with an attached propeller for air operation. The Aircraft does not require a flat paved surface for takeoff or landing. It can take off and land in off-road conditions. The parachute provides the necessary lift.

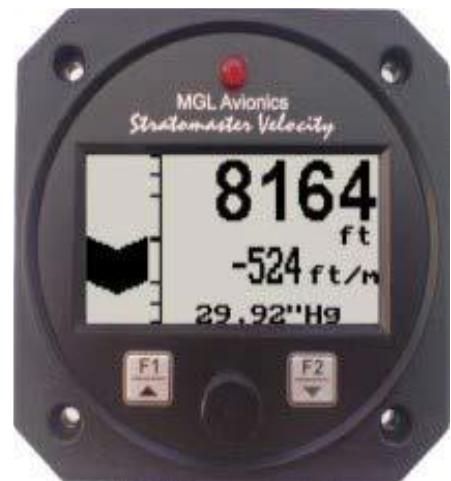
Figure 5. SkyRunner Altimeter

The Aircraft was equipped with a velocity altimeter shown in figure 5, the ALT-3, a 3 1/8" instrument that contained a precision altimeter and a wide range vertical speed indicator. The altimeter conformed to ANSI standard atmosphere rules from -700 ft. up to a maximum of 30,000 ft.

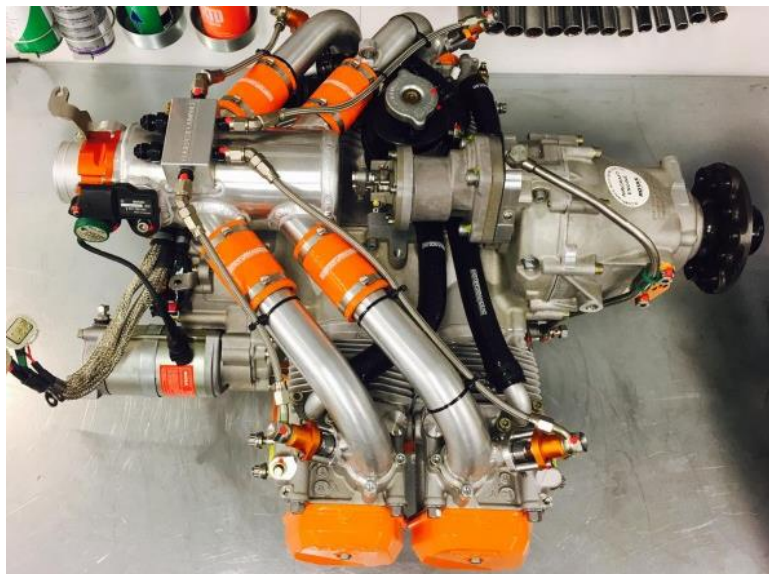
Figure 6. ROTAX 914 UL (Elite) engine

The SkyRunner is equipped with a turbocharged ROTAX 914UL (Elite) edition engine for propulsion in flight as shown in figure 6, and with a Polariz Prostar 1000 engine for ground movement.

The ROTAX 914 UL (Elite) Edition was modified by the Edge Performance Company for lower compression with forged pistons to accommodate the turbocharger and electronic fuel injection system. The carburetor was replaced with a fuel injection system and integrated fuel filters.

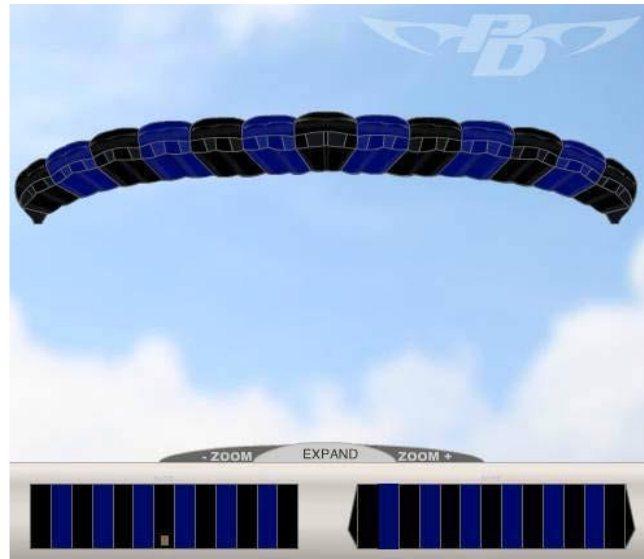
Figure 7. Parachute PG-550

the parachute wing open at the front and closed at the back to maintain sufficient air pressure to form a rigid wing. The wing is manufactured by Performance Designs, Inc. (figure 7).

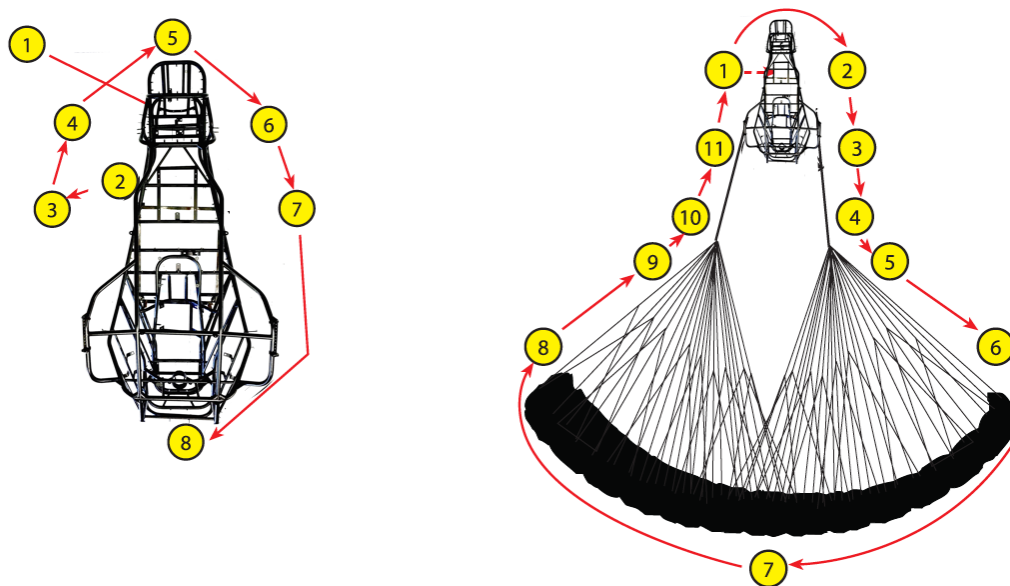
Figure 10. Pre-flight check steps

The manufacturer provided the following information and the figure 10 for a pre-flight inspection.

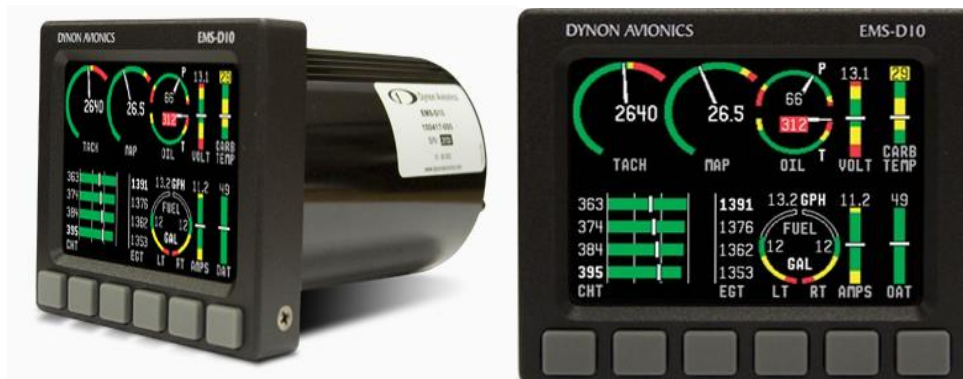
Figure 11. Engine monitoring system Dynon EMS-D10

The Aircraft was not required to have a flight recorder fitted. However, the Dynon engine monitoring system (EMS) - D10 (figure 11), was fitted to record engine parameters such as engine rpm, exhaust gas temperature (EGT), and cylinder head temperature (CHT). The Investigation downloaded the recorded engine data, which provided information for the Accident flight. The EMS was set to record snapshot data every 10 seconds in the internal non-volatile memory as the power switch was turned to the ON position.

The EMS recorded data parameters indicated that the total time recorded since the most recent boot was 33 minutes 15 seconds. The data revealed that the engine reached 5,504 to 5,835 rpm within 10 seconds of being switched on, and remained at 5,800 rpm until the impact when the EGT was 1164 °F and CHT was 170 °F, which were within operational limits as per the recommendations of the Aircraft manufacturer for a normal takeoff.

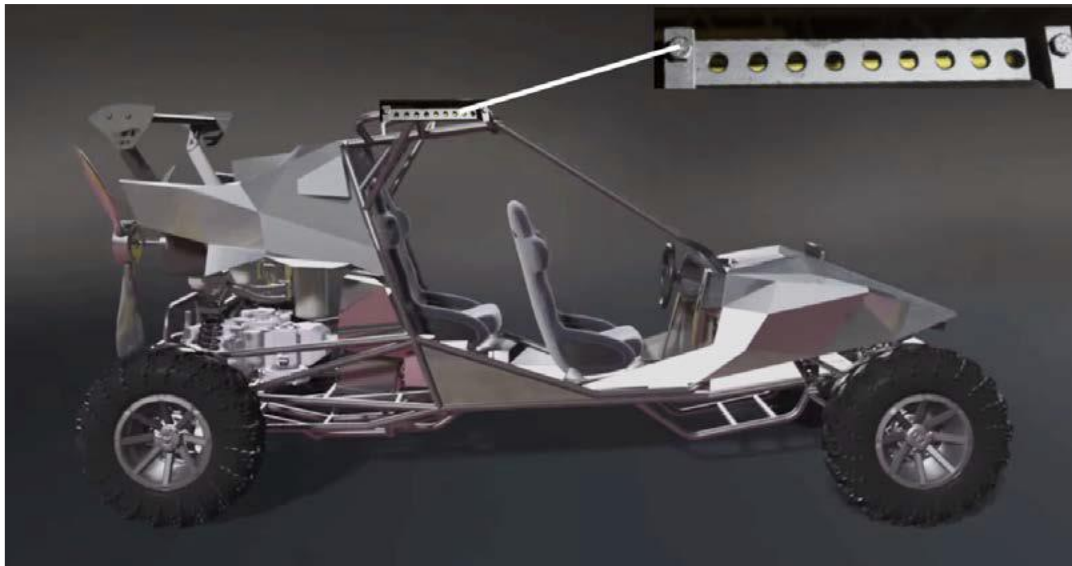
Figure 13. Wing arm CG adjustment mechanism

The Aircraft had a welded steel tube frame. The main chassis is bolted to the lower and upper engine mount portions and the rear suspension drag struts. The front suspension consisted of A-arms. The CG adjustment mechanisms are welded to the frame (figure 13).

The balance of the carriage could be set by adjusting the wing arm CG adjustment mechanism. Variations in the cockpit and fuel loading do not affect the Aircraft's balance significantly. However, the distribution of the load in the carriage affects the attitude of the carriage in-flight in a minor way so long as the prescribed weight limits per seat are followed. These limits were a maximum of 250 lb per seat with a minimum of 80 lb in the pilot seat.

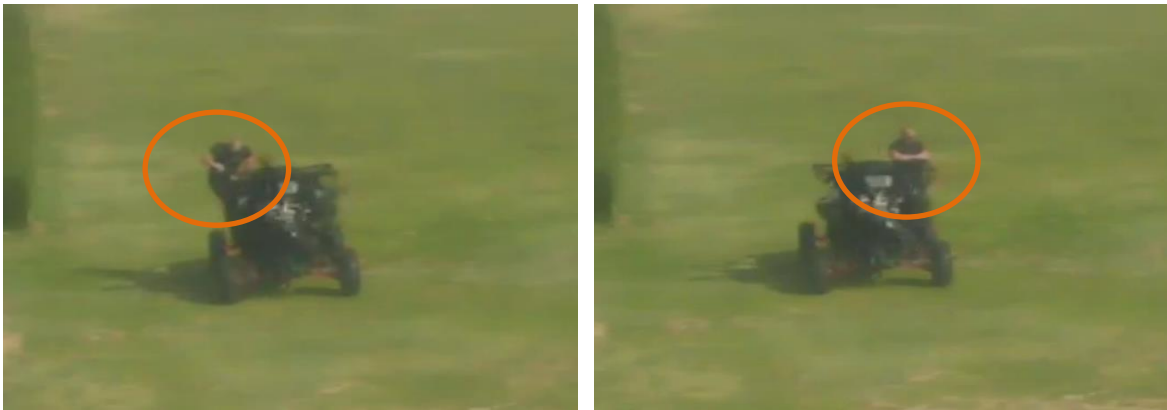
Figure 14. Wing inspection by the Pilot

Videos retrieved from the from the Sky Hub premises closed-circuit television (CCTV) showed that the Pilot conducted the preflight checks as per the manufacturer's checklist in the *pilot operating handbook (POH)* and the Aircraft operating instructions as seen in the figure 14. The engine warm-up test and walk around checks were conducted. The Pilot stated that no Aircraft systems malfunctions or abnormal conditions were noted prior to the flight.

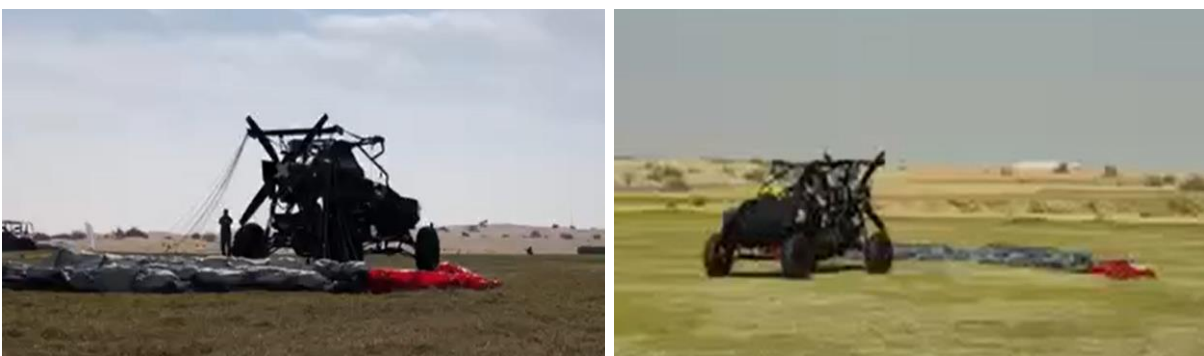
Figure 15. Set Wing before takeoff

It was observed in the video recorded just before the commencement of the take-off roll that the wing was set correctly on the ground as shown on the figure 15.

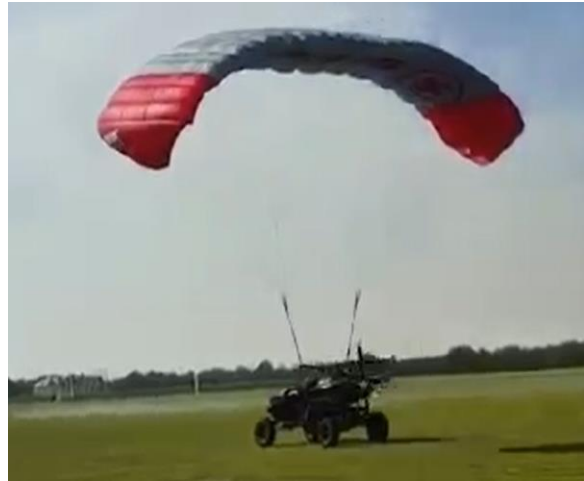
Figure 18. Still from take-off video

Analysis of a still from the take-off video of the Aircraft just before liftoff (figure 18) indicated that the take-off procedures were conducted as per the operations manual and that the Aircraft was in the correct configuration for takeoff. The wing had fully inflated with the cells open and the carriage and the canopy centerlines were aligned. After the liftoff, the Aircraft climbed slowly to a height of approximately 10 ft and remained at that height for five seconds.
