# Air Accident Investigation Sector

## Serious Incident

AAIS Case N° AIFN/0011/2022

## Runway Incursion

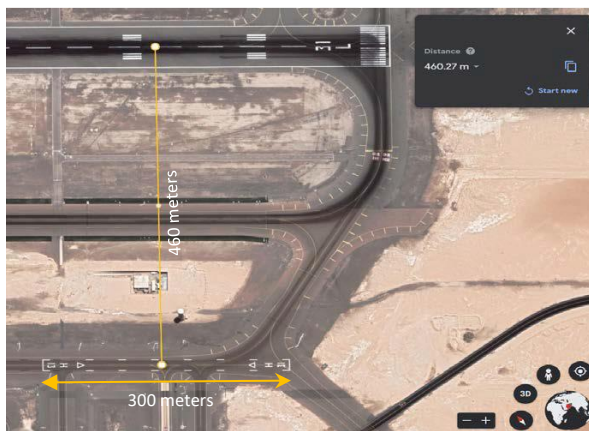
Figure 1. FATO, the runway used for helicopters operations

A defined area for the helicopter final approach and take-off area (FATO) is the heliport used for helicopter operations and is located on taxiway F between E15 and E14, also known as taxiway F13/F31. It is offset and parallel with runway 13R/31L, by approximately 460 meters (figure 1). It is restricted to daytime operations only.

The length of FATO is 300 meters. Parallel operations from FATO and the south runway (13R/31L) are allowed if traffic information has been passed to both aircraft.

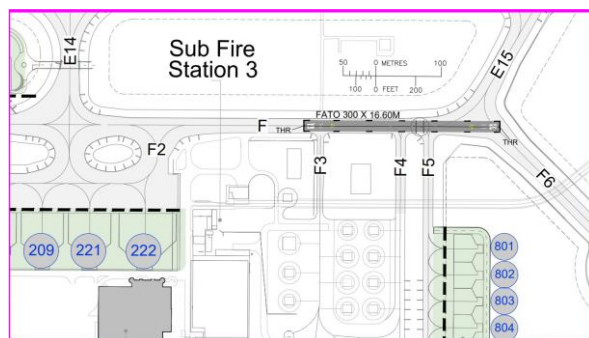
Figure 2. UAE AIP – Heliport chart of OMAA

The related heliport chart as per the *aeronautical information publication (AIP)* (figure 2) shows the FATO location and other information.

- (i) FATO was designated as H31 in the *AIP* and the Jeppesen charts, while it was designated as F31 in *ATSOM*.
- (j) The inconsistency between the FATO designation in Jeppesen charts and terms used by the Tower controller most probably, caused confusion to the flight crew.

In order to have a standard and solid system of using the term FATO 13/31, it is recommended that GANS consider the practicability to include the contents of *Supplementary Instruction 007/23* in the *Air Traffic Services Operating Manual* as SOPs for its air traffic controllers.
