Accident

- Summary Report -

AAIS Case N° AIFN/0009/2022

Loss of Control-Inflight (LOC-I)

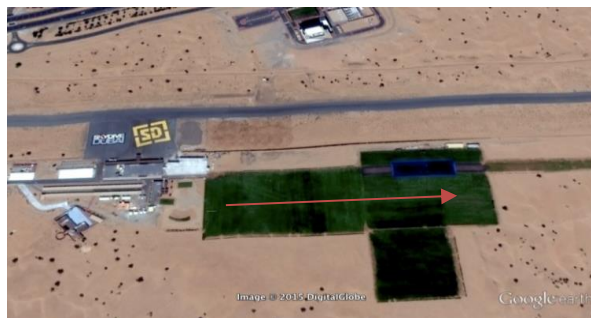
Figure 1. Aerial view of the Club and the field, the arrow shows the take-off direction

The Field Safety Officer provided clearance for the take off and established radio communication after the take off as shown in figure 1.

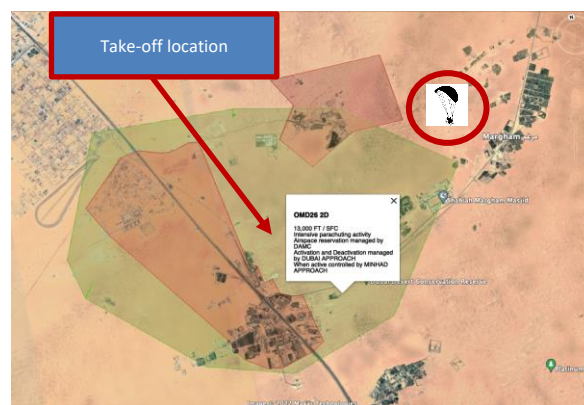
Figure 3. Aerial view of the Club's and the Accident's locations

Thereafter, one of the Club's instructors volunteered to fly and search for the Pilot. After about 15 minutes, the instructor reported seeing the Pilot on ground at approximately 5 kilometres northeast (figure 3) the Club. The instructor landed near the Pilot and confirmed that he was totally unconscious.

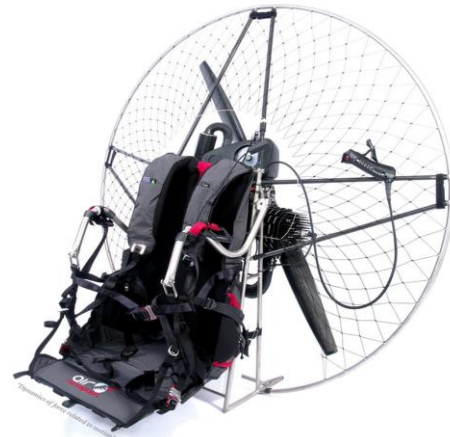
Figure 6. Pilot seat, propeller, and cage

The paramotor, also known as a powered paraglider, consists of a fabric inflatable wing, a pilot seat, engine, propeller and cage. Figure 6

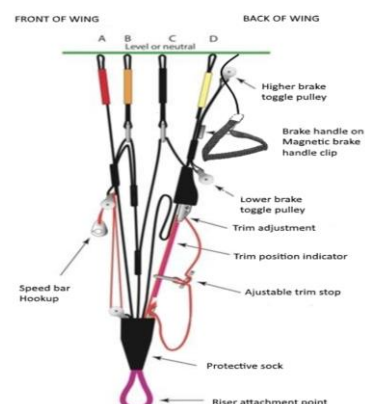
Figure 7. Wing lines description

The paramotor's flight controls comprise brake handles, trims, stabilizer lines, a speed bar and the tip steering lines. The lines are colour coded to indicate which line set they belong to, typically one colour for either A, B, C, or D and the brake lines for easy recognition and to prevent pilot's confusion. Figure 7

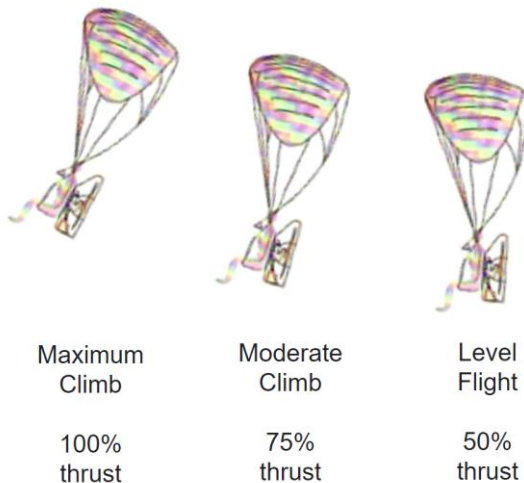
Figure 9. The relation between angle of attack and engine power

As mentioned in the Club's paramotor manual, the angle of attack can be increased either by pulling both brakes which then will lower the trailing edge of the wing and rise the leading edge, or by increasing the engine power which will act as a pendulum and forward the seat of the paramotor to the front which will rise the wing's leading edge (figure 9).

According to the Club's paramotor manual, to avoid stall, the angle of attack shall not exceed 18 degrees.

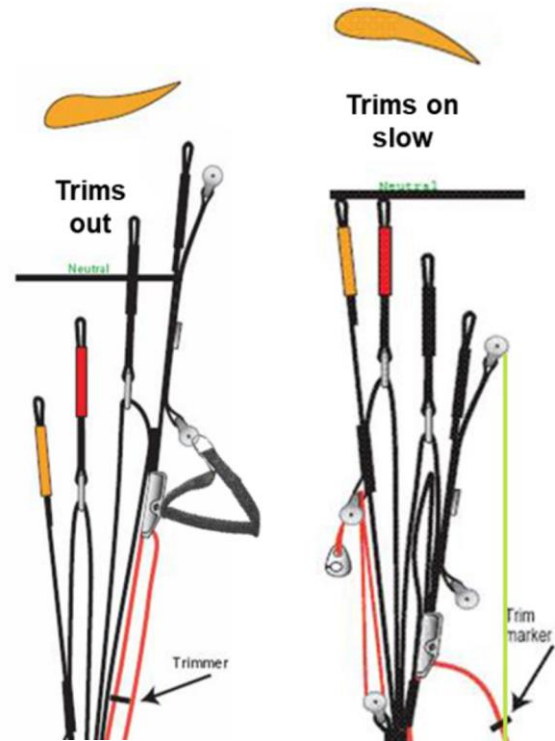
Figure 10. Wingtip steering trim toggle effect

As mentioned in the Club's paramotor manual, wingtip steering is one of the means for making turns. Lines are attached to the wingtips. These lines are connected both left and right to one down-going line called the wingtip line. By

pulling down on this line, the effective surface of the wing will be reduced, increasing the wing loading on that side of the wing resulting in a turn towards that side. (Figure 10)
