# Air Accident Investigation Sector

## Accident - Final Report -

## Runway Undershoot

| Make and Model: | Cessna 208B Grand Caravan |

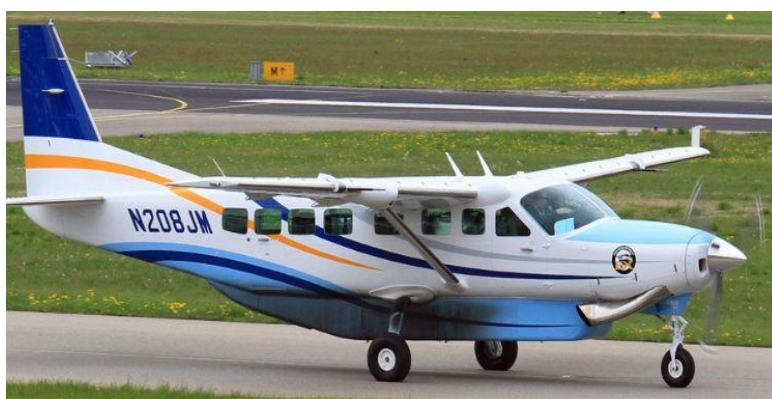
**Figure 2.** Historical photo of the Accident Aircraft

The Accident Aircraft was Cessna 208B Grand Caravan which was a stretched version of the Cessna 208 Caravan. The cockpit was equipped with Garmin G1000. (Figure 2)
