# **Air Accident Investigation Sector**

### **-Final Summary Report-**

AAIS Case N° AIFN/0001/2022

## **Runway Incursion**

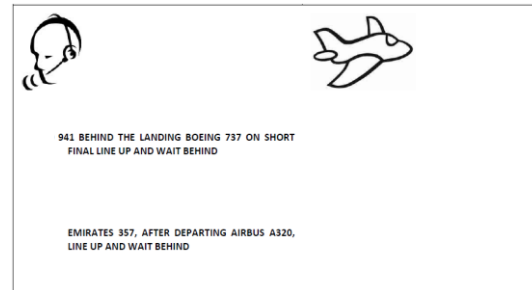
**Figure 3.** AMC 69 Controller instructions to aircraft pilots

2.12.1 Conditional phrases, such as “BEHIND LANDING AIRCRAFT”, or “AFTER DEPARTING AIRCRAFT” shall not be used for movements affecting the active runway(s), except when the aircraft or vehicles concerned are seen by the controller and the pilot. The aircraft or vehicle causing the condition in the clearance shall be the first aircraft/vehicle to pass in front of the other aircraft concerned. Conditional clearances shall not be given to vehicles.

2.12.2 In all cases a conditional clearance will be given in the following order and consist of:

- i. identification; (callsign)
- ii. the condition;
- iii. the clearance;
- iv. brief reiteration of the condition

AIRN controller did not adhere to the DMATS conditional clearance procedures while passing instructions to EK524 flight crew to line up following by the EK568 crossing the active runway before the take-off roll.

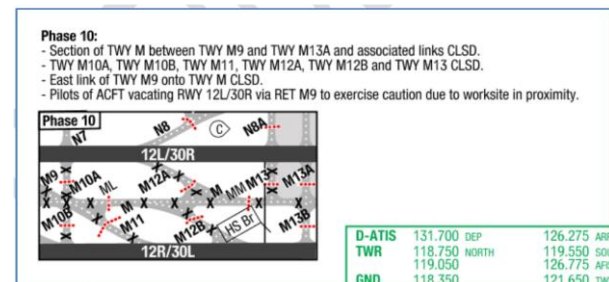
Figure 5. NOTAM Phase 10 information

The segregated mode of operations allows for a departure from runway 30R to be launched without considering an arrival to runway 30L as long as the required conditions have been adhered. The segregated mode of operation was ceased as per the condition that the departure of EK524 was a full-length runway from Mike 15A.

WORKSITE IN PROXIMITY.

REF UAE AIP SUP 68/2021 PHASE 10.
