Serious Incident

AAIS Case N° AIFN/0006/2022

Aircraft Belly Structural Fairing Fracture due to Tire Burst During Flight

Operator:	Emirates
Make and Model:	Airbus A380-842
Nationality and Registration:	The United Arab Emirates, A6-EVK
Place of Occurrence:	During Cruise
State of Occurrence:	The United Arab Emirates
Date of Occurrence:	1 July 2022

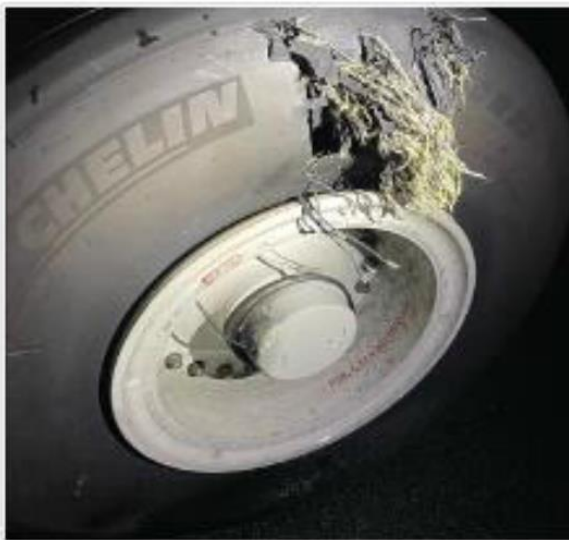
Figure 7. Tire burst pressure effect -radial effect

Pressure calculation for an object away from the tire is a function of tire geometry, tire burst pressure and ambient pressure.

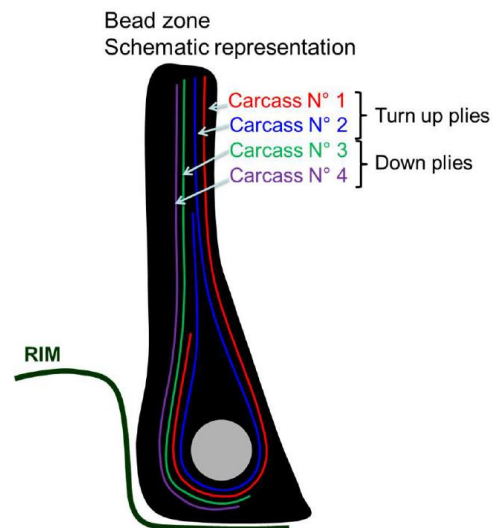
Figure 8. Tire structure

The involved S/N 0056B149 tire corresponds to PN M16004 tire specification. Figure 8 illustrates the tire structure in the bead zone for the PN M16004

The internal pressure is supported by carcass and summit plies. In normal conditions, all carcass plies work together and the total stress on sidewalls is globally uniformly distributed. For the M16004 tire, the structure is made of four carcass plies. Carcass plies No. 1 and 2 (NC1 and NC2) are turn up plies whereas carcass plies NC3 and NC are down plies.

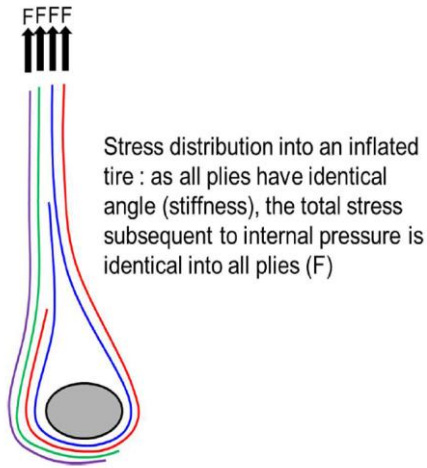
Figure 9. Stress/force distribution in an inflated tire

In a radial tire configuration, all carcasses have an identical angle bordering on 90 degrees. As ply stiffness is directly related to carcass angle, the four carcasses have the same stiffness and then globally hold the same force which is directly related to the tire internal pressure (figure 9). Burst

takes place when the internal force supported by cable carcass reaches rupture force.
