AAIS Case N° AIFN/0006/2024

# Parachute Collapse and Ground Impact Due to Canopy Suspension Line Breakage

Operator:	Skydive Dubai POA
Make and Model:	Fluid Wings, AirWolf2
Place of Occurrence:	Margham, Dubai
State of Occurrence:	The United Arab Emirates
Date of Occurrence:	8 March 2024

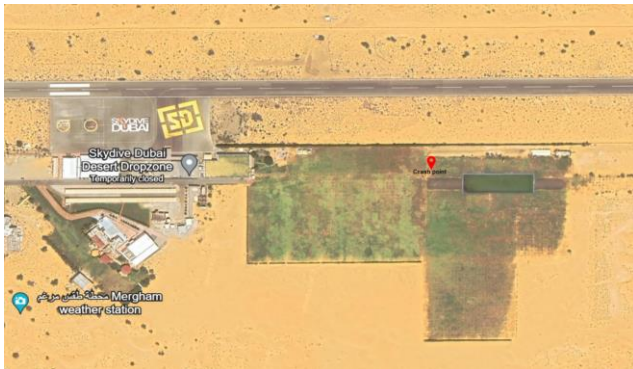
Figure 6. Crash point

At the 40-second mark of the recording, the Parachutist initiated a spiral descent as part of the landing procedure. The first turn was executed to the left, as indicated by the movement in that direction. However, after completing this leftward turn, the parachute lines broke, resulting in an uncontrolled freefall that began at the 45-second mark. The Parachutist impacted the ground within 8 seconds, hitting the crash point at the 53-second mark, as depicted in figure 6.
