Serious Incident - Summary Report -

AAIS Case N° AIFN/0009/2021

Ground Collision

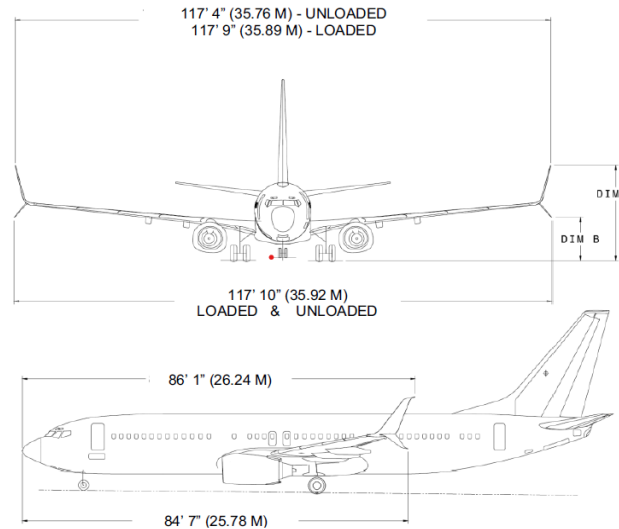
Figure 3. B737-800 dimensions [Source: B737-8 FCOM flydubai]

The B737-800 is a twin-engine aircraft designed to operate over short to medium ranges. The wingspan extends for 35.89 meters (figure 3).

- The width of taxiway Mike is 25 meters;
- Mike 10 Alpha stop bar lights are positioned at about 83 Meters north from the taxiway Mike centerline;
- The wingspan of the taxiing B737-800 was 35.76 meters (figure 3), meaning that the left wingtip was about 17.88 meters from the centerline (half the span);
- The length of the holding A321 was 44.51 meters (figure 5); and
- Assuming that the B737-800 was taxiing on taxiway Mike centerline, as stated by the flight crew.

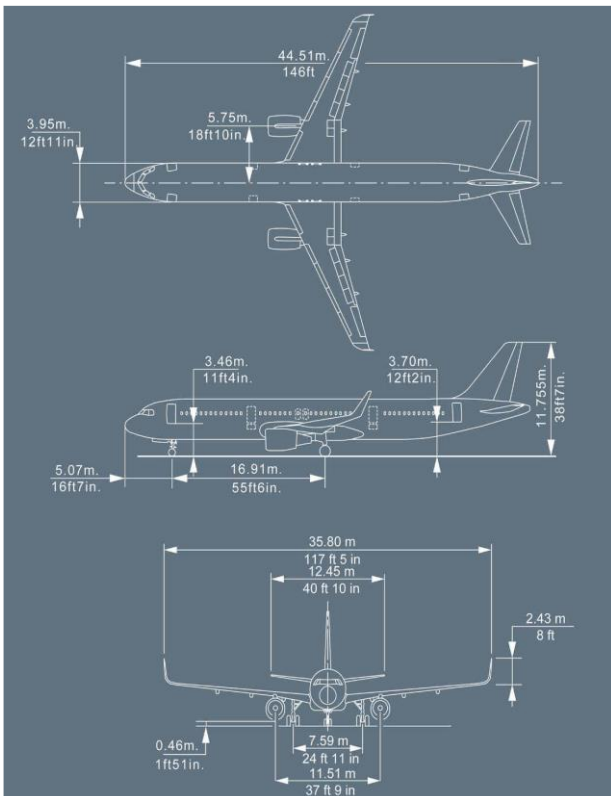
Figure 5. A321 dimensions [Source: FCOM]

The A321 is a medium-range aircraft, powered by two high-bypass turbofan engines mounted under the wings. The aircraft is 44.51 meters long, and the stabilizer height is 11.755 meters from the ground (figure 5). The pilot eye position is 4.56 meters above ground (figure 6).

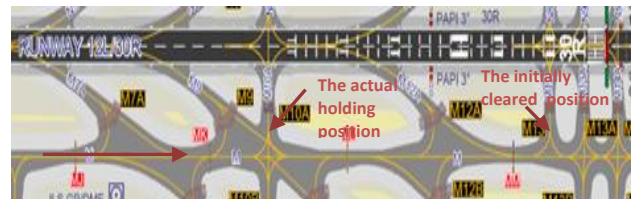
Figure 7. OMDB runway 12L/30R layout [Source: UAE AIP]

OMDB is the primary international airport serving Dubai and is located 2.5 nautical miles east of Dubai. OMDB has two runways, 12R/30L and 12L/30R. OMDB infrastructures were fully compliant with *CAR Part IX ADR – Aerodromes*. Both asphalt runways are 4,447 and 4,351 meters long, respectively. Figure 7 illustrates the runway 12L/30R and taxiway Mike layout.
