الهيئة العامة للطيران المدني
GENERAL CIVIL AVIATION AUTHORITY

Serious Incident

AAIS Case N° AIFN/0004/2025

Tail Strike

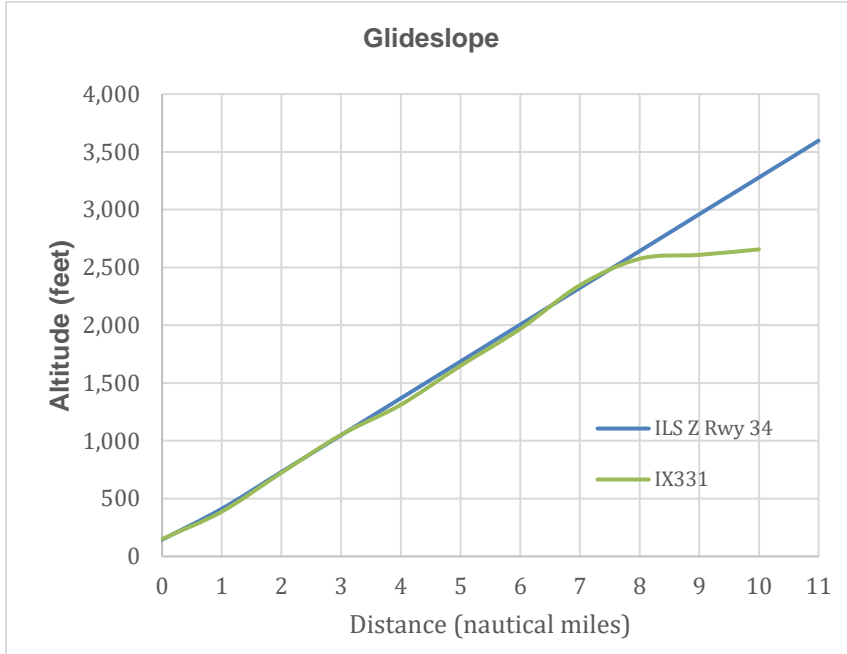
Attachment A. Aircraft Glideslope on Final Approach

The Aircraft crossed the threshold at $V_{ref} +7$ knots with engine thrust above idle, and the rate of descent increased to 1,200 feet per minute below 100 feet radio altitude, exceeding common stabilized-approach limits. These conditions contributed to excess energy at flare initiation and prevented adequate arrest of descent, leading to a firm first touchdown, a bounce, and an improper recovery that culminated in a hard second landing.
