Air Accident Investigation Sector

- Final Report -

AAIS Case N°: AIFN/0011/2023

Controlled Flight Into Terrain (CFIT) (Sea Impact)

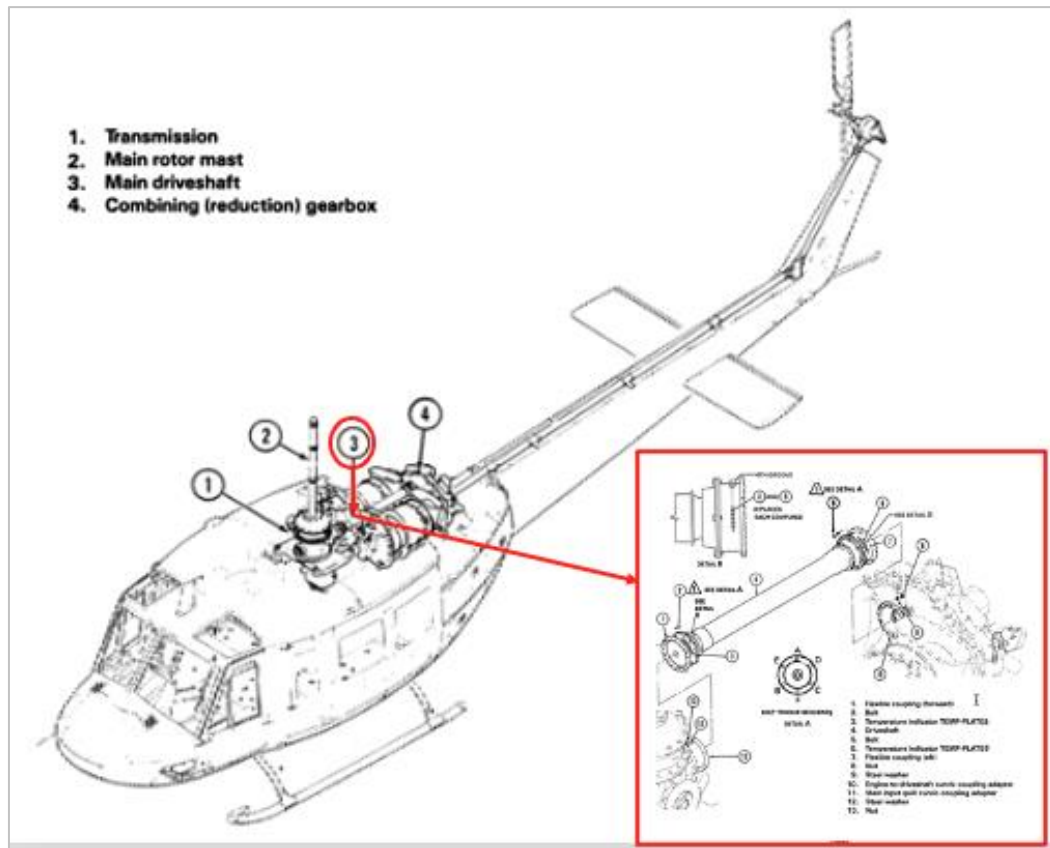
Figure 4. Bell 212 main driveshaft location

The Bell 212 *maintenance manual* troubleshooting stated that a probable cause of grease leakage from the main driveshaft is "Improperly assembled driveshaft coupling" or "faulty packings or seals." Corrective action includes, "Remove leaking coupling, disassemble, inspect, assemble, and install coupling..." or "Replace leaking packing (s) or seal (s)..." Figure 4 illustrates the location of the main driveshaft.
