الهيئة العامة للطيران المدني
GENERAL CIVIL AVIATION AUTHORITY

- Final Report -

AAIS Case N° AIFN/0015/2023

Severe Air Turbulence Encounter (TURB)

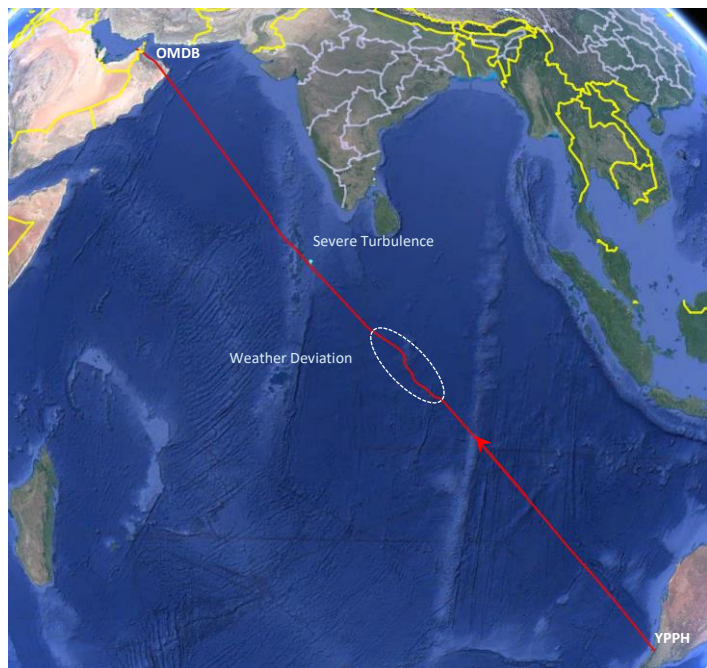
Figure 1. Flight path YPPH - OMDB

About six and half hours into the flight, at 2105:00, while cruising at FL380 in Male FIR, about 35 nautical miles before reaching AQAXA waypoint at Mach 0.84, on a heading of 320 degrees, the Aircraft experienced a period of turbulence lasting about 36 seconds, with most severe turbulence with vertical g variation between -0.5g and +2.16g that lasted for six seconds (between 2105:04 and 2105:10), then moderate turbulence that lasted for 14 seconds (between 2105:10 and 2105:24), followed by light turbulence for another 16 seconds. (Figures 1 and 2 illustrate the geographical location of the Aircraft where the turbulence occurred).
