Accident

AAIS Case N° AIFN/0009/2020

Gyrocopter Landing Strip Excursion after Landing

Operator:	Nad Al Sheba Private Club
Make and Model:	Gyrocopter – ROTOX 914
Nationality and Registration:	United Arab Emirates, A6-GY7
Place of Occurrence:	Nad Al Sheba, Dubai
State of Occurrence:	The United Arab Emirates
Date of Occurrence:	24 July 2020

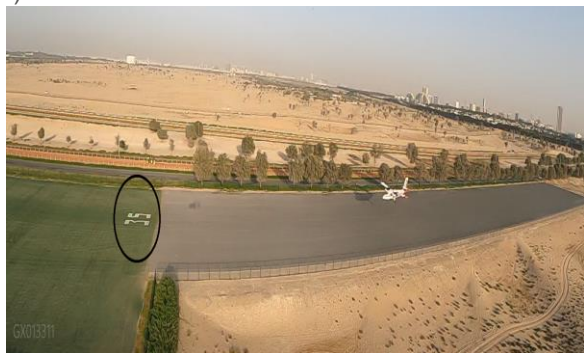
Figure 7. Landing strip 35 with designation clear on the surface.

The Club used a landing strip for takeoffs and landings (designated clearly 17/35). In addition, a wind sock is located to the right of the landing strip landing on 35, and to the left landing on 17. (Figure 7)
