AAIS Case Reference: 16/2012

SERIOUS INCIDENT INVESTIGATION REPORT

In Flight Turn Back – Engine Nacelle Fire

Abu Dhabi International Airport
United Arab Emirates
09th September 2012

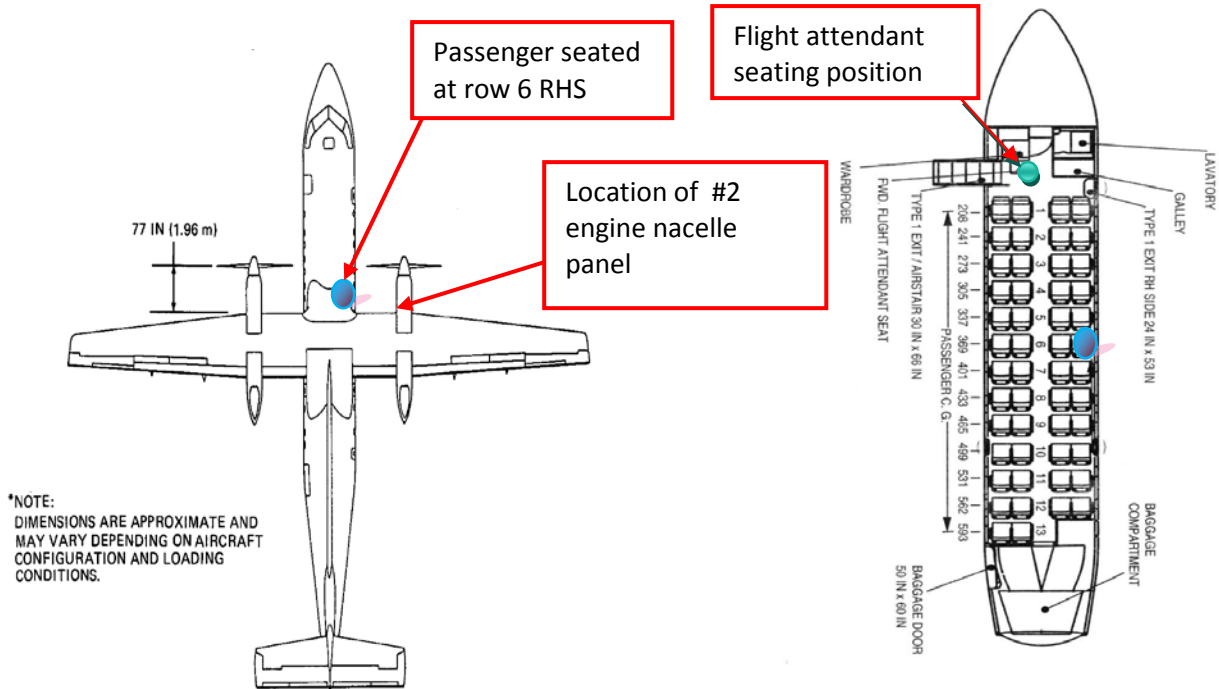
FIG 1
DHC8-315 Aircraft Diagram showing seating position of the passenger and flight attendant and location of the #2 engine nacelle panel

His attention was now focused on #2 engine nacelle panel as he could see a hot spot with fumes coming from the vents located on the panel. Initially he thought it may have been due to some residual fluid within the compartment and after a short while should have subsided. However as the aircraft continued its short taxi for takeoff, he noticed that the fumes were continuing and the color of the panel turning from white, original color, to brown then to black.

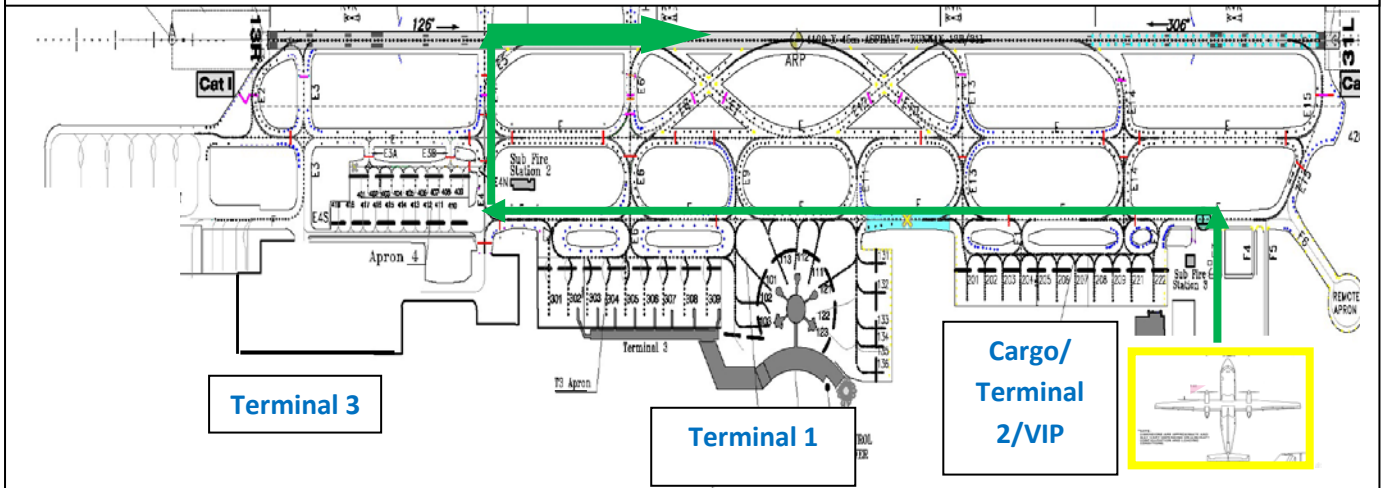
FIG 2

Abu Dhabi Airport (OMAA) - DHC8-315 flt# xxx711 boarding, taxi and take off positions.

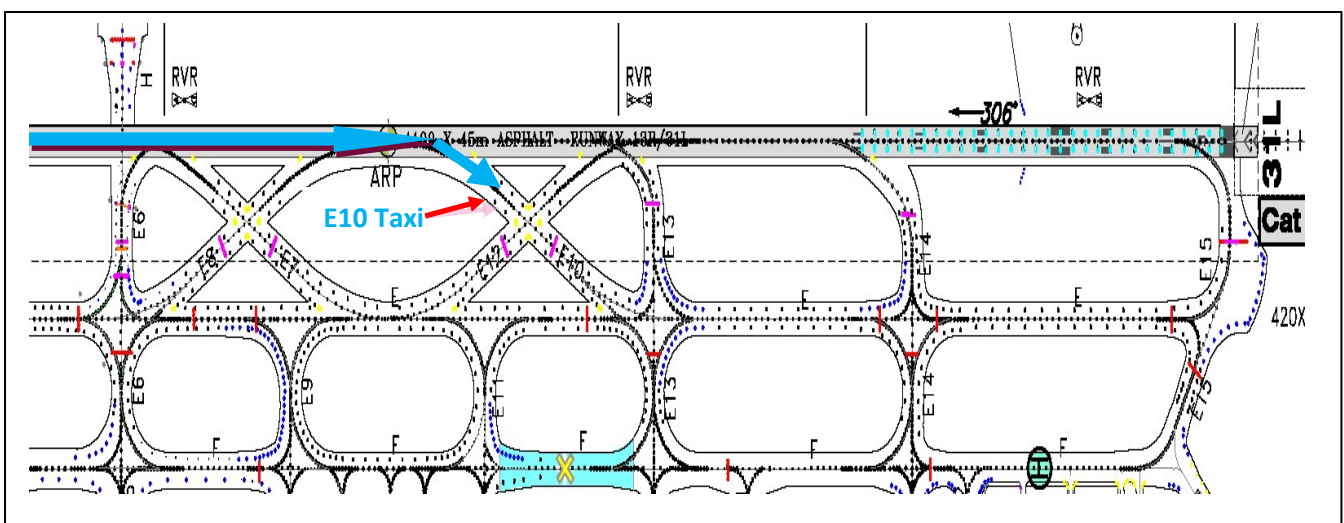
FIG 5
Abu Dhabi Airport (OMAA)- Aircraft landed on RWY 13R and stopped at E10 taxiway

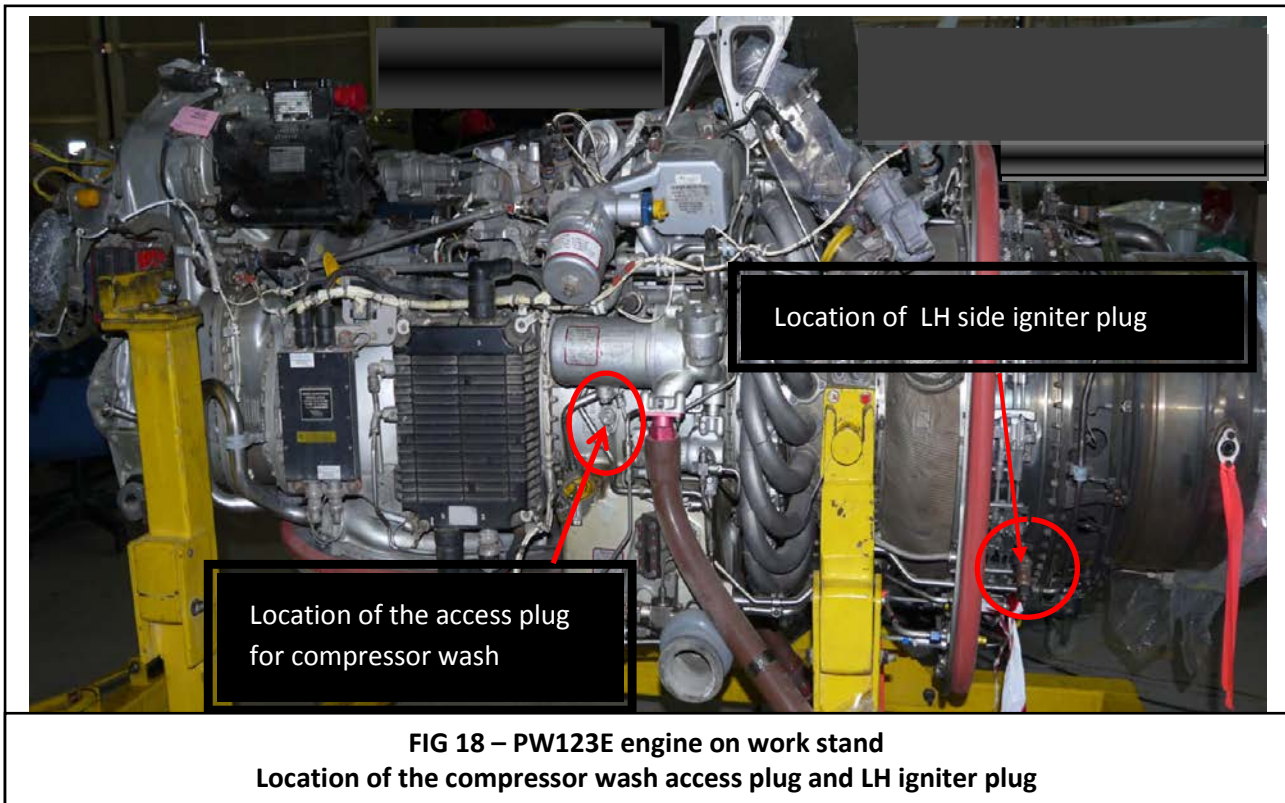
³ The reference for this work can be found in PW&C Maintenance manual 72-00-00 Engine Cleaning, Step C – Turbine Wash, and the airline follows Method 2

⁴ Pratt & Whitney Canada Maintenance Manual 72-00-00 fig 704

As per normal practice, the fitters reported back to the control room and information was passed to the supervisor that the engine washes were completed. Based on that verbal confirmation, the supervisor certified in the aircraft log book that Engine turbine water wash c/o IAW P&WC MM 72-00-00 Engine cleaning Step C, Turbine water wash, Method 2.”

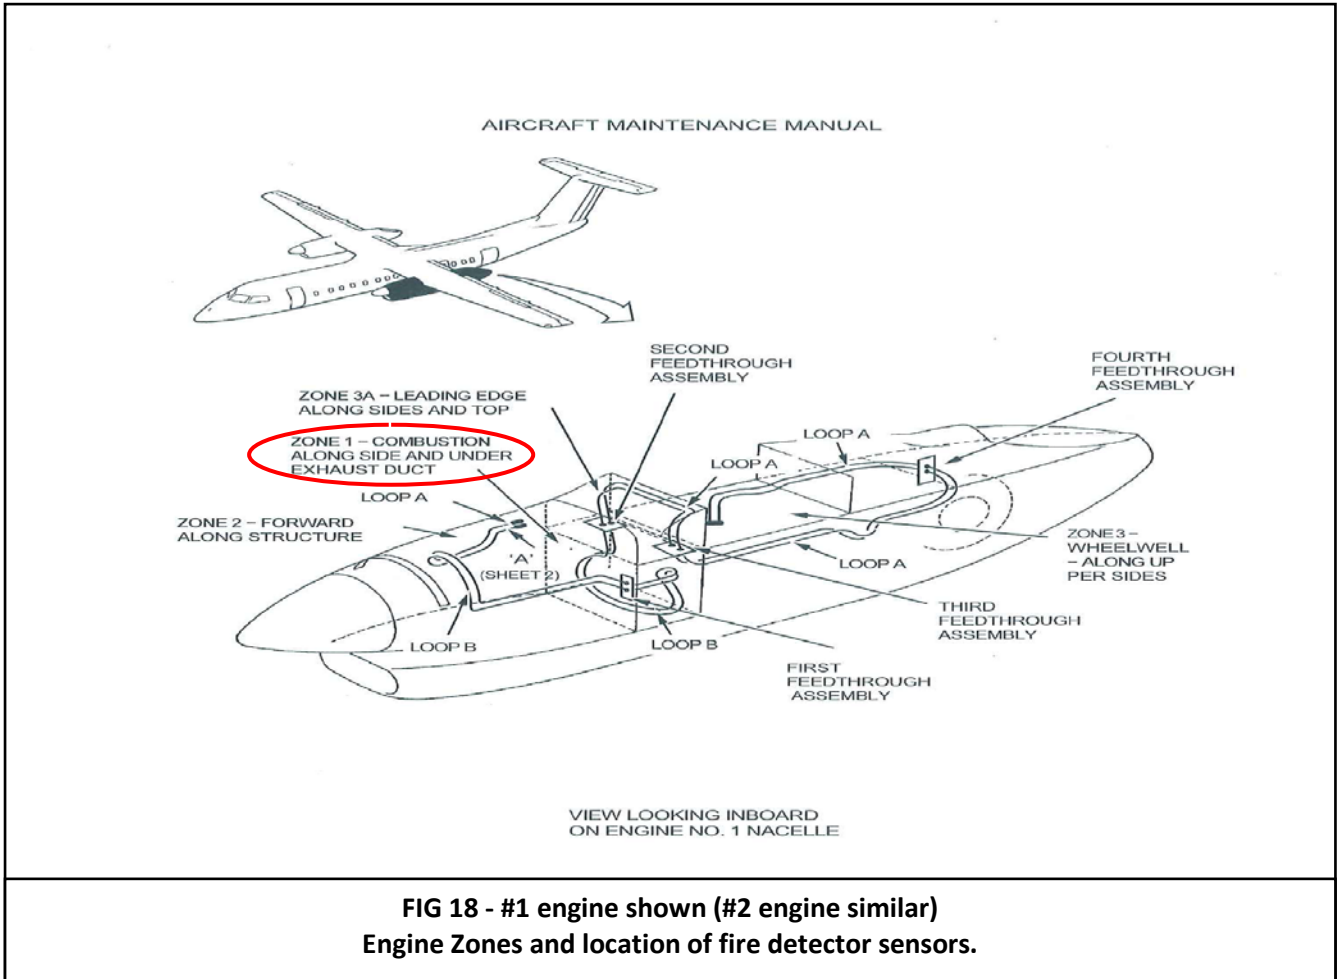
During the entire period from engine start, taxi, take off and return to OMAA, there was no fire/overheat warning reported by the flight crew.

There are two fire detector loops located within the engine compartment, zones, for monitoring and indicating a fire or overheat condition to the flight crew⁵. Whenever the temperature within the zone reaches a predetermined temperature, as per the component maintenance manual⁶ the temperature range is between 177 to 221 degrees Celsius, a warning is triggered in the flight deck indicating an overheat or a fire in the engine area.

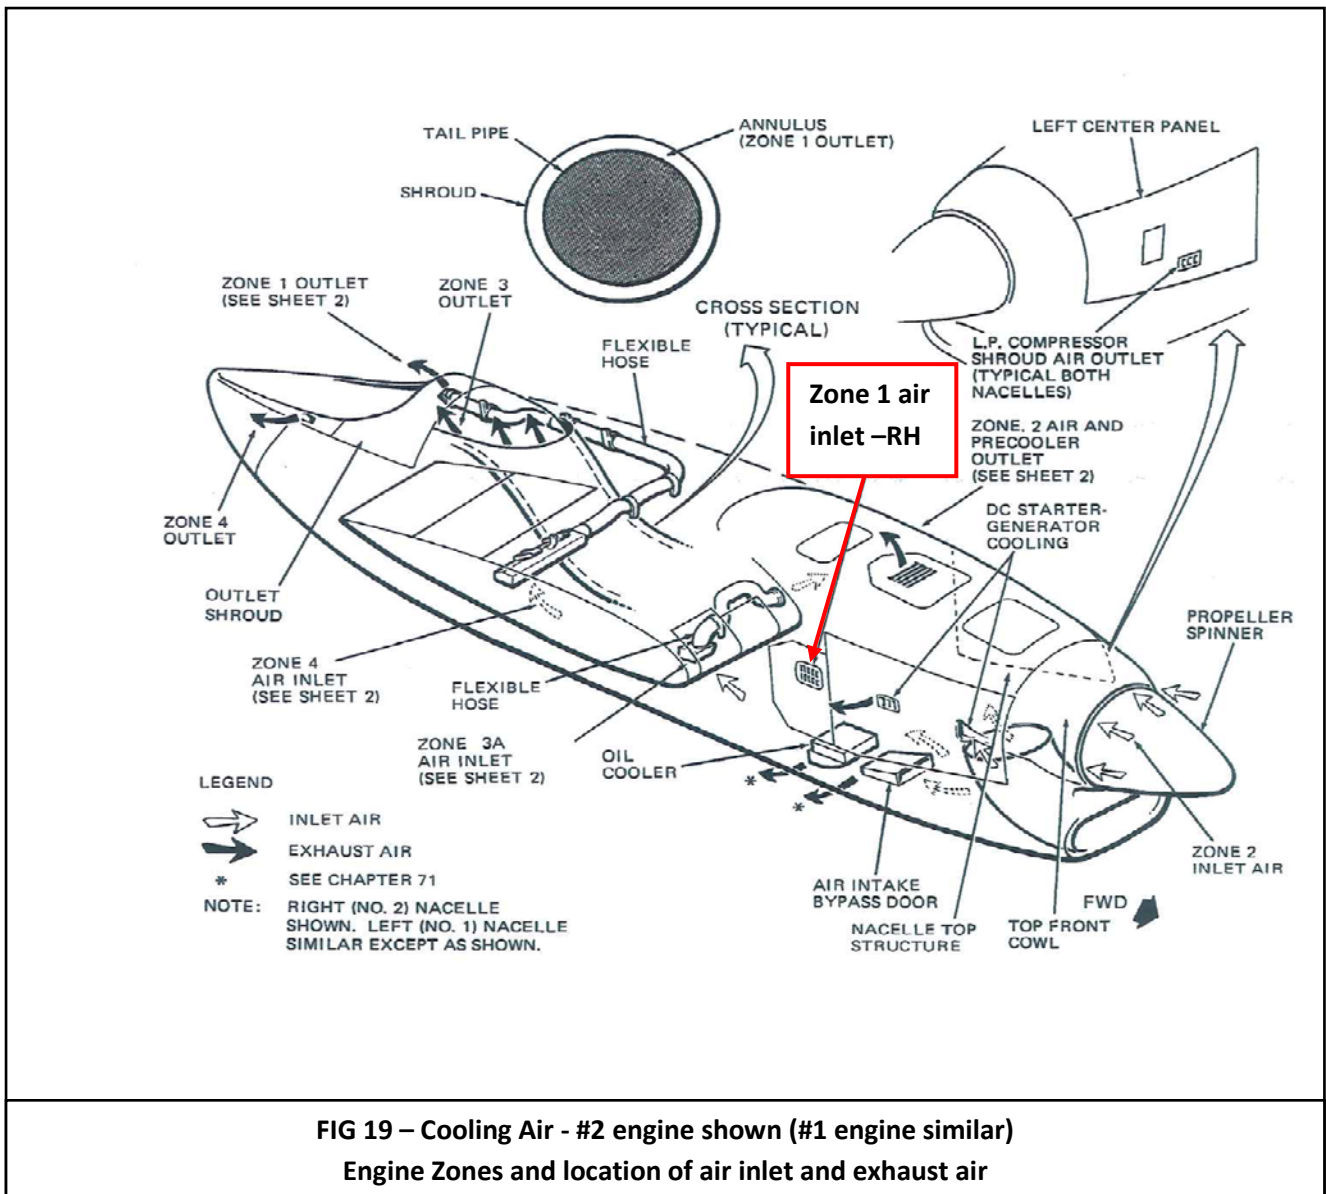
The engine compartment is divided into zones and the zone where the hot gases were exiting in this event, is known as zone 1. This is the engine hot end and tail pipe area and includes the combustion zone. Zone 1 consist of a continuous shroud surrounded by a firewall and is made of fire proof material as mentioned in the manufacture aircraft maintenance manual⁷.

Zone 1 is also cooled by ambient air which enters the area via the forward facing louvers located on the nacelle access panels 415AL, 416AR for # 1 engine and 425AL, 426AR for #2 engine. The ambient air is circulated within the zone and cools and ventilates the compartment. The air is then exhausted from the annulus formed between the engine tail pipe and the compartment shroud.
