Accident
- Final Report -
AAIS Case N° AIFN/0006/2020

Collision with Ground Support Vehicle during Parking

Operator:	Sigma Airlines
Make and Model:	Airbus A300B4-203F
Nationality and Registration:	Republic of Kazakhstan, UP-A3003
Place of Occurrence:	Sharjah International Airport, Sharjah
State of Occurrence:	The United Arab Emirates
Date of Occurrence:	28 February 2020

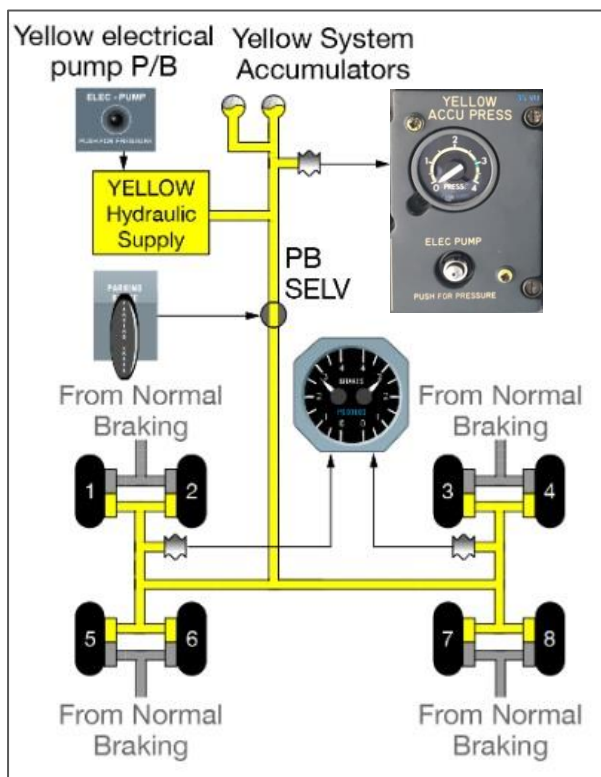
Figure 7. Parking Brake system with the Aircraft's pressure indicator image inserted
[Source: Airbus/AAIS]

A yellow hydraulic system pressure indicator, labelled "YELLOW ACCU PRESS", is located on the center overhead panel of the flight deck. In case of the loss of the yellow hydraulic system, the parking brake system operates through the accumulators which are hydraulically isolated by safety and check valves.

The Aircraft's cockpit indicator, as illustrated in figure 7, is scaled from 0 to 4,000 psi, indicating a green 'normal operation' range from about 3,000 psi. A dual brake pressure indicator was located in the cockpit center panel and displays the available brake pressure from the yellow

³ Figure 7 of the yellow hydraulic system omits the location of the high-pressure filter and check valves located in the yellow hydraulic system supply line

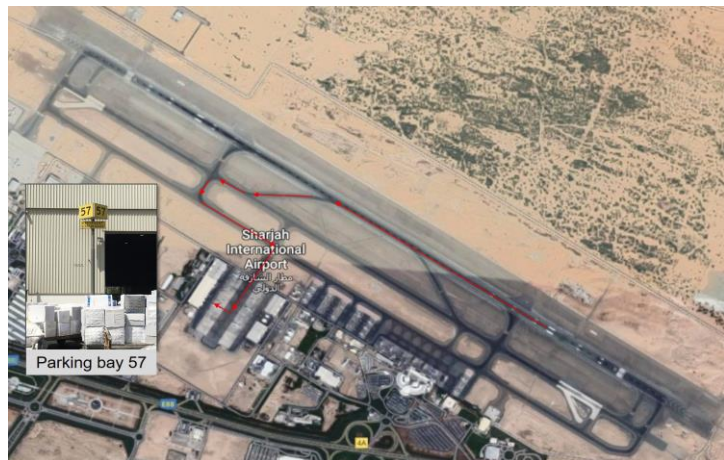
Figure 9. Aircraft landing and taxi route to parking bay 57

The Investigation requested information on the marking compliance, lighting conditions and slope of the cargo apron in general, and in particular for parking bay 57, where the Accident occurred.

The apron markings and the slope of 0.28% at parking bay 57 were found to be compliant with the *Civil Aviation Regulations* of the United Arab Emirates. However, an aerodrome compliance audit conducted by the General Civil Aviation Authority of the United Arab Emirates (GCAA) in January 2020 found that the lighting intensity at bay 57 were not compliant with *Civil Aviation*
