Air Accident Investigation Report

- Preliminary Report -

AAIS Sector Accident Case # 02/2014

Registration: A6-DYR

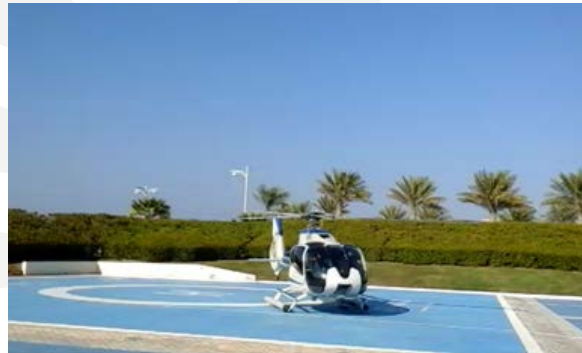
Figure 5: Position On The Heliport Helipad Prior To The Flight

The helicopter was positioned on the helipad on a heading of approximately 200°. The departure is normally a coastal departure along the Palm, inbound to DXB. The flight required lifting to a hover position, a pedal turn to a northerly heading and a standard climbing departure from the heliport.
