AAI Case Reference: 16/2010

## FINAL AIR INCIDENT INVESTIGATION REPORT

### ENGINE FAILURE DURING WARM-UP

IL 76 TD

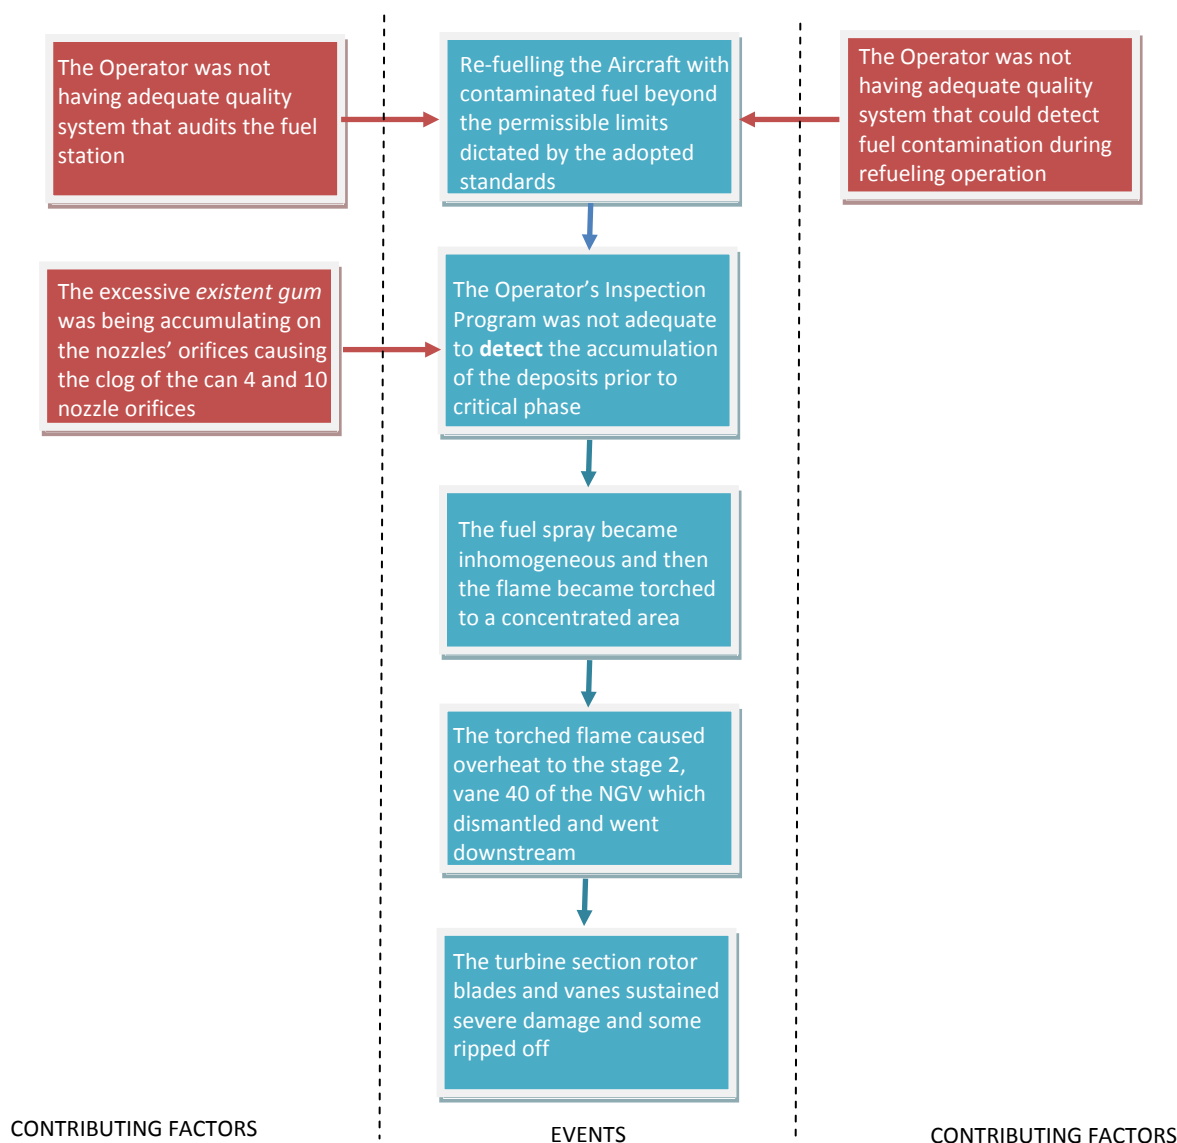
- The accumulation of the existent gum resulted in a flame torching and then overheat stress on the combustion can, and the turbine 2<sup>nd</sup> stage nozzle guide vane forcing it to dismantle and then depart the shroud. The defragmented vane went downstream the engine flow passing through the consecutive turbine rotor blades and guide vanes leaving high impact damage to them.

The tree below illustrates the Events Link Analysis Network (“ELAN”) of the Incident as well as the contributing factor of each event.

The Air Accident Investigation Department determines that the probable cause of engine No. 2 failure was internal damage caused by heat stress resulting from the use of highly contaminated fuel.
