Air Accident Investigation Sector

- Summary Report -

AAIS Case N° AIFN/0012/2016

Forced Landing

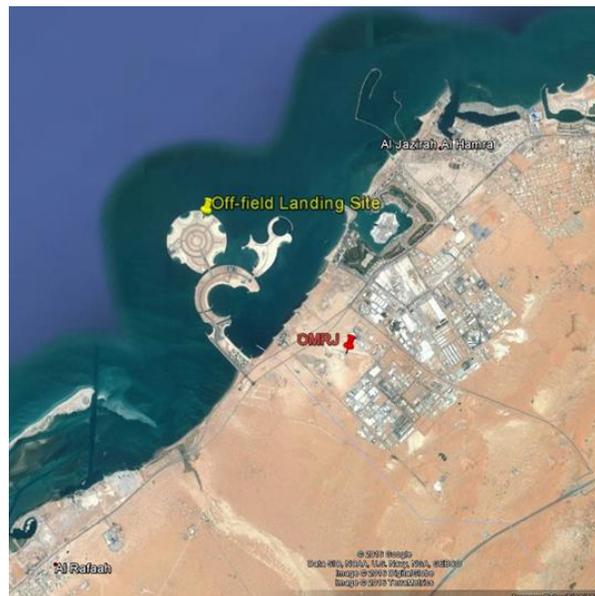
Figure 4 shows the area of OMRJ aerodrome and the selected off-field landing site.

Figure 4. OMRJ and the off-field landing site
