Air Accident Investigation Sector Accident

- Final Report -

AAIS Case N° AIFN/0020/2014

Loss of Control-Inflight

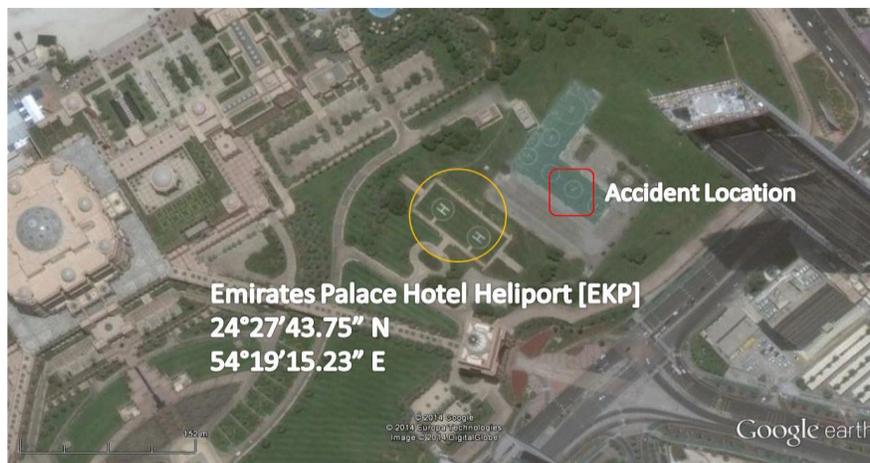
Figure 2. Emirates Palace Hotel Heliport

The heliport was uncontrolled and there was no heliport landing officer (HLO).
