- Summary Report -

AAIS Case N° AIFN/0011/2018

Inadvertent Opening of Emergency Exit Hatch and Deployment of Slide Ramp

Operator:	Saudia Airlines
Make and Model:	Airbus A320
Nationality and Registration:	Saudi Arabia, HZ-AS55
Place of Occurrence:	Dubai International Airport
State of Occurrence:	The United Arab Emirates
Date of Occurrence:	20 September 2018

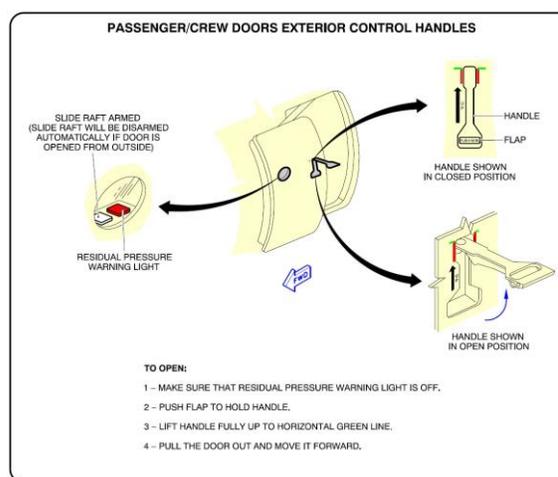
The four type I passenger doors may be operated from outside the aircraft by lifting a control handle upright, after the cabin pressure has been equalized by the flight crew, and the doors have been disarmed by the cabin crew from within the cabin. Refer to figure 3.

Figure 3. Passenger door opening mechanism
[Source: Airbus]

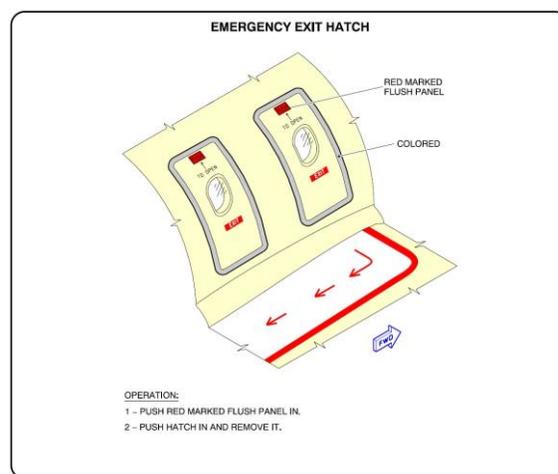
The type III emergency exits are opened from inside the cabin by removing a cover and operating a pull handle. These exits are accessible from the outside via the upper surface of the wing, and they are opened by pushing a red push panel, as shown in figure 4. Applying force to the push

Figure 4. Over-wing emergency exit hatches
[Source: Airbus]

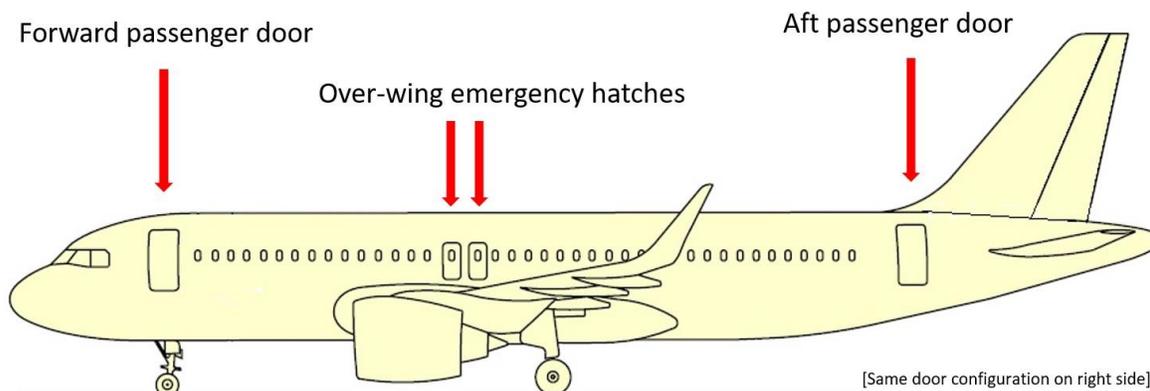
It is equipped with four floor level type I emergency exits (doors 1L, 1R and 4L and 4R), and four type III emergency exits at rows 35 and 36 (forward over-wing exits L and R, and aft over-wing exits L and R) as shown in figure 5. Opening either of the floor level type I exit doors in the armed position, automatically deploys a slide raft to assist evacuees exiting from these doors. The opening of any of the over-wing emergency exit hatches, deploys a slide ramp over the trailing edge of the wing to assist in evacuation.

Figure 5. A320 (Emergency exit) door configuration
