# Air Accident Investigation Sector

AAIS Case N° AIFN/0012/2020

# Fatal Ground Impact after Loss of Control

Operator:	Jetman Dubai
Make:	Jetwing
Place of Occurrence:	Margham, Dubai
State of Occurrence:	The United Arab Emirates
Date of Occurrence:	17 November 2020

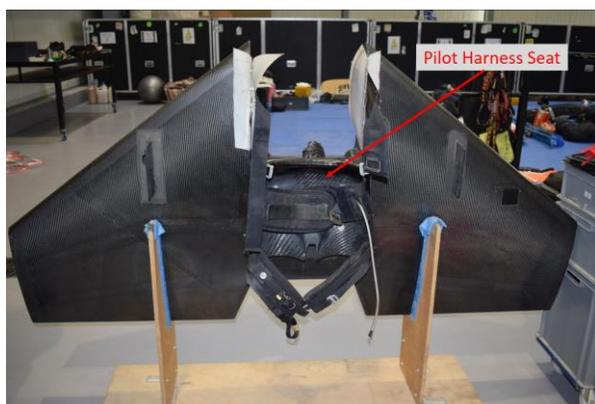
**Figure 4.** Jetwing underside and pilot attachment

A Jetwing pilot is attached to the wing by the pilot harness seat as shown in figure 4, and is equipped with a main and reserve parachute. The main parachute is deployed for normal landings where the wing is still attached, or when the wing is released from the pilot.

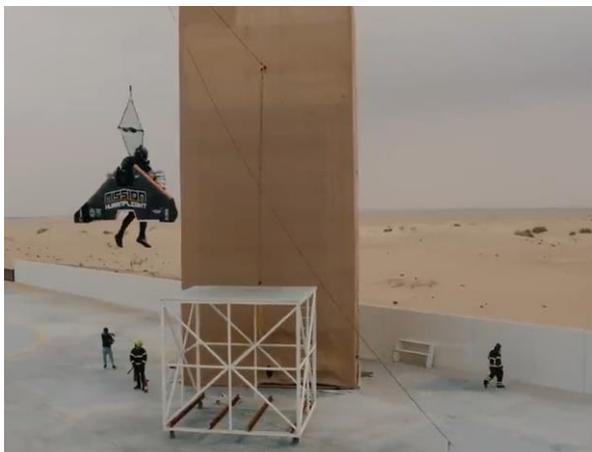
**Figure 5.** Tethered hover test [Source: Jetman Dubai]

Jetman Dubai facility was equipped with tethered Jetwing towers which was utilized for hover training. The training included the takeoff from and landing on a raised platform as shown in figure 5.

It was identified during these sessions that a back-leaning attitude during hover was one of the hazards a pilot may encounter while maintaining control of the Jetwing.
