- Summary Report -

AAIS Case N° AIFN/0013/2019

Paramotor Ground Impact After Lift-off

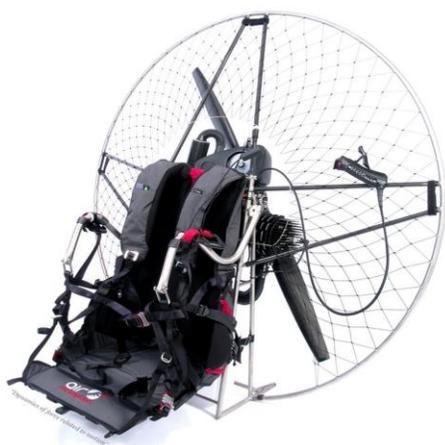
Figure 3. Paramotor engine

The paramotor engine, when at the full power setting, generates a torque which causes it to veer to the right. However, the engine includes a built-in engine torque compensation installation which reduces this torque to a negligible level called 'residual torque'. This residual torque requires minimal counter action from the pilot. The General Manager demonstrated a takeoff at full power with the same configuration that the Accident Pilot applied on his Paramotor. The Investigation found

that the residual torque is minimal and requires no installation to be made to counter it.

The General Manager demonstrated two takeoffs: one with right trim opened; and one with both trim fully closed. It was found that the residual torque was not significant and did not affect the Paramotor controllability if left unadjusted. Although the application of this technique may be beneficial in counteracting the slight residual torque, this benefit may be outweighed by the effort that paramotor pilots need to pay for controlling the paramotor.

The Investigation found that residual torque was not a factor in the Pilot losing control of the Paramotor.

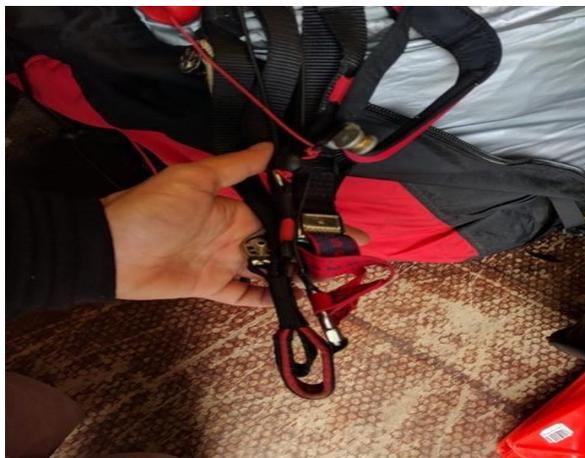
Figure 5. Example of a double loop to compensate torque

Before conducting the flight, the Pilot may have adjusted his Paramotor engine to eliminate residual torque. One way to counter it – as stated in the SOP- is to use risers that have a double attachment point for the carabineer. The wing would be attached to the lower attachment point on the side toward which the torque will deflect the machine.

Another method of eliminating residual torque – as per the SOP- is by opening the trims slightly on the side affected by the residual torque to allow the wing to fly faster on that side. However, the General Manager has demonstrated two takeoffs, one with right trim opened and one with both trim fully closed.
