# Air Accident Investigation Sector

### - Preliminary Report -

AAIS Case N°: AIFN/0013/2015

## Gyrocopter Loss of Control

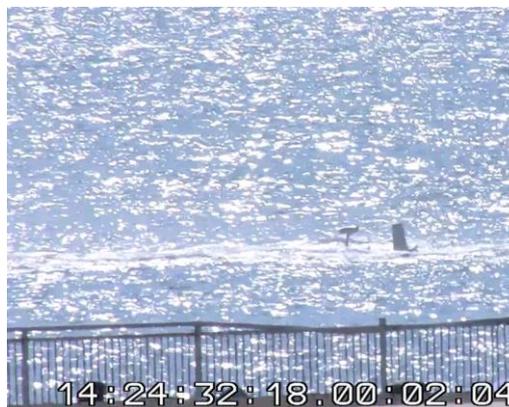
The search and rescue team of divers recovered the Pilot from a depth of about 20 feet below the surface. The Pilot sustained serious injury, with a broken jaw, and was unconscious when taken from under the sea. It is estimated that the pilot was submerged in the water for approximately ten minutes.

The Pilot did not regain consciousness and succumbed to his injuries ten days after the accident.
