الهيئة العامة للطيران المدني
GENERAL CIVIL AVIATION AUTHORITY

Accident - Final Report -

AAIS Case N° AIFN/00018/2012

Passenger Door Separation In-flight

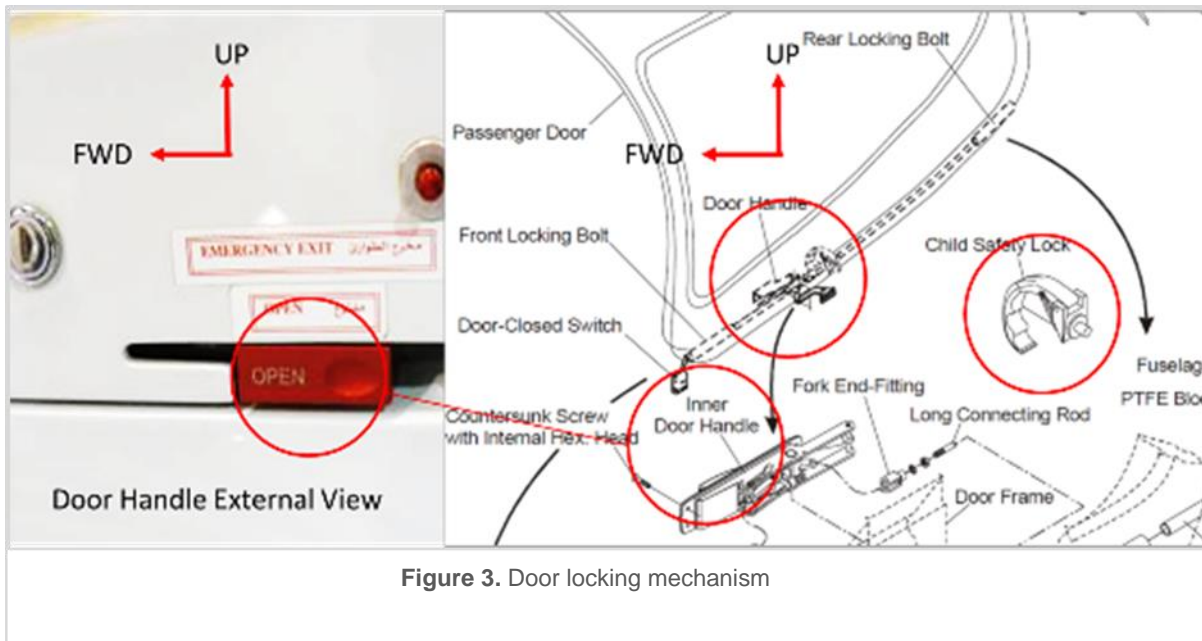
Figure 3. Door locking mechanism

A short connecting rod attaches to the front of the double lever. The short connecting rod goes to the front locking bolt. If the canopy handle is pulled away from the canopy frame, the following actions occur:

- The double lever turns to pull both of the connecting rods
- The long connecting rod pulls the rear locking bolt forward
- The short connecting bolt pulls the front locking bolt aft
- The aft movement of the locking bolt operates a micro switch for the warning caption located on the ICS.
